APPENDIX B
REPORT OF MISSION EVENTS PANEL

Panel 1 was assigned the task to develop a detailed and accurate chronology of mission events directly related to the flight of Apollo 13. This event sequence would then form a baseline of data for analytical use by Panel 1, other Panels, and the Review Board.

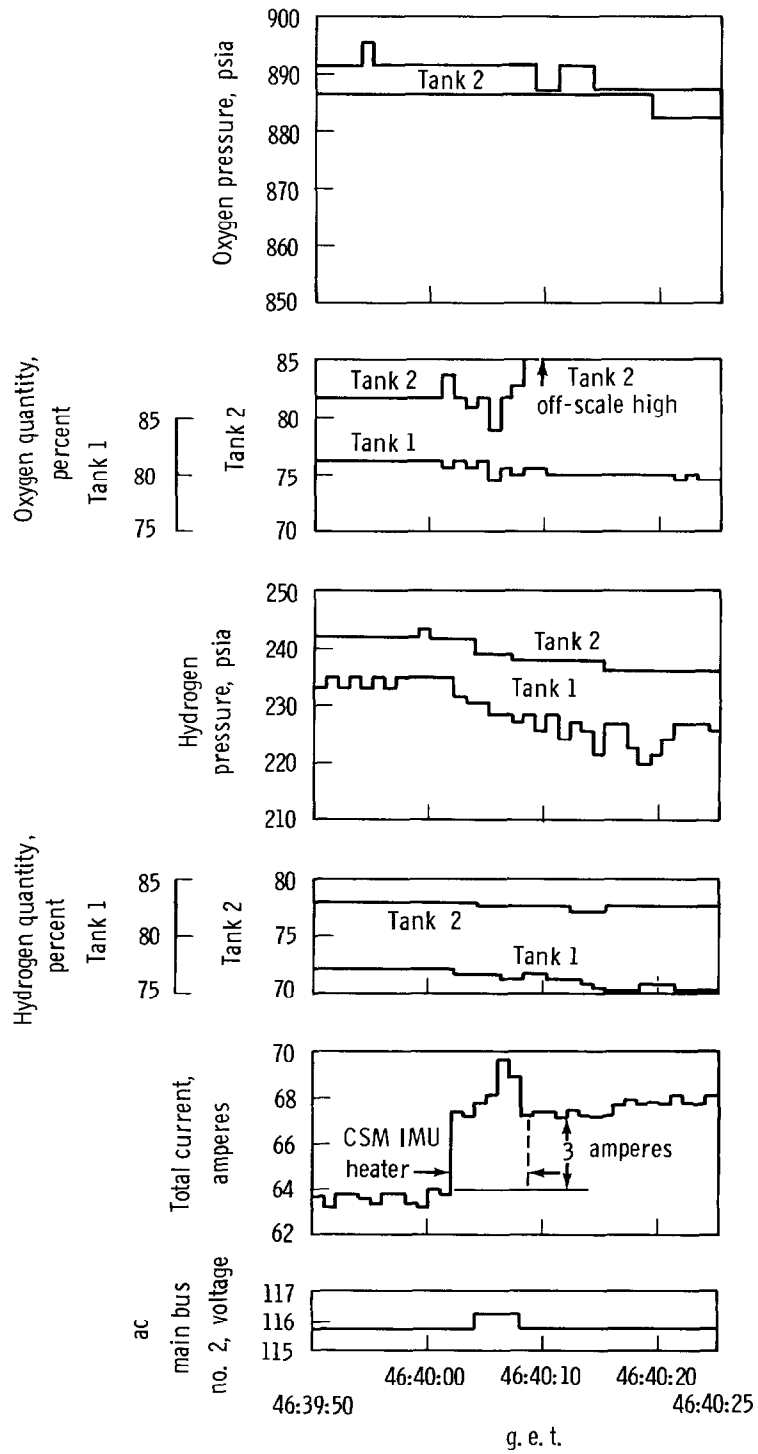
Figure B4-12.- Fan cycle at 46:40.

At 47:40:08 the oxygen quantity changed from approximately 82 percent to 100 percent, or full-scale high. This change in reading or quantity system malfunction occurred just after or at the time the oxygen tank no. 2 fans were turned on. Because of the way the system recovered at the time of the accident, the data indicate that the probe or its associated wiring shorted. Since the instrumentation system was in low bit rate, it is possible to determine exactly when the oxygen

tank no. 1 and no. 2 fans were turned on. The electrical data indicate that the oxygen tank no. 1 and no. 2 fans were turned on between the times of 47:40:05 and 47:40:08. A plot of cryogenic pressures, quantities, total CSM current, and ac main bus 2 is shown in figure B4-12. Therefore, the oxygen tank no. 1 and no. 2 fans were turned on in a period of time between 3 seconds prior to the probe malfunction and the time that the probe malfunctioned.

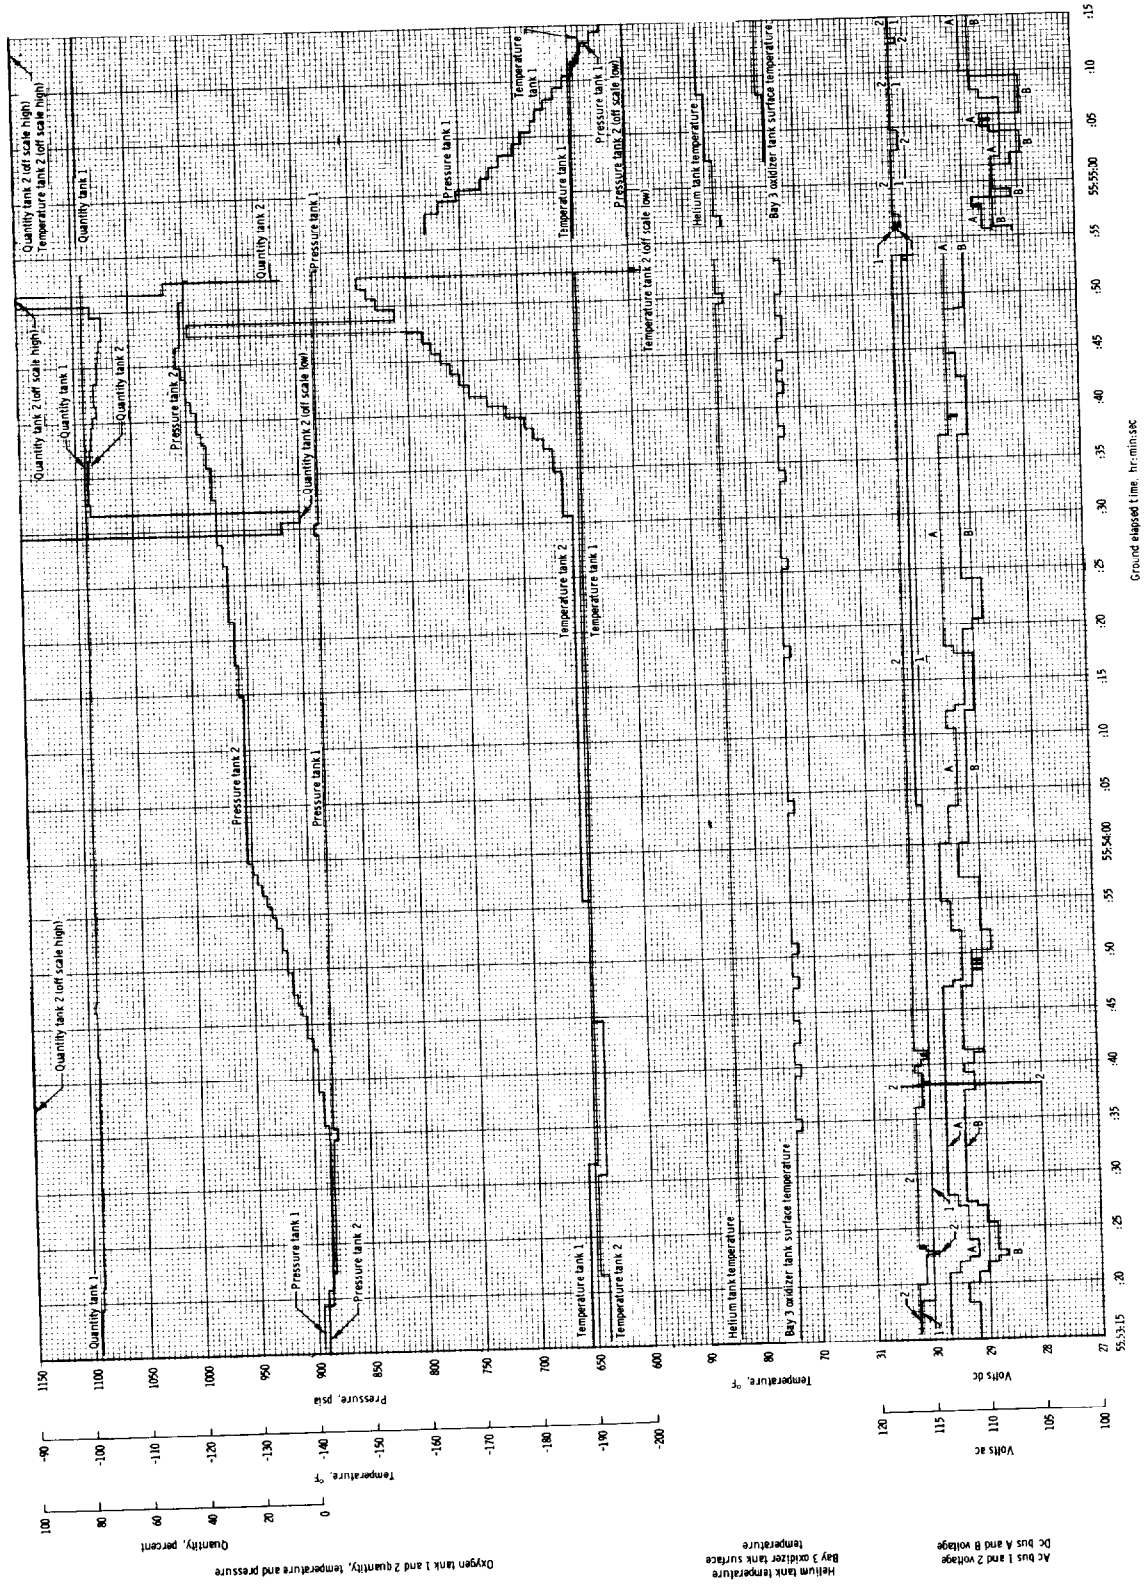
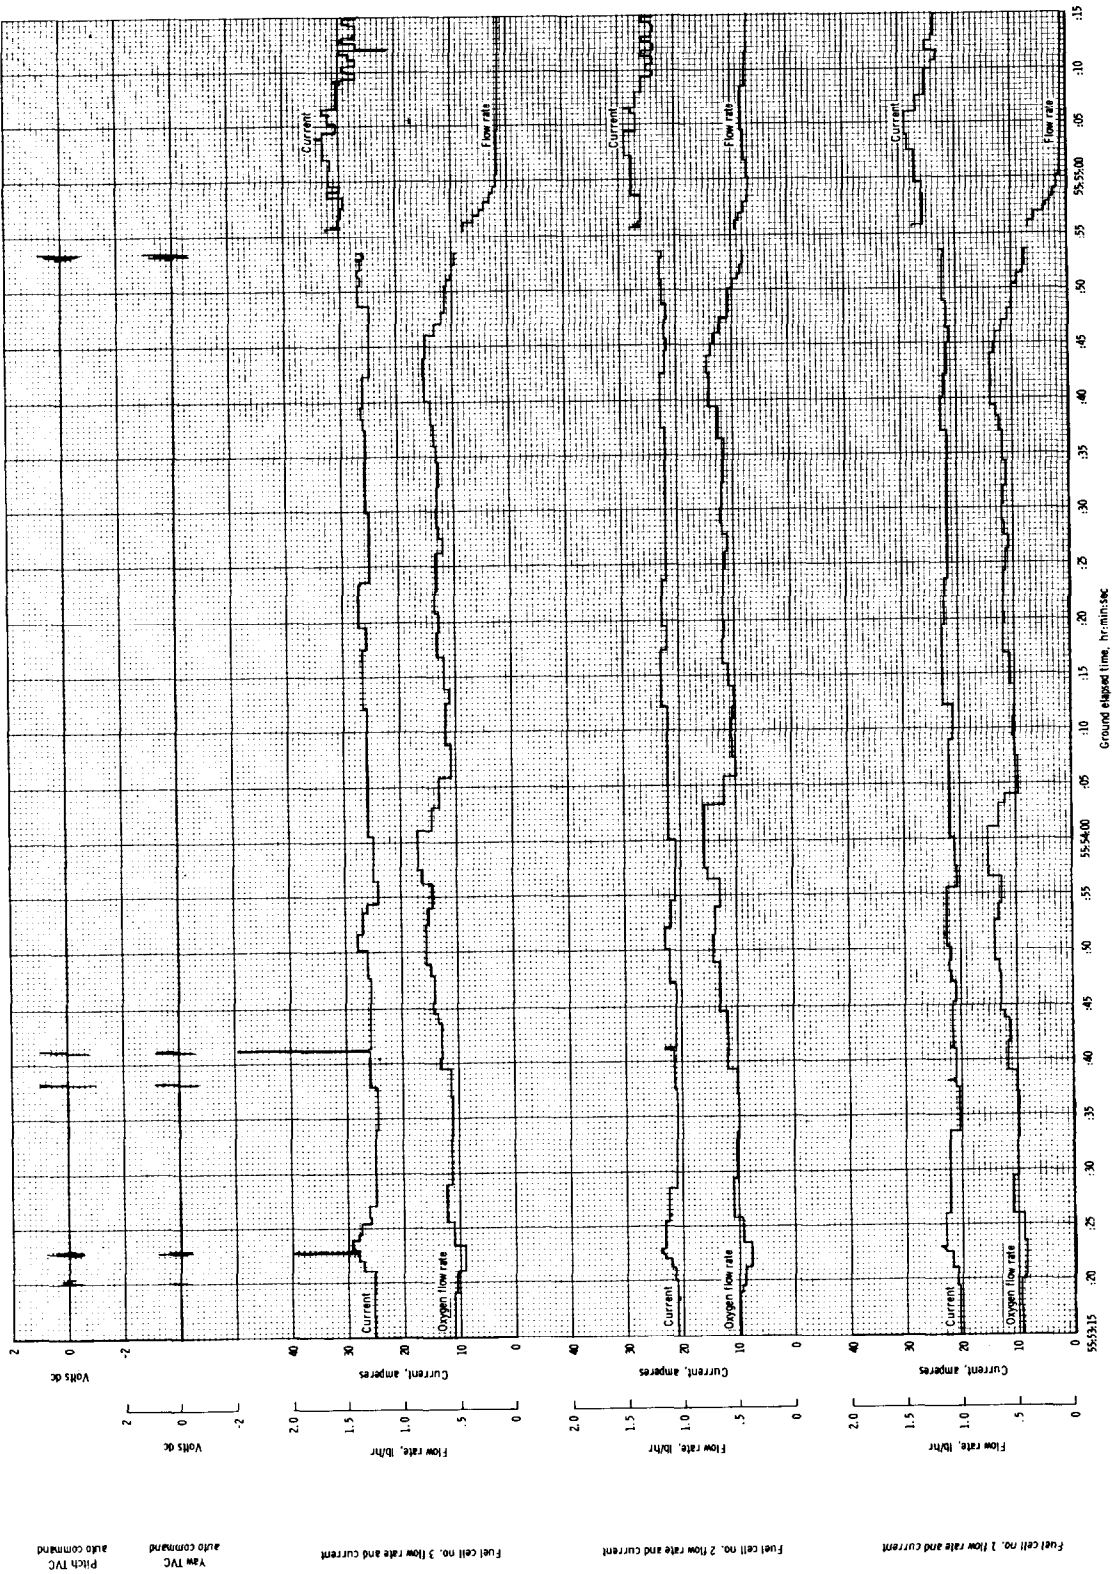
Figure B5-3(a).-- Telemetered parameters during anomaly.

voltage of 0.6 volt, and a glitch in the stabilization control system telemetry indicated that the fans had been electrically energized. These events are shown in figures B5-4 and B5-5. However, it is not certain that the fans began rotating at this time, since the tank no. 2 pressure showed a minimum observable drop and the fan motor stall current does not significantly differ from the running current. The quantity gage in tank no. 2 was already in a failed condition, and the fuel cell flowmeters were already being affected by the fan operation in tank no. 1 so that neither of these instruments could positively verify rotation of the fans in tank no. 2. During the next 20 seconds a series of electrical anomalies occurred which cannot be explained as a result of known loads in the spacecraft. These anomalies are shown in figure B5-4. The first, at 55:53:23 was an 11-amp positive spike in the output current of fuel cell 3. Several events were associated with this spike:

The quantity gage for oxygen tank no. 2, which had been in a failed state ever since the 46th hour, suddenly dropped to 6.6 percent and then to off-scale low at 55:54:30. These readings do not correlate with other telemetered data and are, consequently, thought to be erroneous. The gage then jumped to a 75-percent reading, which may be reliable data since it is about the value to be expected. Afterwards the quantity decreased gradually for 19 seconds until 3 seconds before telemetry loss, at which time an erratic gage output occurred. The behavior of this type of gage when a short across the capacitor probe is removed is to drop to zero for several seconds and then return to a correct reading. However, the gage has other failure modes which result in a wandering false indication. See Part B7 of this Appendix for a discussion of the quantity gage. Because of the gage's erratic behavior, it cannot be stated with complete confidence that the 75-percent reading obtained at 55:54:32 is reliable.

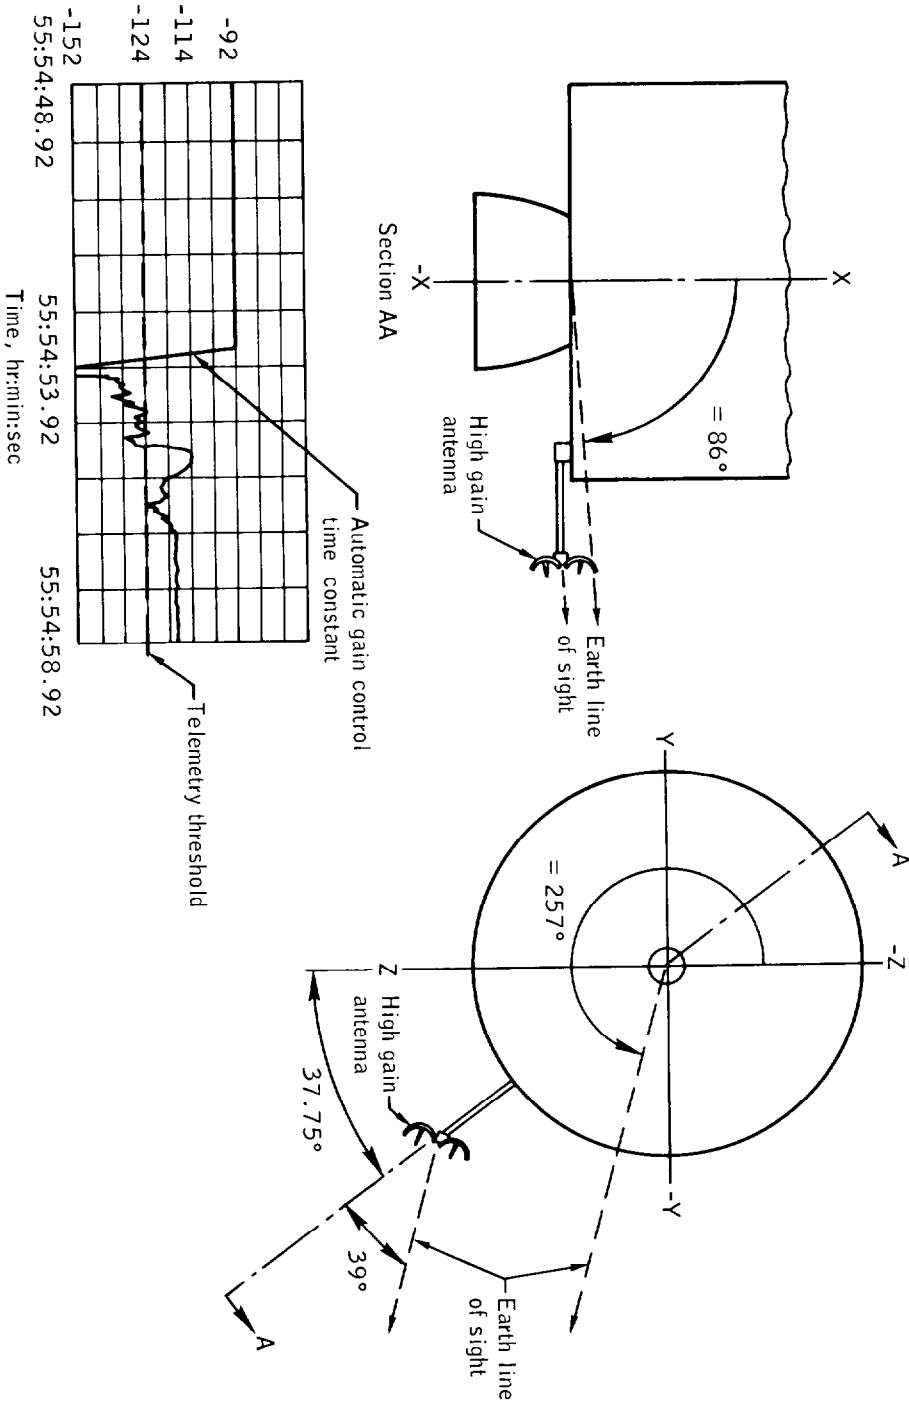
Figure B5-6.- Received S-band downlink power.

Telemetry data recovered completely 1.8 seconds after the loss of carrier power. Sporadic telemetry data are available within the 1.8-second period.

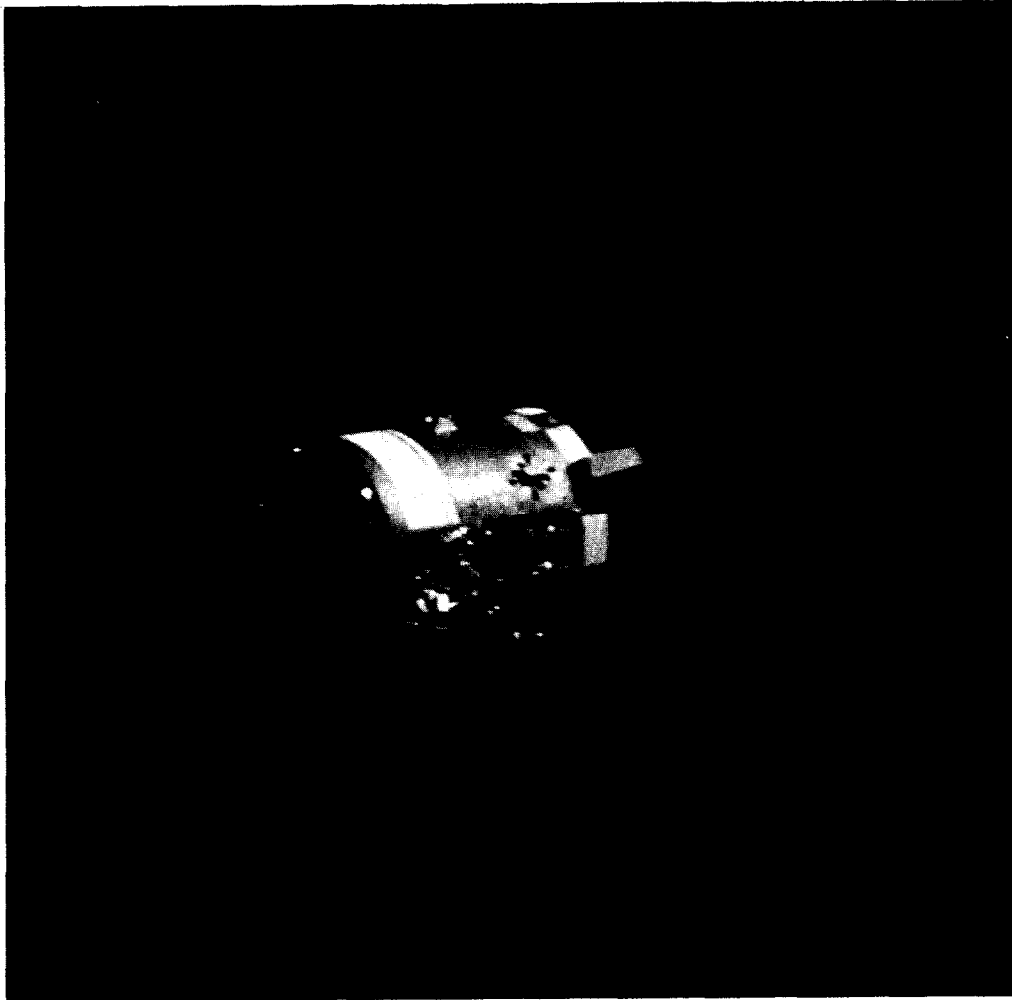
Figure B5-9.- Photograph of service module taken by crew.

Photographs later taken by the crew show the panel covering bay 4, the bay containing the cryogenic oxygen tanks, cryogenic hydrogen tanks, and fuel cells, to be missing. One of these photographs is reproduced in figure B5-9 and a photograph prior to launch is shown in figure B5-10. The high-gain antenna located adjacent to bay 4 shows a misalignment of one of the four dishes. The photographs also show that the axes of fuel cells 1 and 3 have shifted 7 degrees in such a way that the tops of the fuel cells point outward. It is not possible to determine conclusively from the photographs whether or not cryogenic oxygen tank no. 2 is present, partially missing, or totally missing. It is probable that the loud bang heard by the crew was caused by the separation of the panel from the spacecraft approximately at the time of telemetry loss.

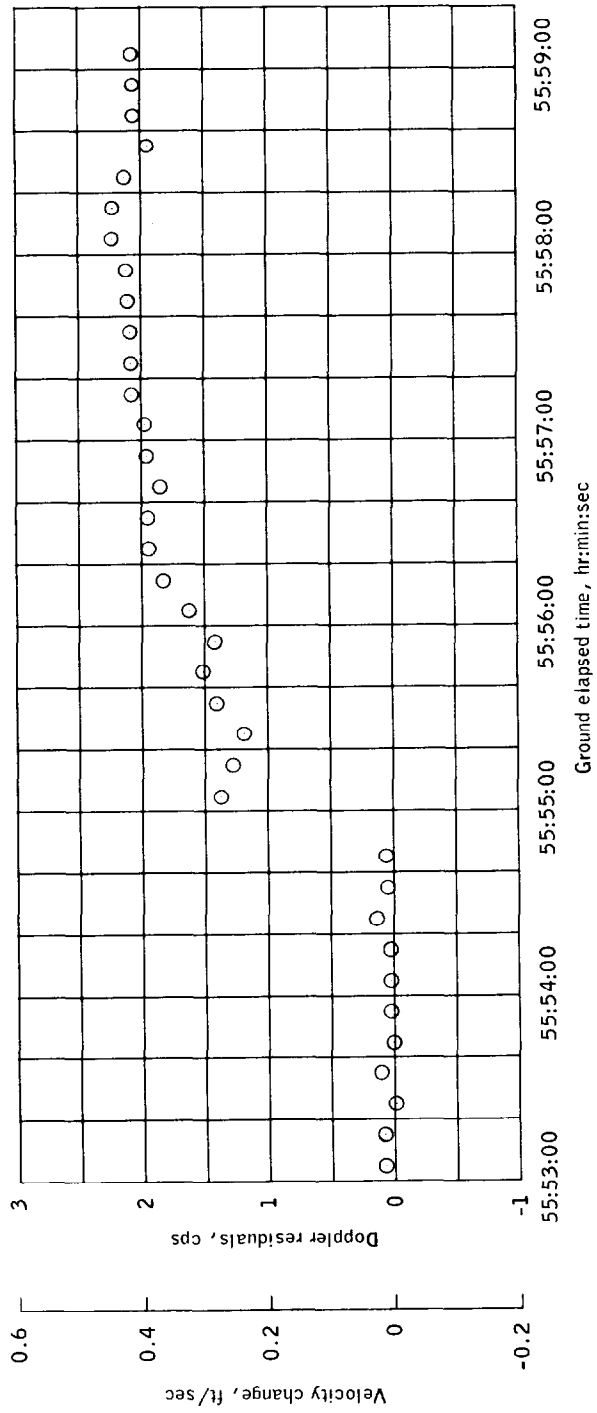
Figure B5-12.- Velocity increment at 55:54:53.

Between 55:54:45 and 55:55:05 doppler measurements indicated a radial velocity increment of 0.26 fps. This is shown in figure B5-12. Following this abrupt change in velocity at approximately the time of telemetry loss, additional velocity changes were observed, as shown in figure B5-13. These velocity increments were caused in part by venting from the spacecraft and in part by firings of reaction control system jets.
