MILL TAILINGS DAM BREAK AT
CHURCH ROCK, NEW MEXICO

OVERSIGHT HEARING
BEFORE THE
SUBCOMMITTEE ON
ENERGY AND THE ENVIRONMENT
OF THE
COMMITTEE ON
INTERIOR AND INSULAR AFFAIRS
HOUSE OF REPRESENTATIVES
NINETY-SIXTH CONGRESS
FIRST SESSION
ON
MILL TAILINGS DAM BREAK AT CHURCH ROCK, NEW MEXICO

HEARING HELD IN WASHINGTON, D.C.
OCTOBER 22, 1979

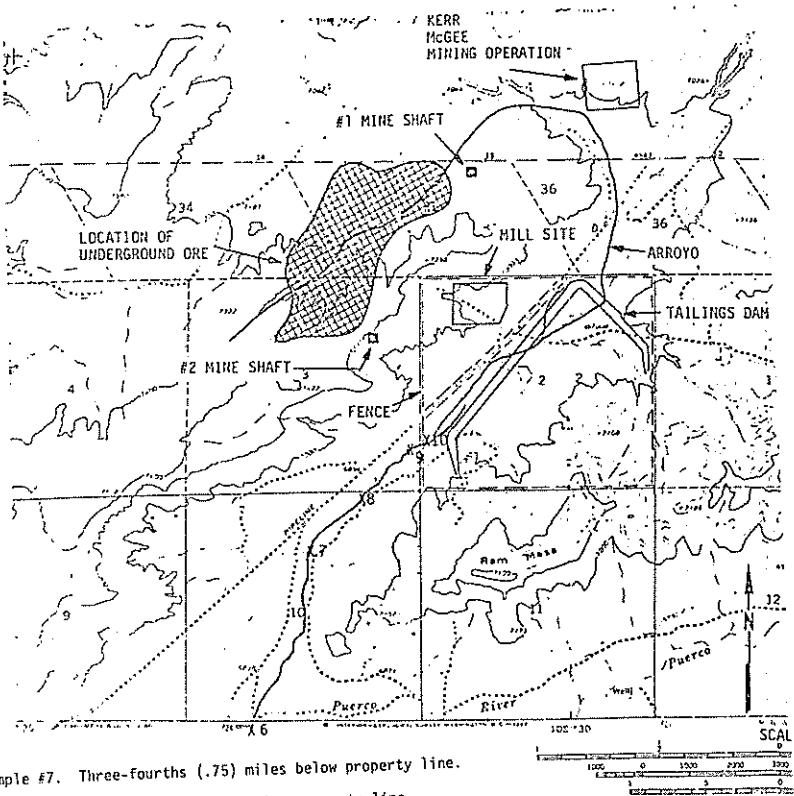
DAM BREACH STREAM SEDIMENT SAMPLES

- Sample #7. Three-fourths (.75) miles below property line.
 Sample #8. One-half (.5) miles below property line.
 Sample #9. Five hundred (500) yards below property line.
 Sample #10. Above and below the spill inside the property line.

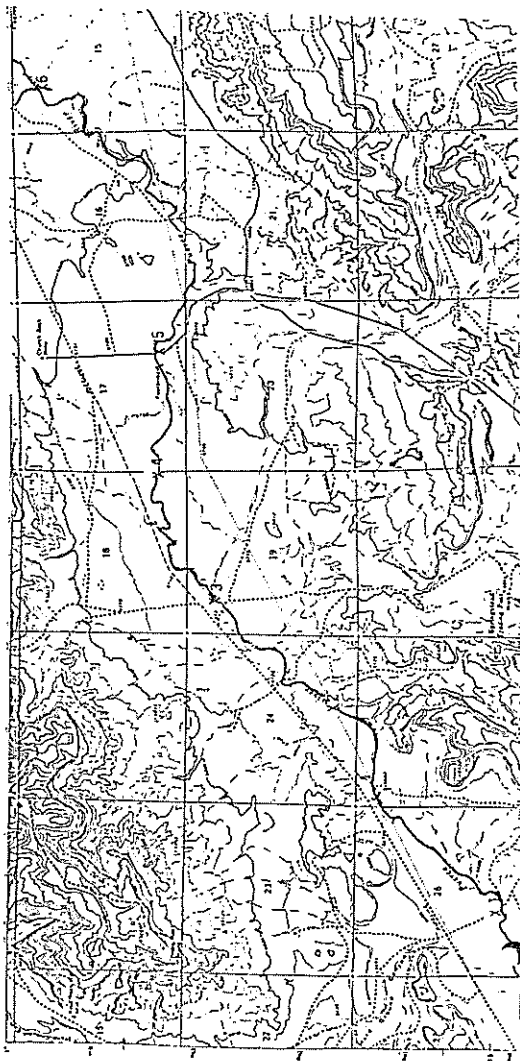
DAY BREACH STREAM SEDIMENT SAMPLES

- Sample #1. Ten (10) miles below property line.
 Sample #2. Seven and one-half (7.5) miles below property line.
 Sample #3. Six and one-half (6.5) miles below property line.
 Sample #4. 566 Bridge, Five (5) miles below property line.
 Sample #5. Pinedale Bridge, Four (4) miles below property line.
 Sample #6. Below Puerco confluence, one and one-half (1.5) miles below property line.

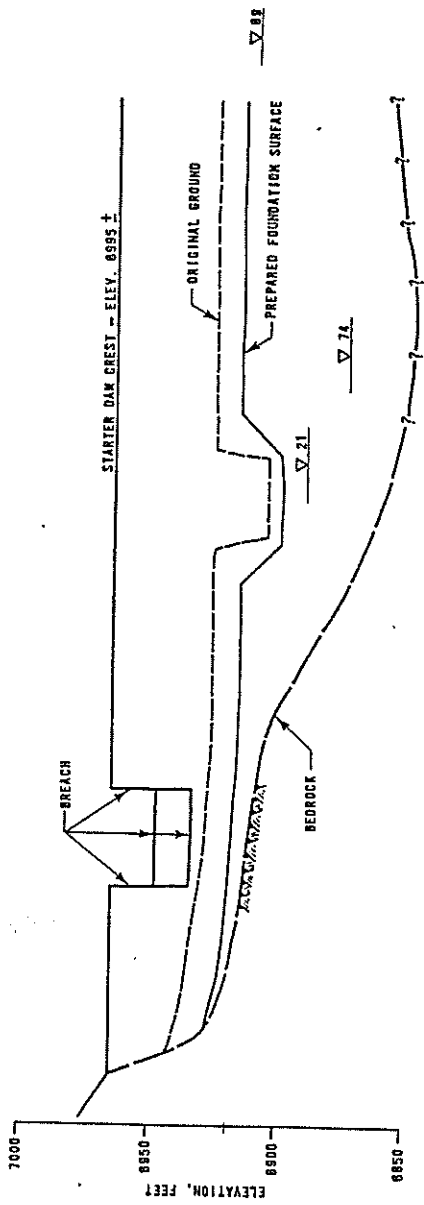
FIGURE 1

What we have stated and found is that a unique bedrock situation, such as this bedrock shown in red, comes down, levels off below, the embankment drops, again has resulted in the formation of a crack due to differential settling. We mean it put a certain load on soil that was initially level. If that has x amount of settling, oil compressable here and half of that much here, this will, of course, settle more resulting in a horizontal strain at the top of the embankment, that results in a crack.

This crack, with water flowing through it, would result in internal erosion and create the breach. It does not start except something on the order of a 1-inch crack.

Mr. HANSEN. Looking at the dimensions, approximately 60 feet from the top down to the bottom. It slopes off here something on the order of 10 degrees in either direction. This resulted in then cracking.

PROFILE ALONG STARTER DAM CENTERLINE
(LOOKING DOWNSTREAM)
SCALE: 1" = 50'

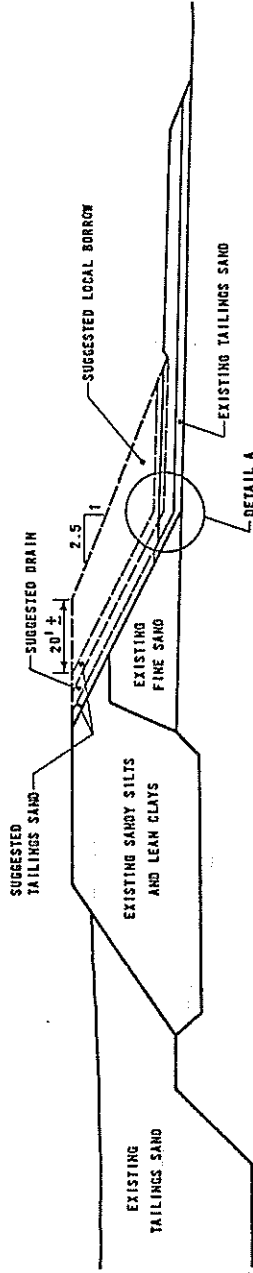
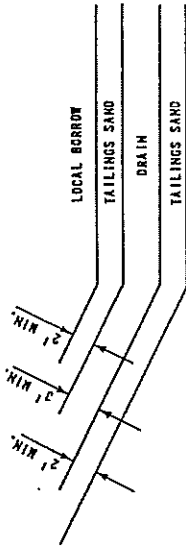
FIGURE 1

SUGGESTED REMEDIAL STARTER DAM SECTION

A program to monitor the settlement and other performance characteristics of the dam should be started now and continued over the active life of the tailings system.

A beach should be maintained in front of the embankment to feed tailings into any cracks that might form and to restrict the flow of liquid into these cracks. It is recommended that a beach be developed that extends to the vertical projection of the toe of the dam, and be maintained in this position until the monitoring program develops sufficient data for rational modification.
