The Kyshtym accident, 29th September 1957

The Kyshtym accident on the 29th of September 1957 resulted in the contamination of a large area of land with radioactive materials and, along with the Windscale accident a short time later, constitutes one of the first major accidents at a nuclear facility involving dispersal of radioactivity to the wider environment. Large areas with agriculture and rural settlements were contaminated to a high degree necessitating the development and implementation of various countermeasures to mitigate the consequences of the accident.

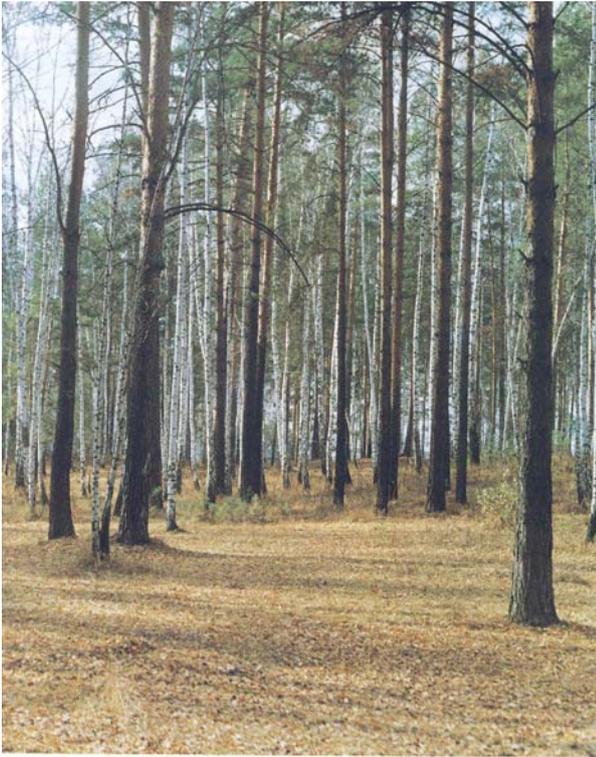
Figure 3. A birch forest in the EURT (picture from the mid 1990s).

The earliest impacts of radiation in pine forests of the area were being observed in 1958 with significant damage to the trees being evident including yellowing of pine needles, defects in tissue development and morphological changes in tissue structures. In areas with contamination greater than 18 MBq/m^2 , death of vegetation was evident and such effects were sustained for up to 3-4 years after the accident.
