Phénix

30 years of history:
the heart of a reactor

An original reactor: a sodium-cooled, fast neutron breeder reactor.

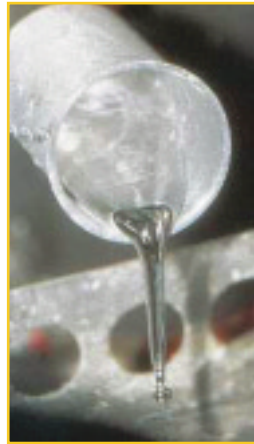
Liquid sodium

The performance required, considering the technological capacities of this time, led to the choice of sodium as coolant. It has many advantages: it plays only a small role in slowing down neutrons (which is essential for a fast neutron reactor), its properties in thermal transfer are excellent, it can circulate easily, its boiling point is high (883 °C at air pressure), it is only slightly corrosive provided it is pure, it is a common industrial product, it is produced in large quantities in France (several thousand tons per year), and so on. It nevertheless has two disadvantages: it is opaque, hence the need to develop highly sophisticated techniques as a replacement to direct vision when handling and inspecting, and it produces a chemical reaction when in contact with air or water. This means that a wide range of precautions become obligatory to maintain the tightness of the circuits which contain it and limit the consequences of possible leaks.

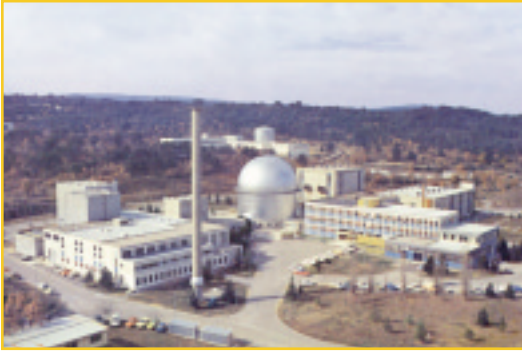
The Rapsodie reactor at Cadarache

temperatures and so on), with the exception of electrical production. Similarly, certain choices had already been made and would not be questioned for the following reactors: the hexagonal design of the fuel sub-assemblies, suspended vessel, intermediate heat exchangers, mechanical pumps for the main cooling systems and electromagnetic pumps for the auxiliary cooling systems, and so on.

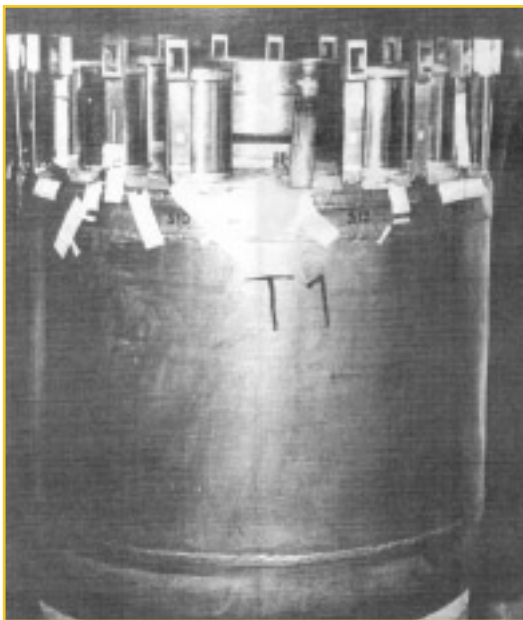
Mock-up of the reactor block undergoes explosive test

[4] In particular, a model at a scale of 1:25 of the reactor was subjected without damage to explosions corresponding to energy release three times higher (in relation to the scale of the model) than those retained for the containment design basis accident.

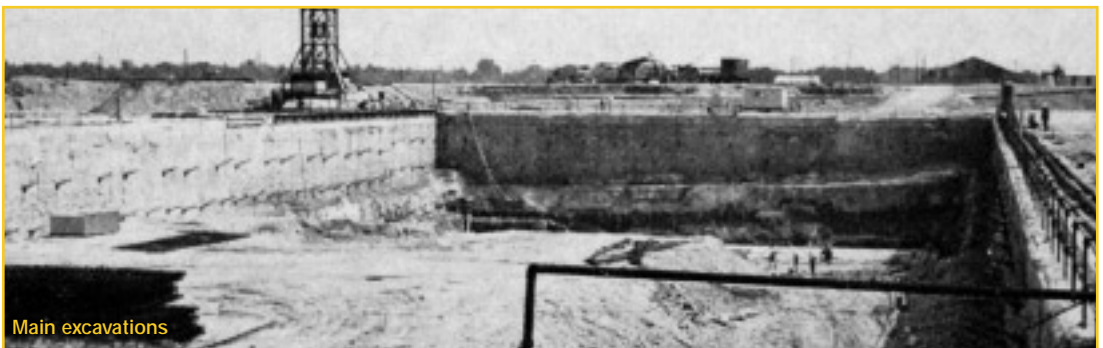
Main excavations

The site itself was opened in October 1968. The first stages consisted of digging the **main excavation** inside which the foundations and infrastructures of the buildings would be placed. The excavation site was enormous: 180 meters long, 50 meters wide, and 11.5 meters deep. Its boundaries were side walls moulded in the

ground to retain the natural soil. A network of pumping pits in the water table made it possible to control the water supply and uplift caused by the removal of river deposits and rock. The earth work took eighteen months to complete.

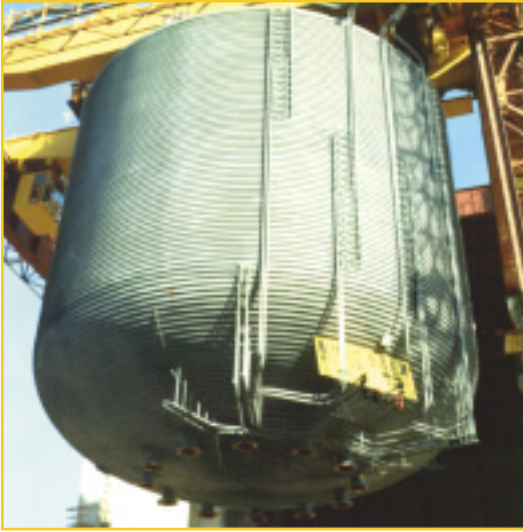
The primary containment enters the reactor building

The primary vessel was made of carbon steel and delivered to Marcoule as formed metal sheets presented for blank assembly in the workshop prior to delivery. The vessel was mounted in 18 mm thick conical shells. These shells were then stacked by manual welding. The twelve cooling sub-circuits, with a total length of 4,300 meters of pipes, were welded on to the outside. After checking the welds and leaktightness, the vessel was ready in April 1970. It was installed in the reactor building on November 2, 1970, in an operation requiring many delicate maneuvers because of the mass of the vessel (130 tons) and the narrowness of the gaps in the concrete pits into which it was placed on jacks.

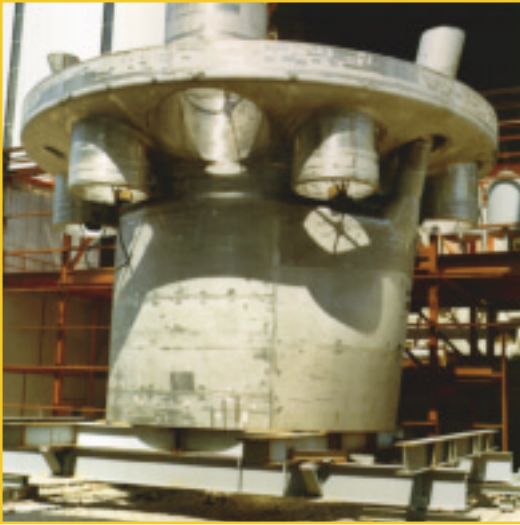
Inside the main vessel, the support for the lateral matting support was installed, then the diagrid with its inlet nozzles was positioned on the stellite coated plates wedged on the matting. Finally, the fully mounted primary vessel was descended into the reactor block and welded on to the lateral shielding support.

Installing the primary vessel

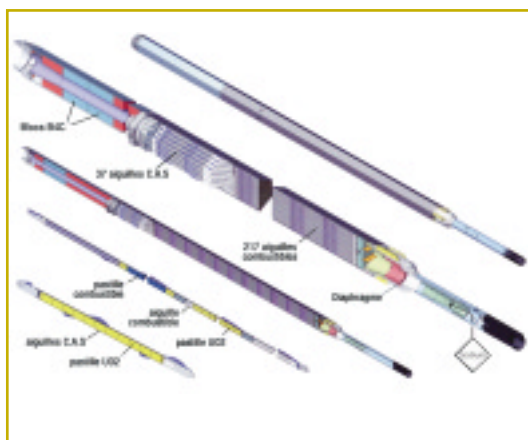
Fuel sub-assembly

The 316 stainless steel used in the hexagonal wrapper was substituted for a titanium-stabilised stainless steel of the same grade with a much smaller swelling under irradiation.

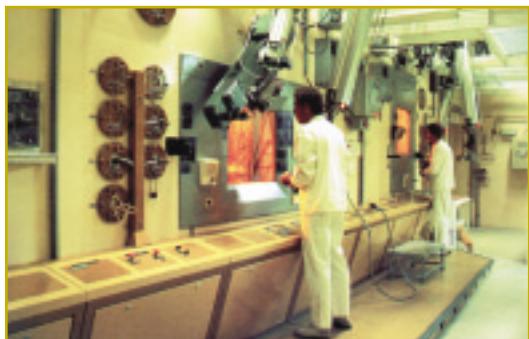
Spent sub-assembly dismantling cell

ditioned fuel pins. These fuel pins were transferred to the CEA pilot reprocessing unit at Marcoule and the reprocessing plant in La Hague after each handling activity. Several fuel pins were transferred to CEA examination laboratories at the Cadarache, Saclay, Fontenay-aux-Roses and Grenoble Research Centres. Sub-assembly structural waste (spikes, hexagonal wrappers, heads) were transferred to Marcoule site storage pits.

The most serious failures occurred while **dismantling the hexagonal wrapper**. Dismantling this wrapper involved sawing and tearing off in a coiling fashion a strip of metal from two sides opposite the hexagonal wrapper. Due to the decrease in ductility of stainless steel under irradiation, the coiling of cut-out metal strips on one side led to the rupture of the strip on more than one fuel sub-assembly. Several sub-assemblies were sent to laboratories at Cadarache to be dismantled by milling, before sending the fuel pins back to the Phénix plant for conditioning.

The decision was made that it was best to start the milling process on an angle of the hexagonal wrapper. Therefore, a cell was built next to the irradiated elements cell in which this new milling process was to take place. Furthermore, one fuel pin located in one angle of the bundle in new sub-assemblies was replaced with a fuel pin containing steel pellets only to avoid damaging fuel pins during this complex operation.

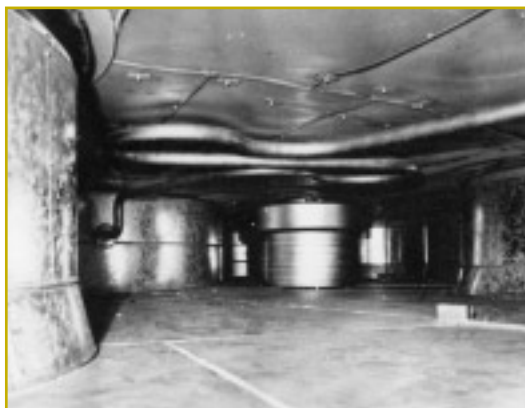
Space between roof and slab of the reactor

The actual **reactor block** - referring to the vessels, roof and concrete slab - also functioned correctly and an extensive range of monitoring instrumentation allowed to verify it. The reactor block was fitted with over 550 sensors, including 450 thermocouples, with all information being processed by computers. These sensors were designed to measure and record temperatures of the sodium coolant and reactor structures, flow rates, cover gas pressure, sodium levels in free contact with gas, material stresses, structural movements and vibrations, etc. The relevance of results obtained during plant start-up tests actually transformed this monitoring equipment - an originally temporary situation - into a complex measuring system available to plant operators and CEA R&D units developing fast neutron reactors.

As the reactor had been shut down for five months due to problems with the intermediate heat exchangers (cf. § 2.4), an inspection of the vessel pit bottom and the space between the main vessel and the primary vessel was organised in March 1977. Not only was the insulation in perfect condition, but the possibility of accessing spaces close to the reactor taking in account the temperature and activity conditions was also demonstrated^[3].

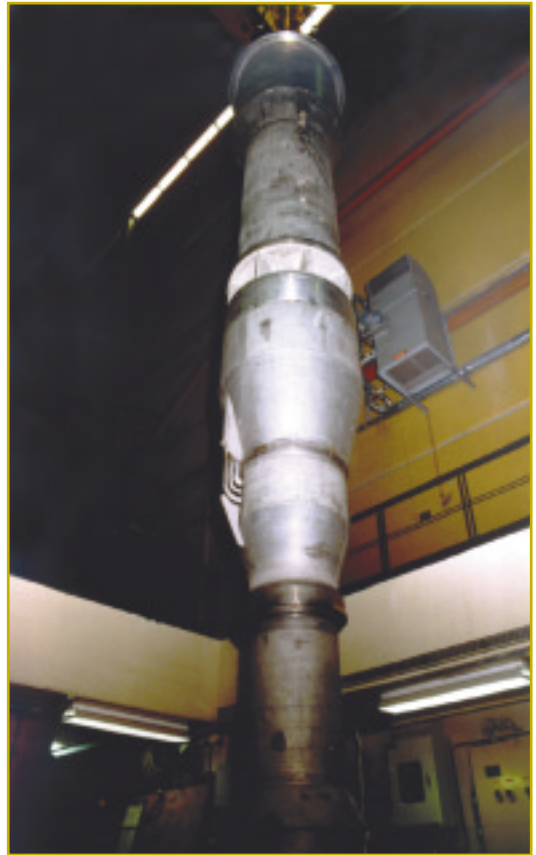
Primary pump

[4] This incident occurred again in September 1981 following which all primary and secondary coolant pumps were modified. This involved tightening the ring by adding a mechanical fixation.

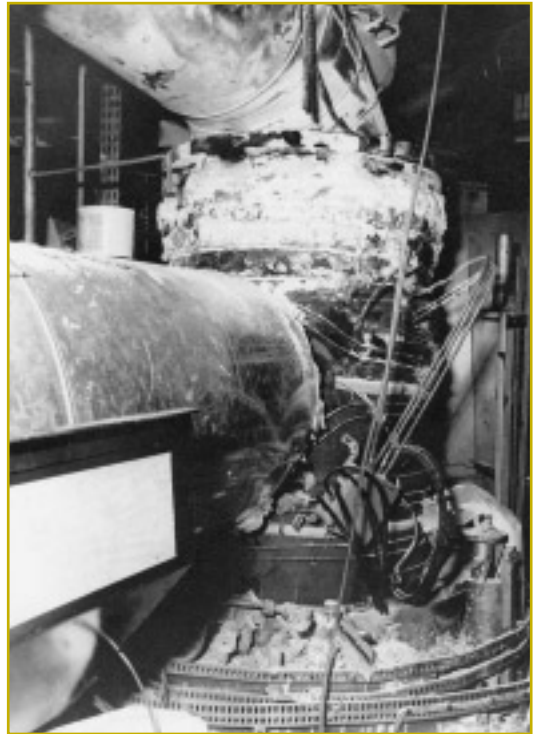
Heat exchanger with insulation removed after a sodium leak

At 3 o'clock in the morning on July 11, 1976, while the plant was being restarted following a refuelling, the sodium coolant started leaking into the upper part of the intermediate heat exchanger E located in the secondary system N. 2. The fire was brought under control using two field operators who quickly arrived on location. The field operators only used one of the two Marcalina power fire extinguishers^[5] they had brought along. The secondary circuit was then drained. This was qualified as the first real sodium fire in the Phénix plant and revealed the professionalism of the shift team on duty at the time, highly praised by the CEA hierarchy.

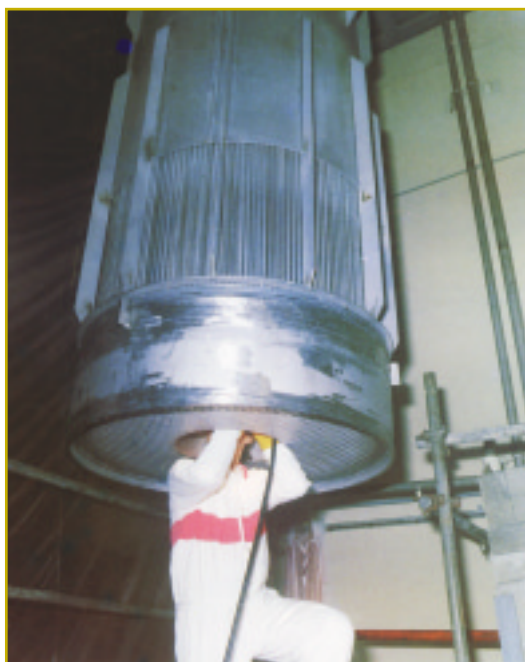
Repairing a washed and decontaminated intermediate heat exchanger

Examination, confirmed by metallographic analysis, revealed a crack in the joining weld on the metal plate closing off the sodium outlet in the secondary system above the heat exchanger. This rigid plate connects two long shells at different temperatures. The differential thermal dilatation of these two plates caused the weld to crack. This problem was described as a generic defect related to a faulty design (insufficient bending radius generating a concentrated stress region), a non-compliance with project specifications (excess thickness of shell) and

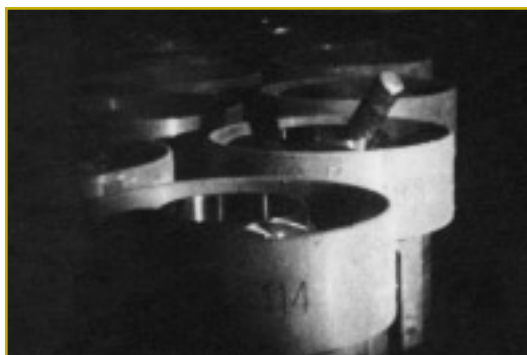
Unusual object in the drum

The space above the sodium in the storage drum is monitored using a periscope. In June 1976, during the loading of new fuel sub-assemblies, an unusual object resembling a metallic rod was discovered on top of a handling flask in which a breeder sub-assembly had been placed half an hour beforehand. After having visualised and photographed the object several times, the object disappeared. This unusual object was in fact a rod of solid sodium that had formed by freezing in the upper neutron shielding channel of the new fuel sub-assembly while being inserted into the storage drum and had been held upright under the effect of the hydrostatic pressure. The temperature of the argon atmosphere in the storage drum was high enough to melt the sodium rod.

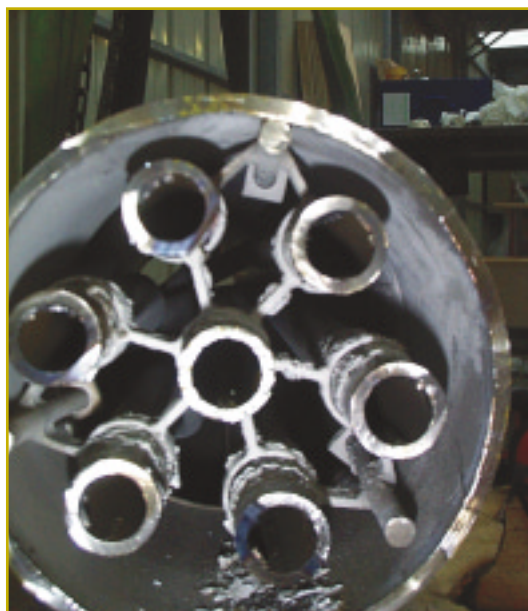
Cross section of steam generator module

In conformity with regulations, **steam generators** are normally expected to resist a pressure of 1.17 times the operating pressure. However, during examination of the technical file in March 1980, the French government Mining Service requested this be raised to 1.5 times the operating pressure, as is the case for new machinery. This request was based on the argument that most of the machine could not be inspected (tubes inside the modules), despite the fact that leaks can be detected by measuring the hydrogen content in the secondary cooling system.

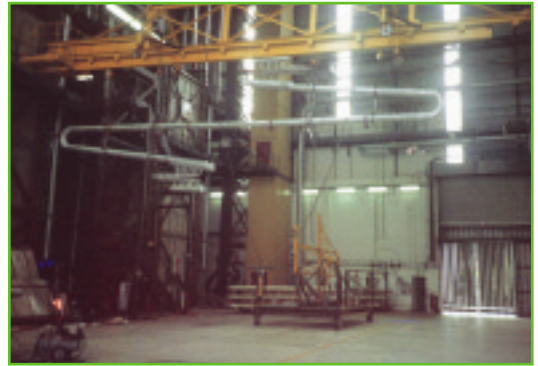
Steam generator module during handling

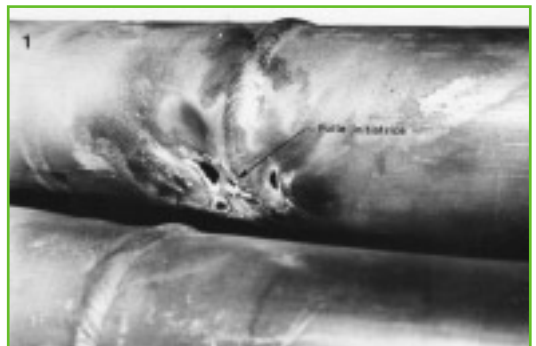
Steam generator tube with leak

At any rate, the defect which caused the sodium - water reaction was identified on the edge of a tube butt weld. The reaction's wastage effect twice damaged another tube (during the first incident, when operator reaction took a longer time, and to a lesser extent, during the fourth incident, when the tube was located just opposite the leak). The module shell was only slightly affected each time. The steam generators' safety bursting discs were never affected, which proves that the increased pressure had not reached the failure threshold (10 bar).

The expert investigations which were conducted on the modules involved in the four incidents and on the other modules showed that the tube defects were always on the butt weld beads. The defects were worse on the higher number modules (those which are closer to the steam intake) and on the first welds

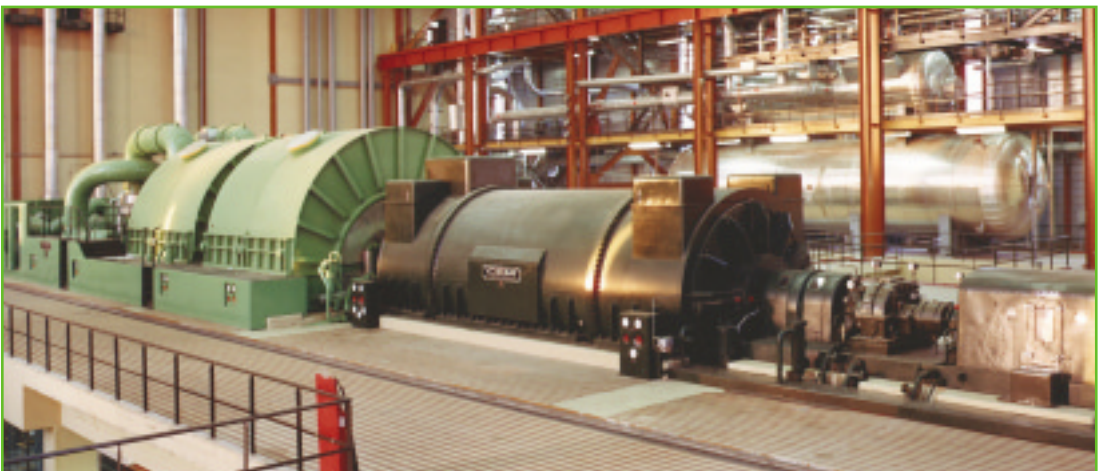
The turbo-generator set

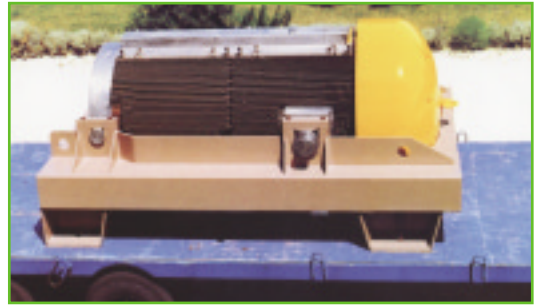
Transport cask for irradiated pins

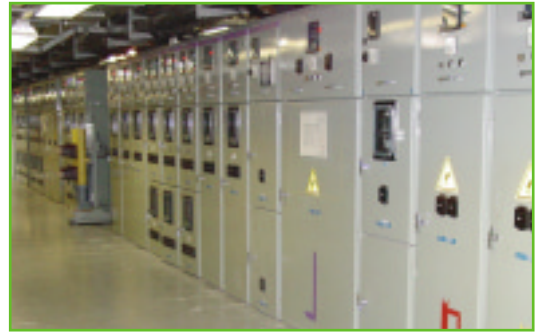
Electrical equipment cabinets

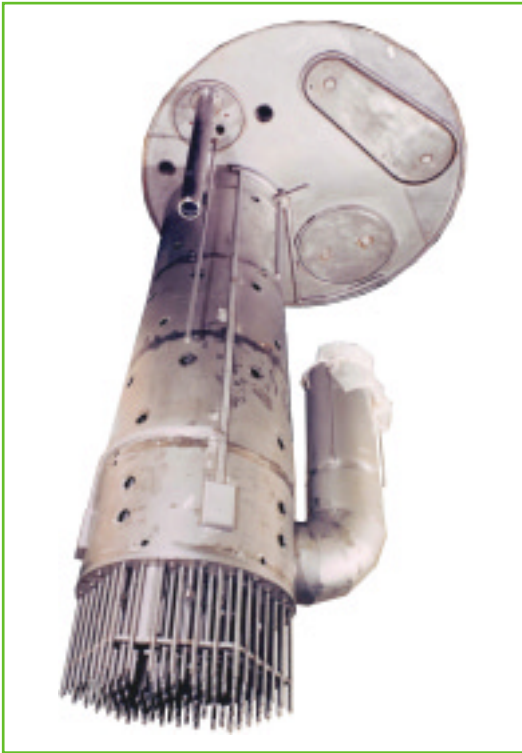
The core cover plug

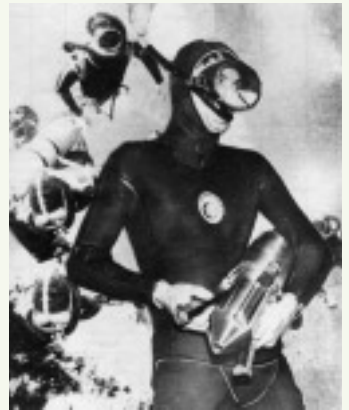
An intervention by divers

illustrating the underwater renovation of the pliers of a rod mechanism (a highly radioactive element because of its presence in the core) was a montage showing a diver holding the actual object of the operation in his hands. The following month, the first director to react to this surprising information was exceptionally awarded the "Grand Prix for readers of the monthly report".

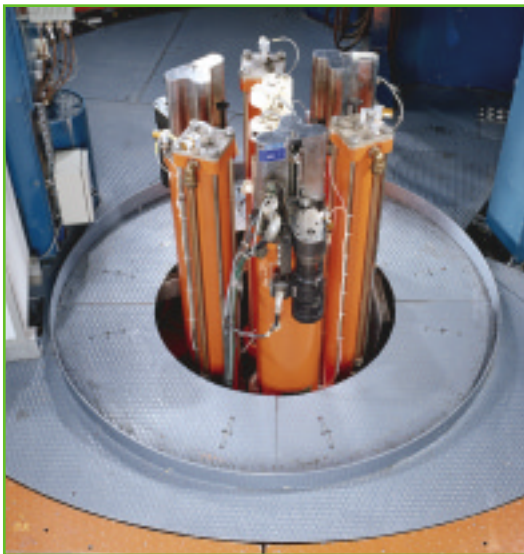
Control rod mechanisms

- Elimination of the holes in the upper part, and increased sodium temperature exiting from the SAC (to avoid the thermal cracking of the electromagnet),
- Questioning the design of the electromagnets, in several steps
- Changes in the connection between the magnetic head and the rod,
- Change in the materials and the design of the rod and the mechanism (to limit friction between the rod and the guide tube, and between the electromagnet and the rod dash-pot cylinder).

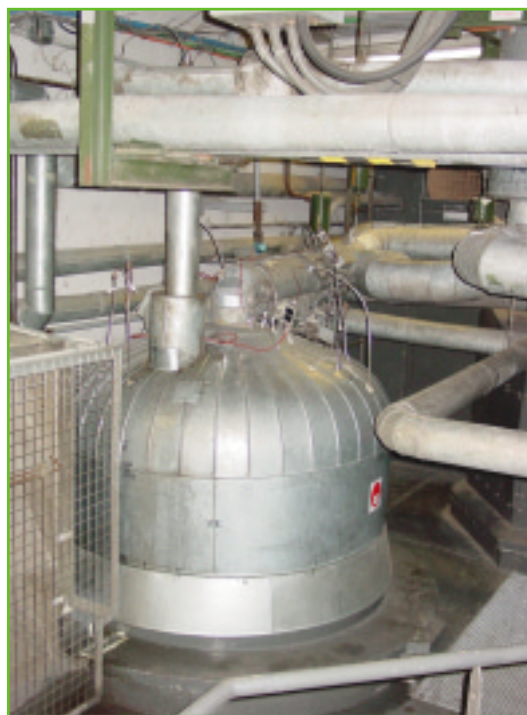
Secondary cold trap

These traps are changed regularly. A report established in May 1983 showed that 13 tons of secondary sodium were consumed, essen-

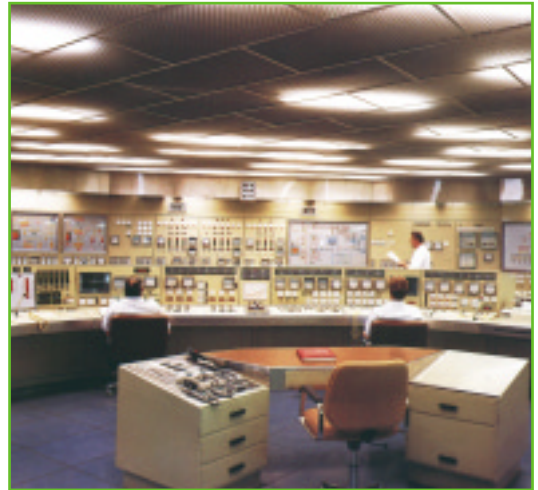
The control room

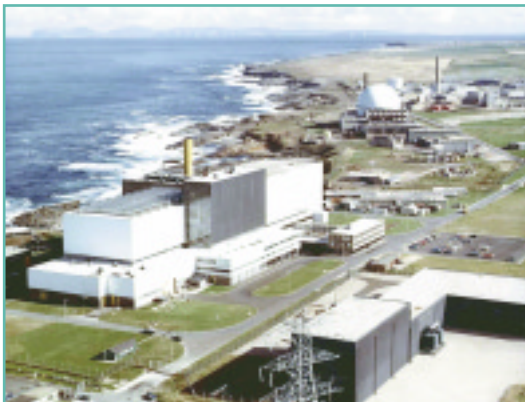
The British PFR and DFR reactors

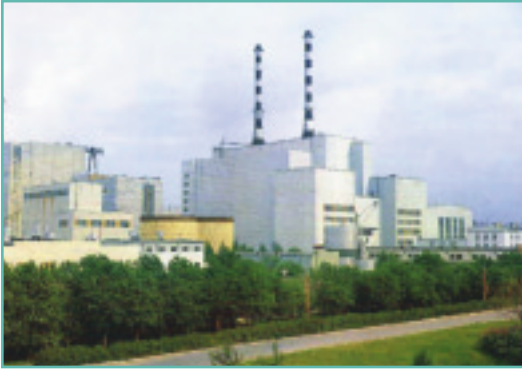
The Russian BN 600 reactor

The BN 600 nuclear power plant was then built in Beloyarsk, near Ekaterinburg. Equipped with an integrated 1470 MWt reactor and three 200 MWe turbine generators, it diverged in February 1980 and reached rated power in December 1981. It is still on operation and is an essential part of the electricity supply to the entire region, where it contributes 3.5 TWh yearly. It has won many awards for its availability and regular operations. The BN 600 has an annual load factor which often exceeds 80% and very few unscheduled shutdowns, due in particular to the redundant equipment in many sensitive

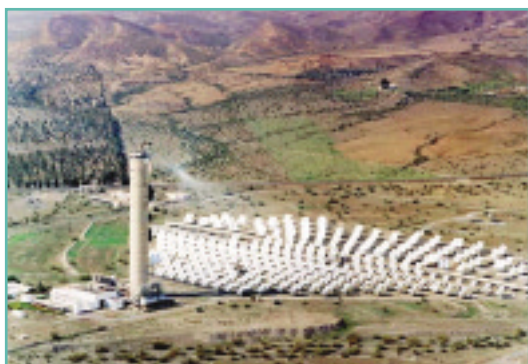
Almeria solar power plant

After this brief overview, another incident occurred which had serious repercussions on the French fast neutron reactors. The incident took place a thousand kilometres away from the Phénix plant, in the **Almeria solar plant**, in southern Spain. 70 tons of sodium are used here, to transport the solar energy which the mirrors concentrate on a boiler to the steam generator which turns a 500 KWe generator. In order to work on the sodium circuit, the operators cool the piping to freeze the sodium at ambient temperature, then they cut the circuit. But, on 18 August 1986, a problem occurred with the formation of the solid sodium plug and pressurised sodium spewed through the cut made, splashing off the nearby steel structures and causing a fire in the hall. The metallic beams distorted and a hole was blown in the roof. The temperatures reached an estimated 1200°C during approximately fifteen minutes. Fortunately there were no fatalities and the workers sustained only slight injuries.

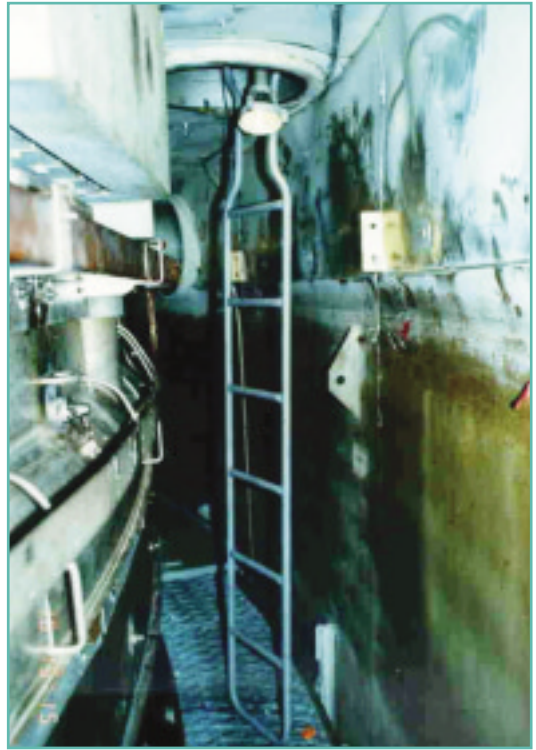
Space between main vessel and containment vessel

The inspection of the inner space between the main vessel and the safety vessel was

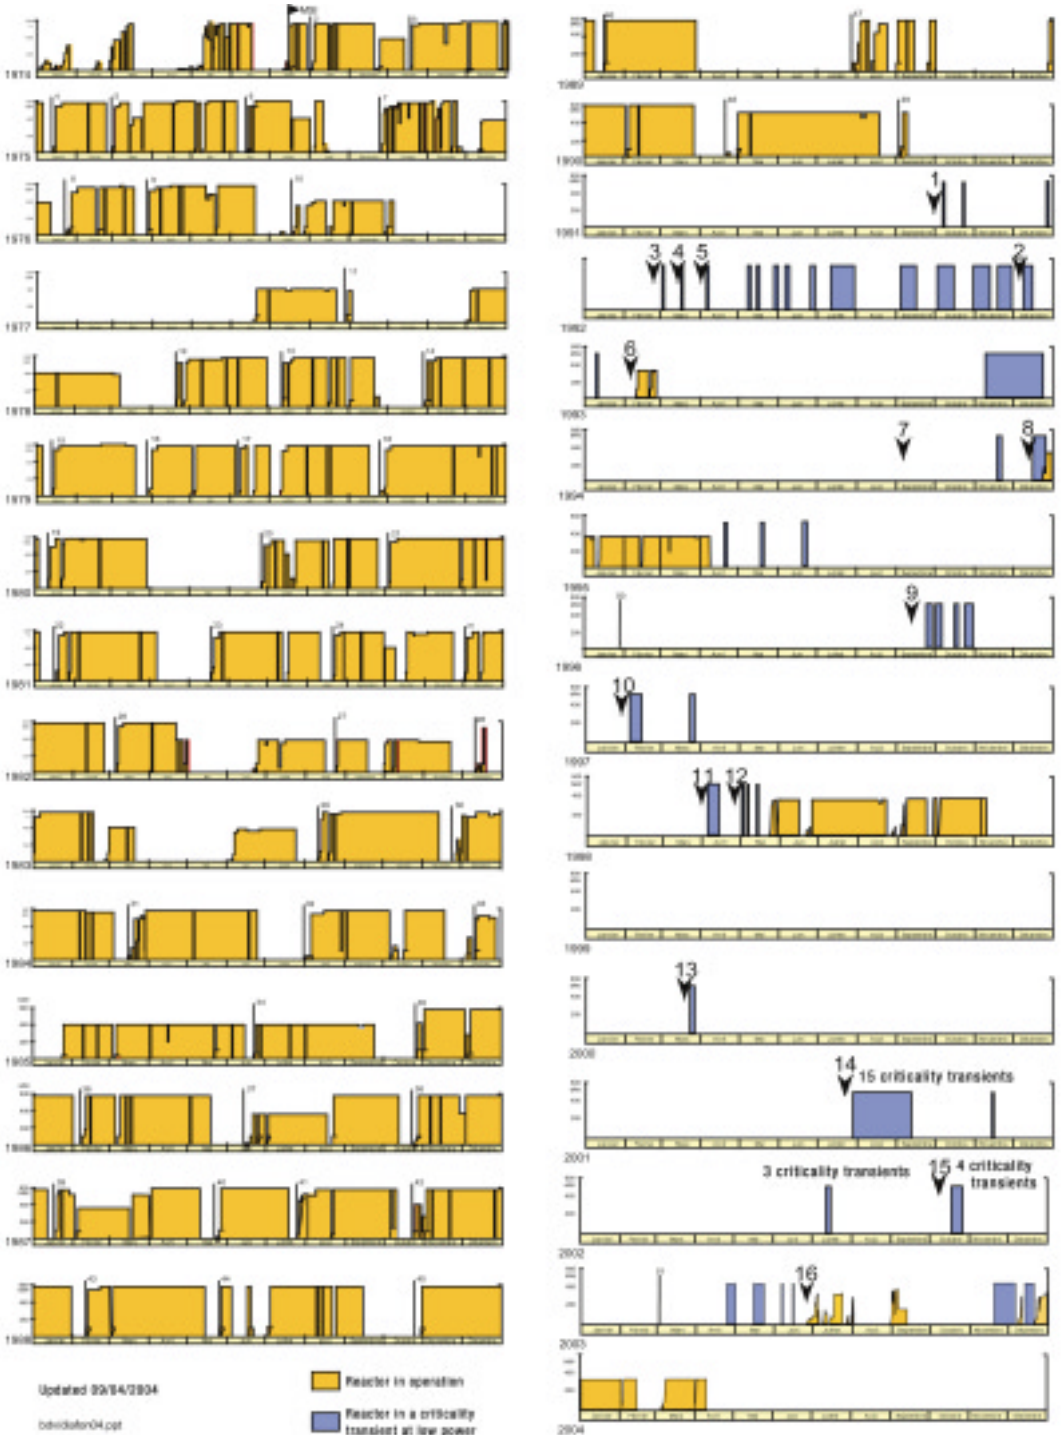
Phenix power plant - operational chart

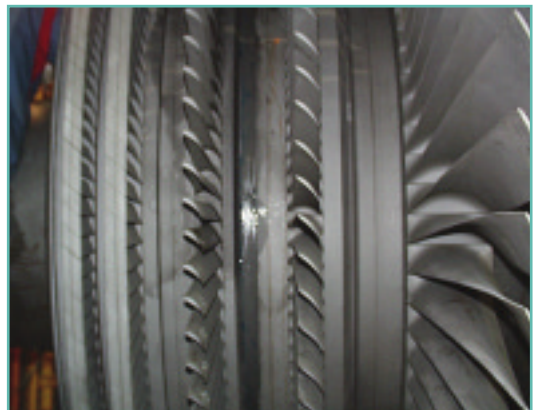
Turbine rotor blades

Just as during the preceding inspection in 1980, the **turbo generator** was entirely taken apart and evaluated. The high and medium pressure cylinders were in good condition and there were no traces of erosion on the blades. Many cracks on the low pressure rotors were however detected. It was first thought that the corrosion which caused them was also due to the sodium entering the water - steam circuit in April 1982. However, later analyses showed that soda had entered the water circuit at the same time as the hydrazine, for the hydrazine had indeed been delivered to the plant in tanks which had also been used to transport soda.

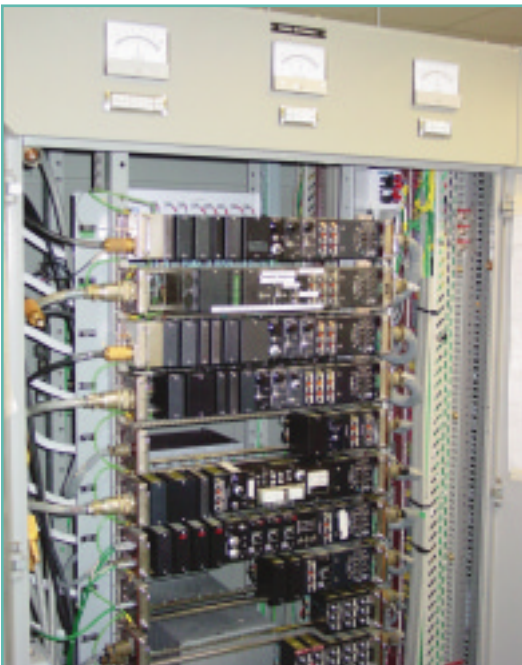
Neutron chambers' electronic cabinets

- Electromagnetic disturbance likely to be generated by the electrical supply, the earthing systems or electromagnetic radiations. It was found that the equipment was well designed with respect to the risk of interference excitation, yet it was difficult to extend such assurances to all the measurement material used occasionally,

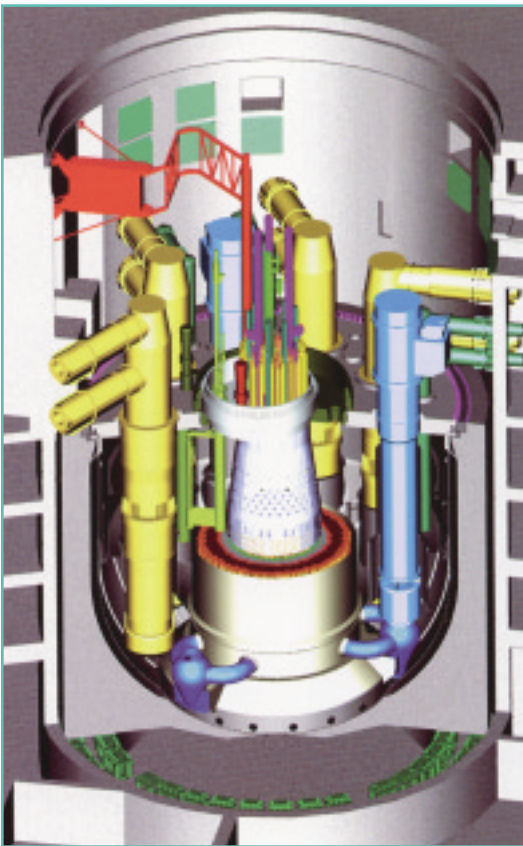
Diagram of European Fast Reactor project

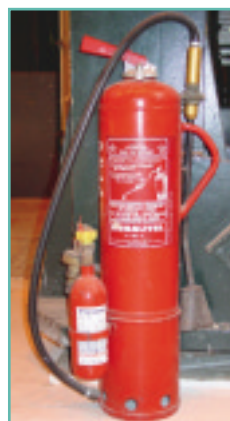
Sodium-fire extinguisher

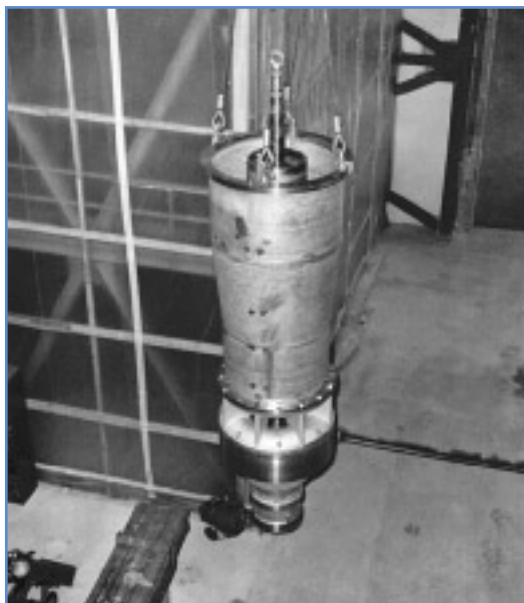
Secondary pump

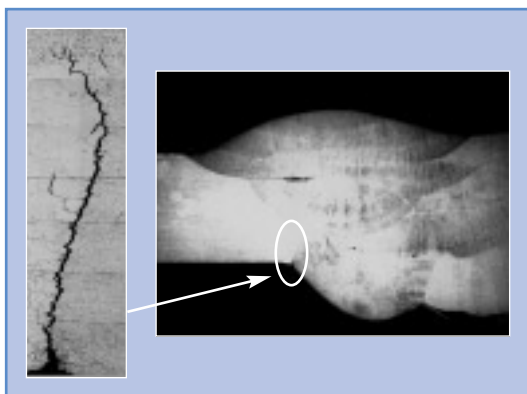
Weld defect on 321 steel tube

The experience gained from inspecting the secondary circuit welds showed that gamma radiography on 321 steel does not reliably provide information located at the root of the weld in the thermally affected zone. Between 1987 and 1989, the department of advanced techniques at Saclay developed, at

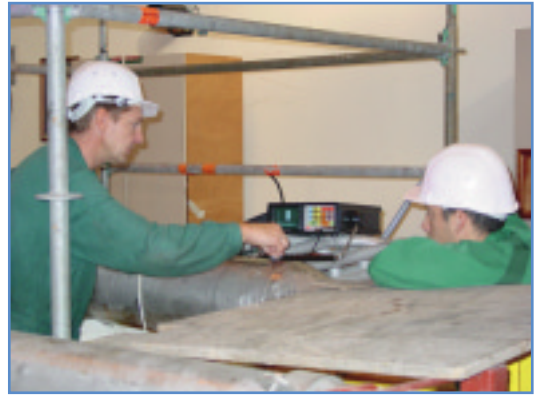
Inspecting secondary cooling circuit pipes

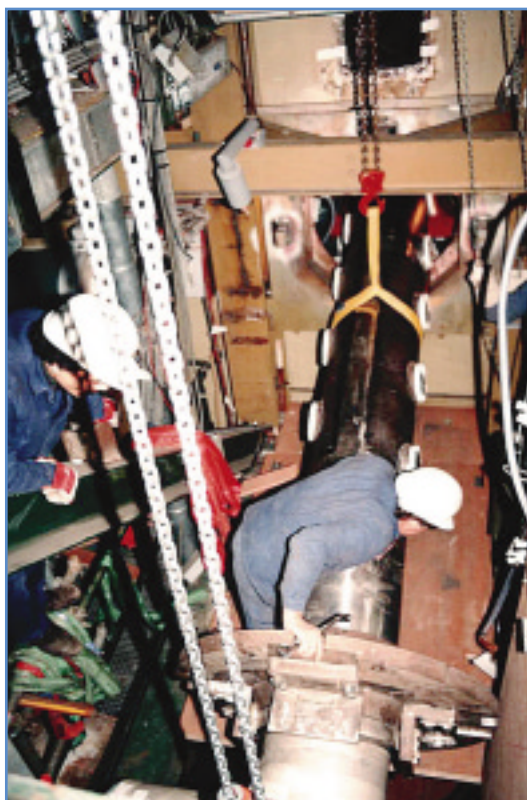
Replacing secondary cooling circuit pipes

The isolation valves at the steam generator inlet (hot leg) were removed, for after discovering creep-related defects it was demonstrated that they were not essential to operations. Another crack-sensitive site was identified as the flange supporting the seal-

ing bellows for the secondary circuit penetrations in the wall between the reactor building and the steam generator building. These flanges were inspected using ultrasound and dye penetrant tests and the indications found were scoured out. However, the flanges on secondary circuits N. 1 and 3 were eliminated in 1999 and were replaced by different design parts.

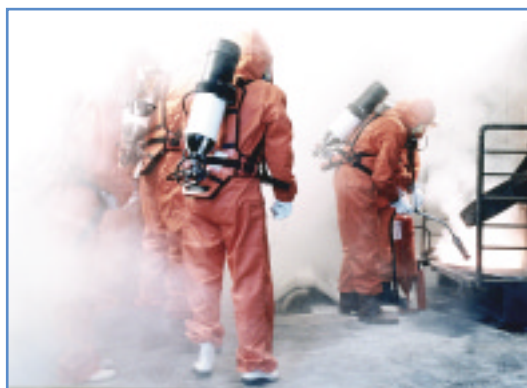
Sodium-fire extinguishing exercise

After the studies and work done at the Creys-Malville plant to guarantee safety in the event of a **major sodium fire** burning in spray form, a similar approach was required at the Phénix plant. The risk of a major sodium fire had to be taken into consideration, including a simultaneous reaction between the sodium from the leaking circuit and the oxygen from the surrounding air and water discharged by the circuits destroyed by the sodium fire. This reaction, sometimes called a sodium-water-air reaction, or sodium-

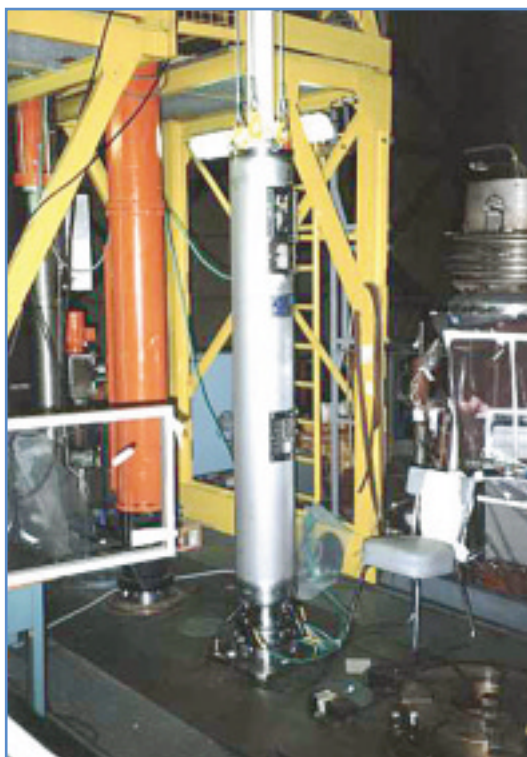
Complementary shutdown system

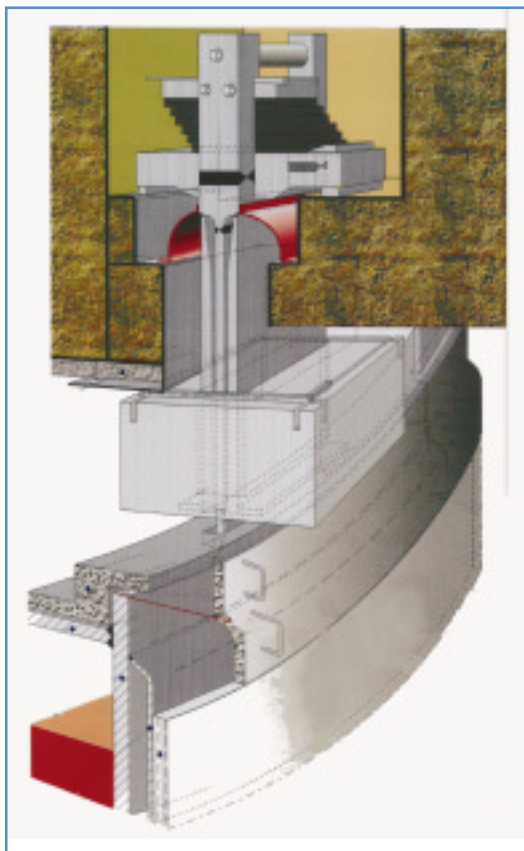
Upper hanger of main vessel

Tests were defined for the most sensitive equipment emerging from this analysis. This was the framework for the inspection on the reactor vessel hangers, and other, more complex inspections were being prepared for the conical shell and the core cover plug (cf. § 6.1).

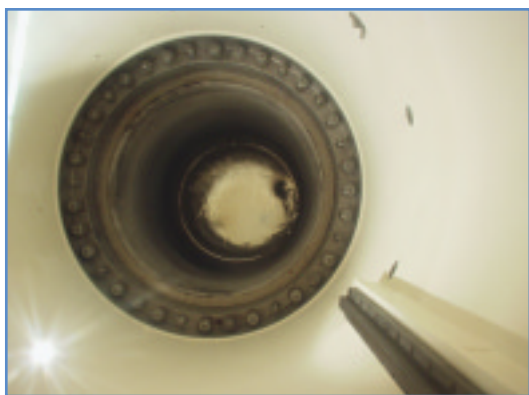
The primary sodium seen through a slab penetration

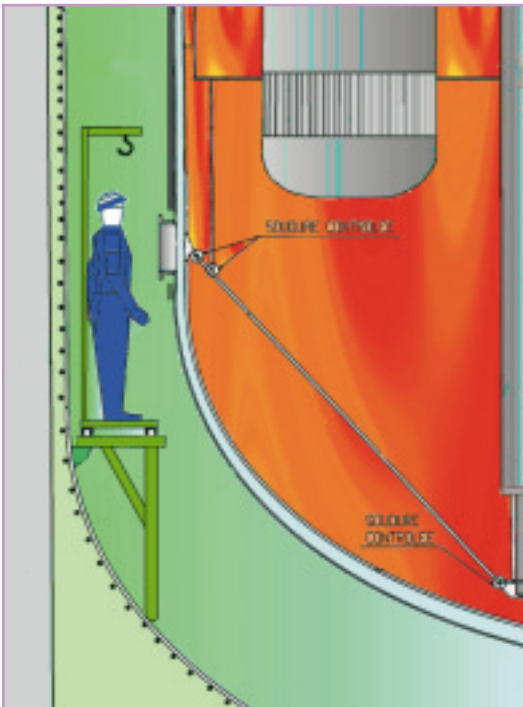
Schematic of the conical shell

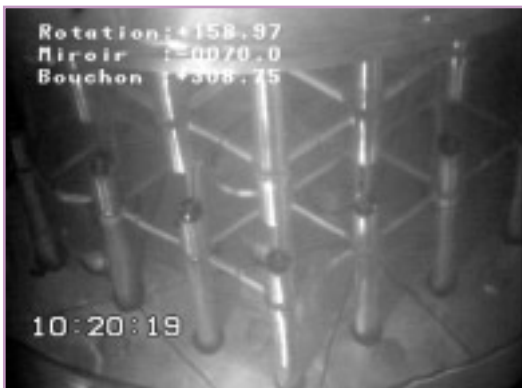
The images of the structures observed inside the reactor block were of excellent quality considering the extreme environmental conditions for the optical instruments in the reactor block cover gas. The structures looked very good. It is worth noting that the free surface of the sodium was used as a mirror to see the underside of the core cover plug grid. All the images obtained showed that the structures examined were in good condition. The only significant finding was that one of the eight screws of the upper flange of the core cover plug was missing; these screws were needed for assembling the apparatus but have no subsequent function, and it was shown that even supposing lost screws reached the hot pool, this would not compromise safety.

Core cover plug reflected on the free surface of the sodium

The visual inspection of the core cover plug was conducted between 15 March and 6 April 2001. Draining involved transferring about 400 m³ of sodium at 180°C from the reactor vessel to the primary sodium tanks to bring the level in the reactor down as far as the sub-assembly heads. Advantage was taken of this to make a geometrical verification of the core lattice, especially its flatness, to make sure there was no disorder that might be linked to the negative reactivity trips (cf. § 4.6). Once the operation was completed, the sodium was transferred back to the reactor.

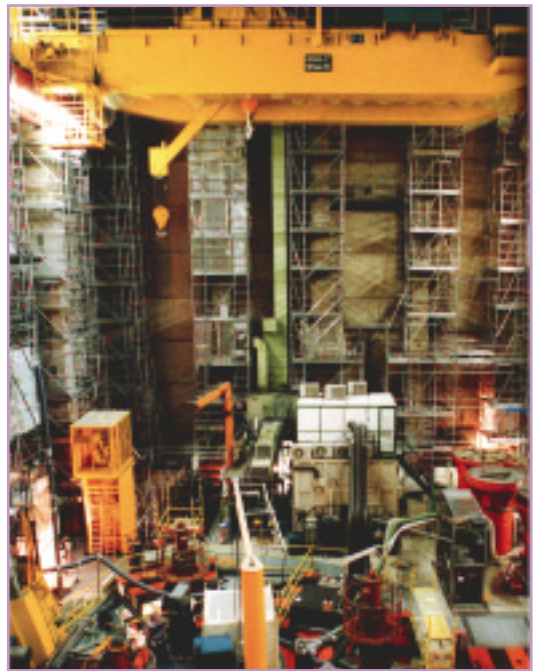
Inside the reactor building, the columns were reinforced wherever there were lap joints in the steel reinforcements, so that the transverse stresses from an earthquake would no longer risk shearing the columns. The operations consisted of locating the steel rods precisely (they were not all in the places indicated on the plans), taking cores from the concrete, anchoring the support plates, welding the steel casings and finally injecting resin between the casings and the concrete. Outside the building, after putting up scaffolding from bottom to top of the east and west fronts, the facades and roof were reinforced. This work was done (whenever the wind permitted!) between April 1999 and June 2000.

Hall of the reactor building during seismic reinforcement work

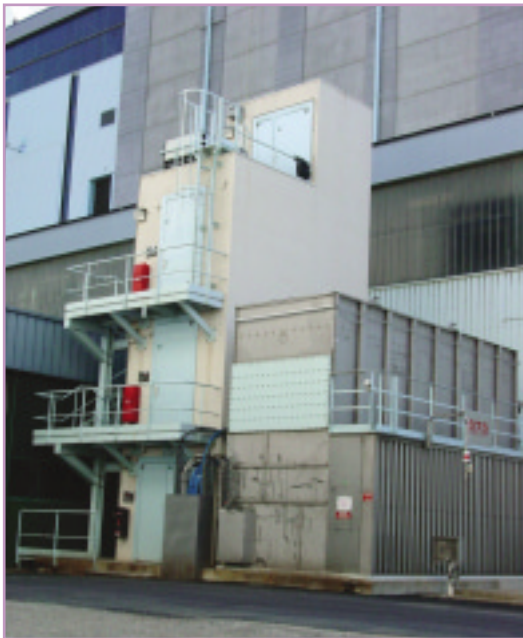
er with ventilators and is linked to its own diesel-driven generator. These systems are designed to function in the event of an earthquake or major sodium fire. Seismic standards and the nature of the ground make pile foundations necessary, with the piles sunk as much as 18 metres down. To test their heat exchange capacity, the air coolers were tested in summer, with the reactor reaching a temperature of 400°C. The heat exchange capacity was less than expected, but was acceptable once the adjustment of the circuits' operation had been modified.

Emergency cooling system air cooler (on the right, near the pump room)

By contrast, fine-tuning of the air coolers, which can operate on a water-spray basis, required repeated studies and tests to make sure they would work efficiently both in extreme cold (-17°C) and during a heat wave (+35°C). As a result, reheaters were added to the water headers at the inlets to and outlets from the air coolers, and changes were made to the instrumentation

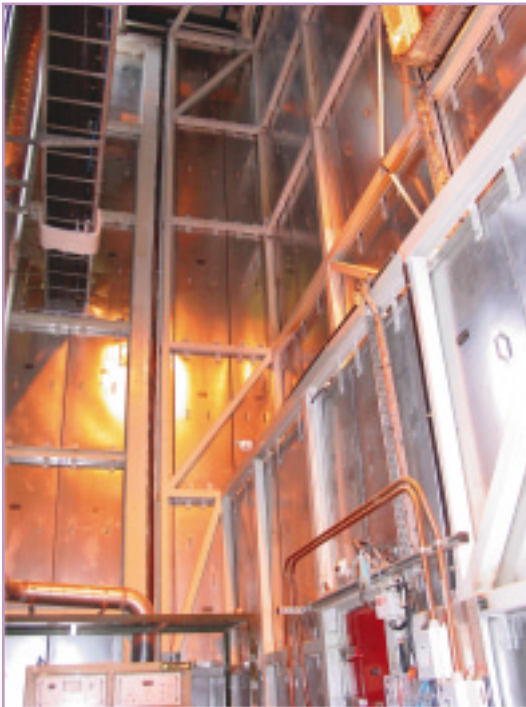
Other methods to protect the steam generator building from major sodium fires were also introduced. These were dampers for closing the ventilation air intakes, failure panels on the sides of the building, a new conventional fire detection system and a sodium fire detection system (Na 101: flame spectrometers), heat insulation under the ceilings of basement rooms in the building, insulated channels around the secondary sodium circuit draining lines and protection for the electrical conduits.

Steam generator building partitioning

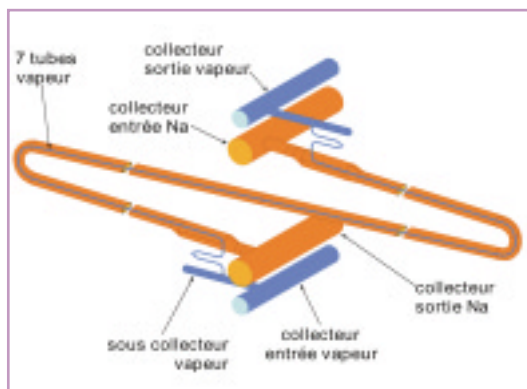
Schematic of a steam generator module

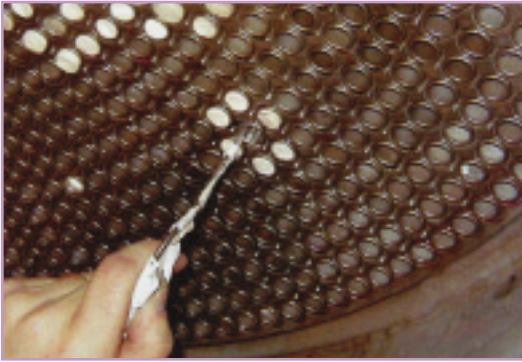
Inspecting the tubes of an intermediate heat exchanger

During the summer of 1999, inspection revealed non-compliant welds on heat exchangers M and L. The defective welds of intermediate heat exchanger M were repaired. Even then, the tube bundle did not meet the tightness criterion. In January 2000 a second series of investigations revealed cracks at the edge of the melted zone of the same welds. After repair, the tube bundle was put through a further tightness test and this time passed the test. Reassembled and tested, intermediate heat exchanger M was delivered to the site on 19 July 2000. A few months later it was introduced into the reactor to replace defective heat exchanger H.

asked to check the tightness welds between the tubes and upper and lower tube plates of intermediate heat exchangers L and M, to manually repair any defective welds and to also check intermediate heat exchanger K, installed in the reactor in February 1999, which risked having the same defects since it was of identical manufacture.

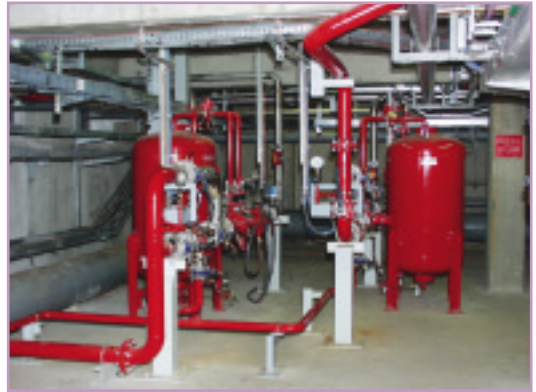
Fire protection was re-examined in the same way as the analyses performed on EDF pressurised water reactors. A number of significant alterations were made to prevent a major fire or reduce its safety impact: fire-stop doors were installed, smoke removal systems improved, the structural steelwork insulated, automatic

fire extinguishing devices installed in certain sensitive areas, fire sections for fire containment were created, etc.

Fire-fighting equipment

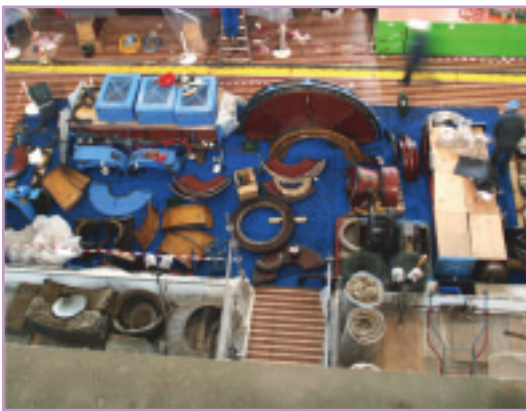
The **turbo-generator set** was given its ten-yearly overhaul between October 1999 and April 2000. Following the results of the magnetic particle testing, three rotor blades of the turbine's low-pressure cylinders were replaced. Then in August 2002, slight corrosion was observed on the rotor blades of the turbine's low-pressure cylinder. This was due to saturation of the air dryer of the low-pressure cylinder during tests with the condenser. Both low-pressure cylinders were opened to clean the rotors and remove two blades to inspect their attachments to the shaft, which proved to be in satisfactory condition.

Turbine undergoing overhaul

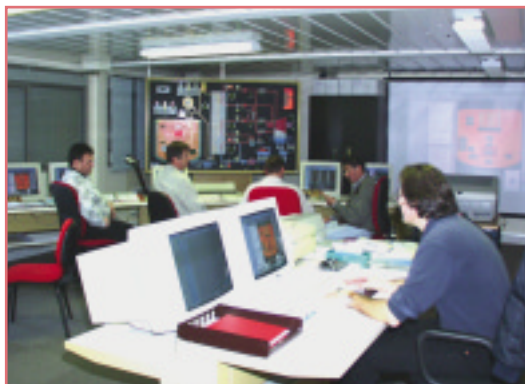
The Simfonix simulator

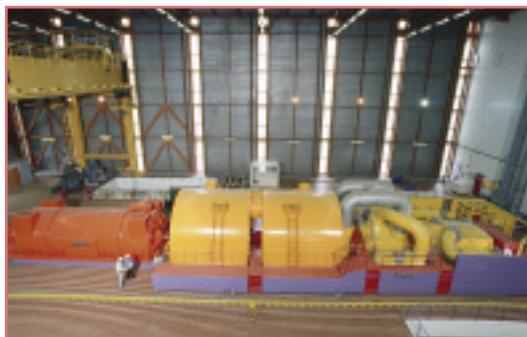
The turbo-generator set
