Phénix

30 years of history:
the heart of a reactor

An original reactor: a sodium-cooled, fast neutron breeder reactor.

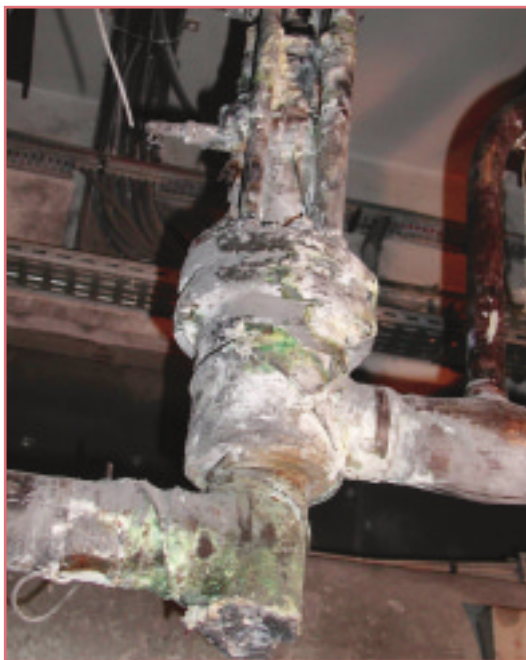
Valve with insulation removed after a sodium leak

Two **sodium leaks** occurred during this period. On March 16, 2003, a valve bellow in the sodium purification circuit N. 1 of the secondary circuit was no longer leaktight. The sodium leaked through the bellow and rapidly found its way into a space between the valve shaft and the packing. Approximately twenty litres leaked out of the purification circuit which provoked a small sodium fire. The aerosols generated during the sodium fire spread into the partitioning of the secondary circuit N. 1 and even leaked into the secondary circuit N. 3, not to mention the area where the water and steam pipes are located.

The leaktightness defect in the packing seemed to be a generic problem with all bellow valves, therefore approximately fifty valves had to be upgraded. Furthermore, a thorough cleaning of the regions into which sodium aerosols had spread was performed to prevent them from corroding equipment, especially smoke detection equipment and electrical connectors. This incident revealed a few defects in the steam generator building's partitioning (cf. § 6.3). Even though this partitioning must not be completely leak-tight so that hot gases can be evacuated in the event of a serious sodium fire, it must nevertheless help delay the transfer of sodium aerosols generated from the affected area into the circuit in operation. This delay is used to identify with certainty the faulty circuit and avoid draining the wrong circuit. A systematic research of smoke transfer possibilities from one area to another was carried out and specific improvements to the partitioning were made.

Following a leak in the metal leaktightness bellow of a sodium flow regulating valve in the n.1 secondary purification circuit on Sunday 16 March 2003, the valve was rapidly dismantled and replaced with a new, but identical, valve. In the workshop, the dismantling operations of the cable stuffing box (made of asbestos) and reassembly with a new cable compatible with the sodium are validated. A leaktightness test was also validated (with a maximum hypothetical leakage rate of one kilogram of sodium per hour).

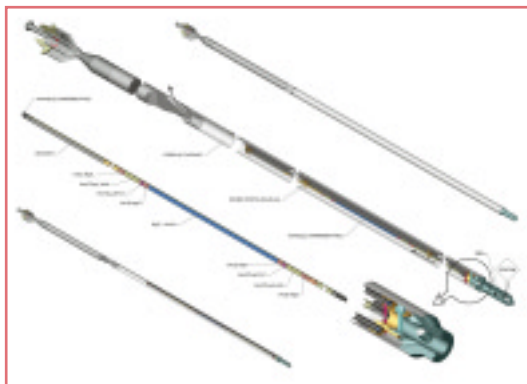
Ecrix experimental rig

The **Ecrix B and H** experiments are being developed to test the feasibility of incinerating americium using a heterogeneous recycling mode. Two identical experimental fuel pins are inserted into the reactor and subjected to different irradiation conditions. Each fuel pin contains a stack of fuel pellets composed of fine particles of americium oxide evenly distributed in an inert magnesia matrix. In order to increase the efficiency of the transmutation process, these experiments are performed in a device capable of locally moderating the neutron flux by slowing down neutrons. It is therefore possible to take advantage of the great flux of neutrons available in the core by combining the high thermal neutron cross sections, which help obtain a fission rate of 30%, associated with a transmutation rate over 80%. The Ecrix B experimental device is inserted in the center of the core with a boron moderation, whereas the Ecrix H experimental device is located on the core periphery and neutrons are slowed down using calcium hydride.

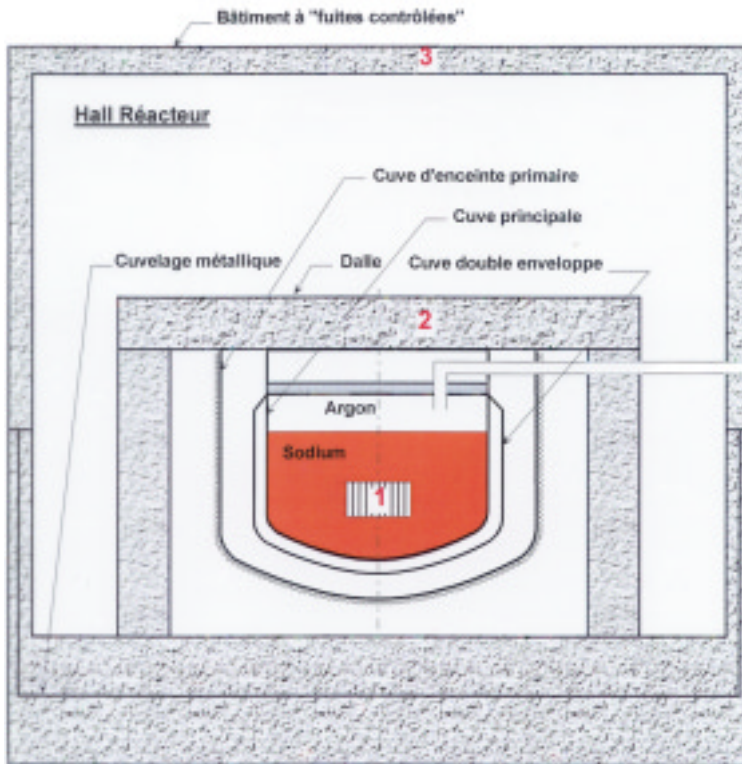
Schematic of the containment. 1 : fuel pins clad. 2 : Second containment barrier. 3 : Reactor building

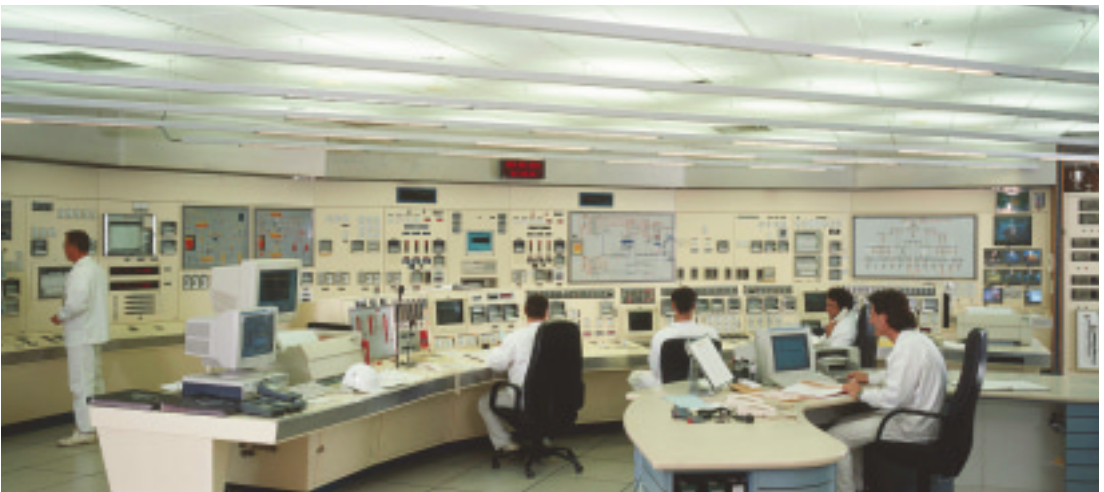
NOMINAL TECHNICAL CHARACTERISTICS

Thermal power:563 MWt
Gross electrical output:250 MWe
Neutron flux at core centre	$.7 \cdot 10^{15}$ n/ cm ² .s
Fraction of delayed neutrons360 pcm
Active volume in the core1.4 m ³
Maximum temperature at pellet centre2,300 °C
Average power density1,200 kW/ dm ³
Maximum linear power rating of fuel pins450 W/ cm
Maximum temperature of cladding700 °C
Temperature coefficient	- 2.7 pcm / °C
Power coefficient	- 0.5 pcm /MW
Doppler effect in the fissile region at 1,500 °K	- 0.3 pcm / °C
Sodium temperature at core inlet:400 °C
Sodium temperature at core outlet:560 °C
Primary sodium flow in the core:2,800 kg/s
Sodium temperature at intermediary heat exchanger inlets:350 °C
Sodium temperature at intermediary heat exchanger outlets:550 °C
Secondary sodium flow in each system:740 kg/s
Water temperature at steam generator inlets:246 °C
Water temperature at steam generator outlets:512 °C
Steam pressure at superheater outlet:165 bars
