# **Testing Thermocline Filler Materials and Molten-Salt Heat Transfer Fluids for Thermal Energy Storage Systems Used in Parabolic Trough Solar Power Plants**

## **Abstract**

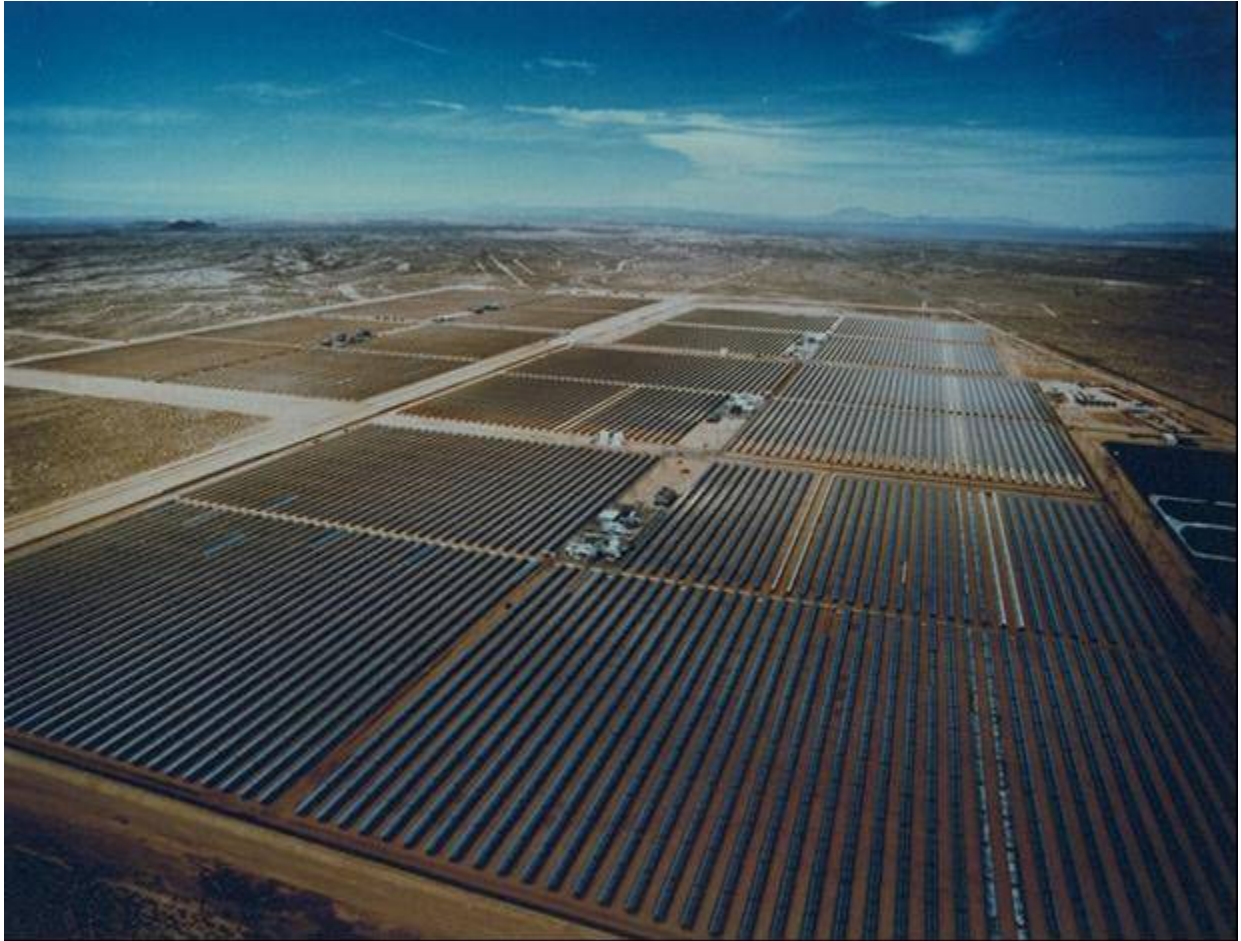
**Figure 1 - Solar Electric Generating System - Barstow, CA**

Parabolic trough electric power generating plants have already been developed at the utility-scale, particularly in the United States. The Solar Electric Generating Systems (SEGS) near Barstow, California (Fig. 1) have accumulated over 145 years of operational experience generating electricity from concentrated solar thermal energy utilizing large fields of parabolic trough concentrators. A number of these SEGS plants, with total generation capacity of about 354 MWe, were built over a period of time in the 1980's and continue to operate successfully and economically. The operation of the SEGS plants has demonstrated the ability of this technology to compete in the commercial power supply market of southern California. As such, SEGS plants based on current and improved parabolic trough systems and components will constitute one of the highest priority technologies for consideration in national and international strategies for meeting the growing power demands of nations.

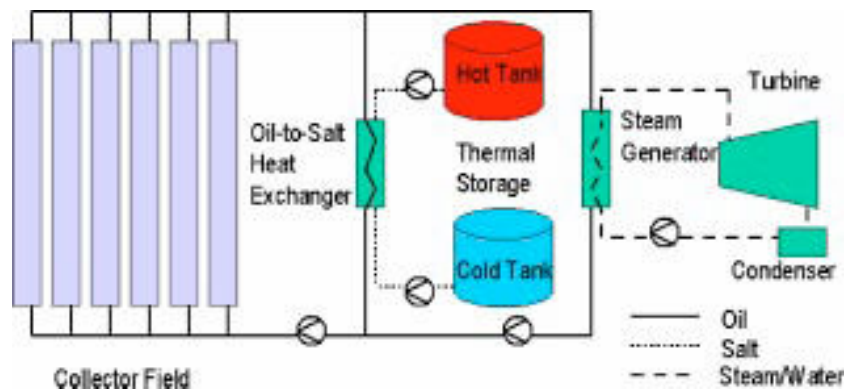
**Figure 2 - Indirect, Two-Tank Thermal Energy Storage Schematic**

interim oil-to-salt heat exchanger) in the “hot” tank for later use when it is required. This type of indirect, two-tank system was used at the Solar Two solar power plant built and operated in the mid-1990’s. [5]

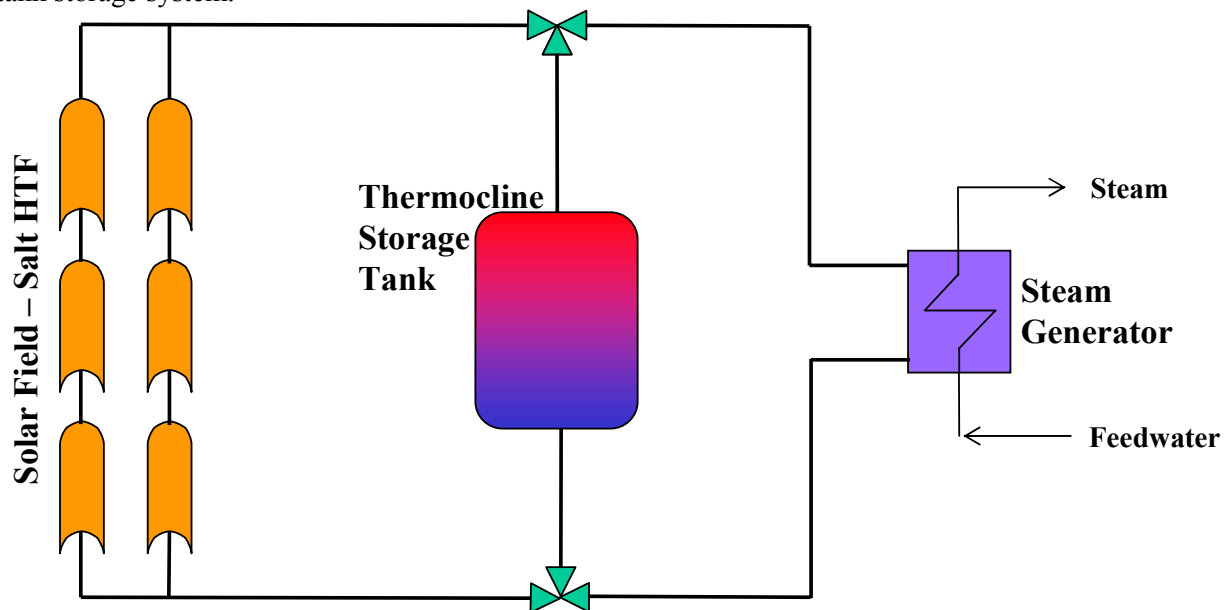
Figure 4 - Direct Thermocline TES Schematic

Another option to potentially reduce thermal energy costs significantly is to use direct, single-tank thermocline storage systems with molten nitrate salts as the direct heat transfer fluid (Fig 4). The thermocline storage system uses a single tank that is only marginally larger than one of the tanks in a two-tank thermal storage system (such as that used at Solar Two [5]). With the hot and cold fluid in a single tank, the thermocline storage system relies on thermal buoyancy to maintain thermal stratification. A low-cost filler material, which is used to pack the single storage tank, acts as the primary thermal storage medium. The filler displaces the majority of the molten salt that might be used in a comparable two-tank system. System studies [2,6,7] have evaluated the more traditional two-tank energy storage systems and single tank thermocline storage systems and have shown that thermocline-based energy storage configurations may offer the least-cost energy storage option. They offer potentially reduced capital costs for tank construction (and related pump, valve and piping costs). The use of lower cost filler media reduces the overall required quantities of the relatively higher cost molten salt heat transfer fluid. As such, in cost comparisons the thermocline system was found to be about 35 percent cheaper than the two-tank storage system.

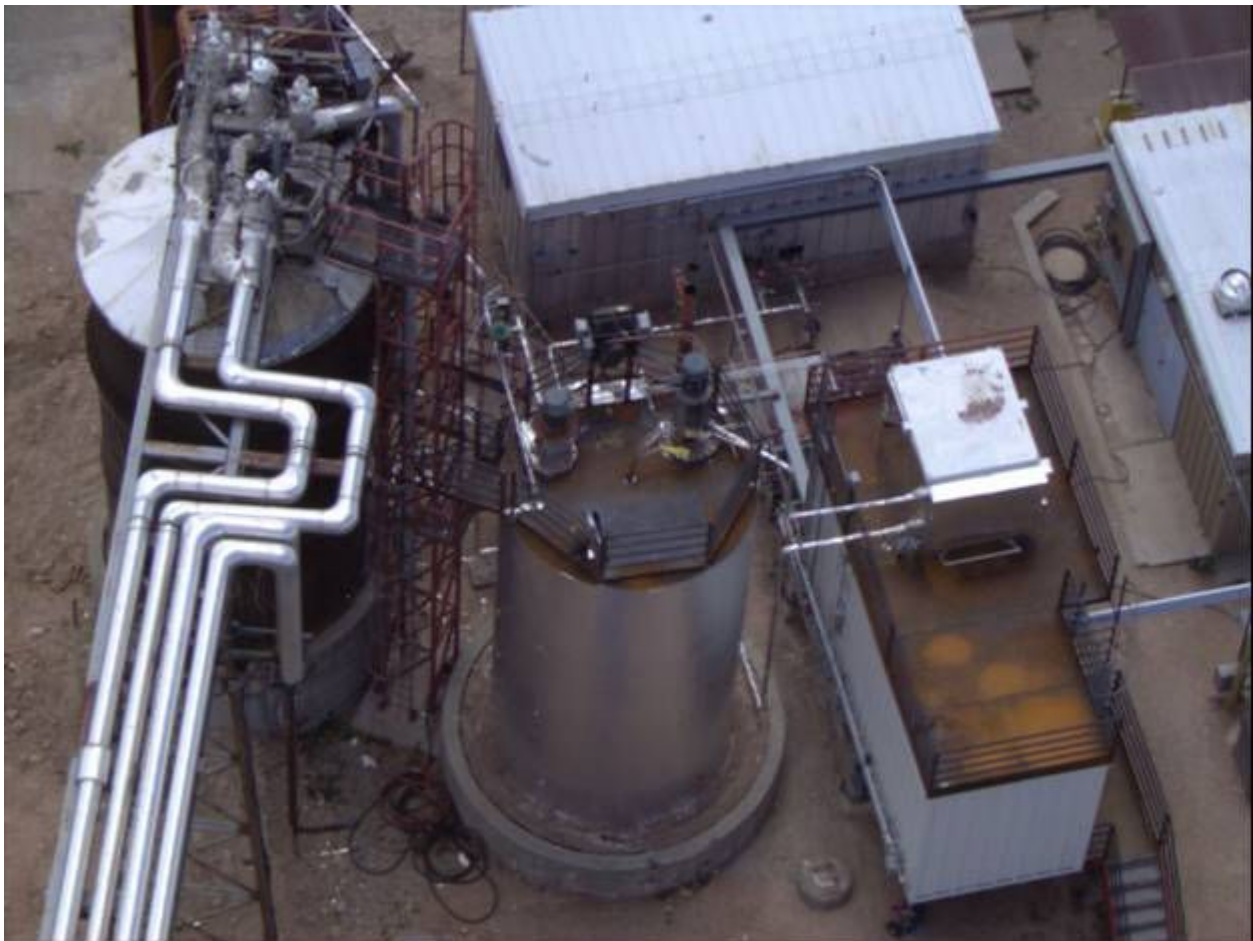
**Figure 6 - Aerial View of Thermocline Test Apparatus**

A carbon steel tank, 6.1 m tall by 3.0 m diameter, was fabricated to meet American Petroleum Institute (API) Code 650 Appendix J. A thermocouple tree was placed in the middle of the tank with thermocouples every 15 cm, vertically. In addition, thermocouples were placed on three radial arms each at three discrete levels from the tank bottom. The tank had a radial flow distribution manifold at 10 cm from the bottom, which was connected to a standpipe, housing the cold pump. The hot pump was supported from below to pump salt from the top of the tank. A number of electric mineral-insulated heat-trace cables were wrapped on the exterior surface of the tank to provide heat input during the initial heating process and make up for heat loss. The tank was insulated with 23 cm of fiberglass insulation on the sides and with 20 cm of calcium silicate ridged block insulation on the top of the tank. Figure 6 provides an overall view of the actual system installation. See Appendix A for test apparatus fabrication details and illustrations of the installation process.

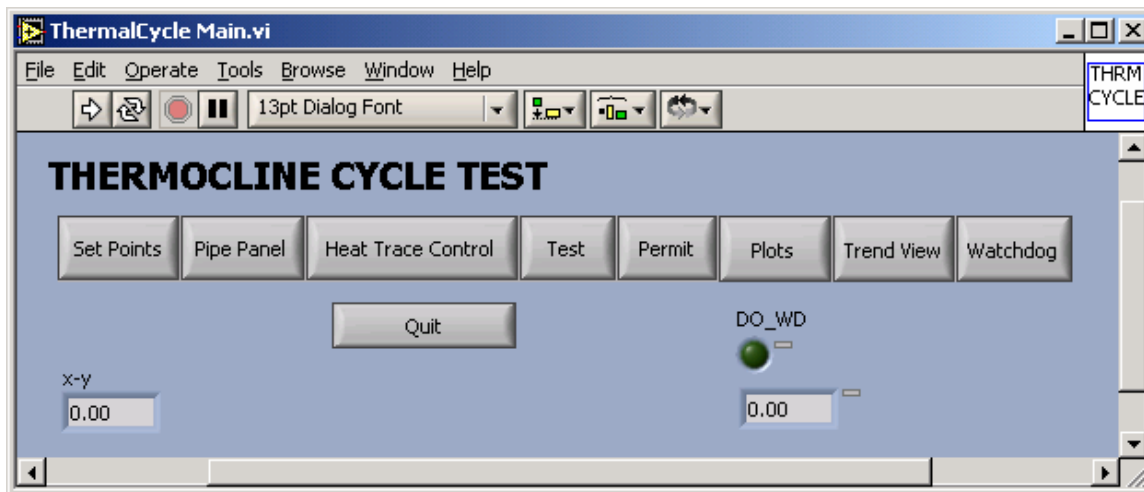
Figure 13 – LabVIEW Main Panel

The program started up from a simple panel with buttons to “press” to bring up additional panels to control the test or view temperature trends. The start up panel is shown in Figure 13.

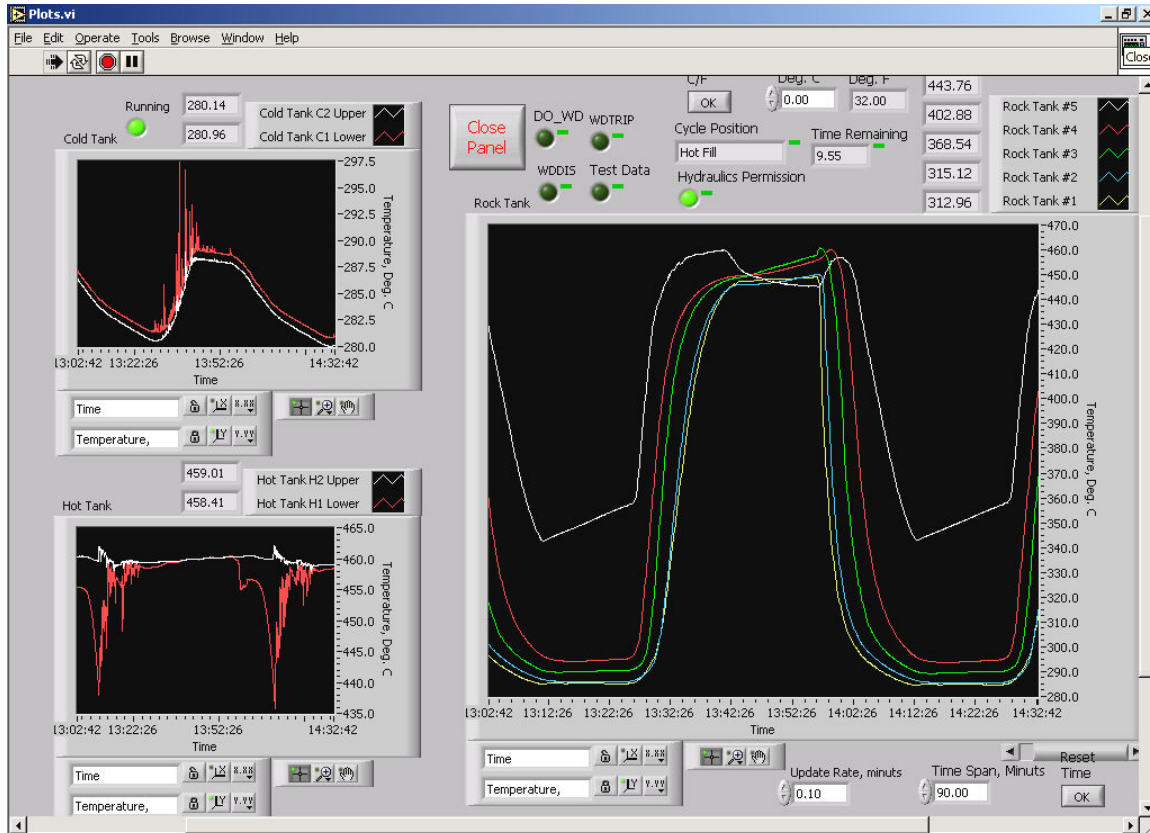
Figure 15 – LabVIEW Plots Panel

The Plots panel displayed real time plots of the cold tank thermocouples, the hot tank thermocouples, and the rock tank thermocouples. A sample Plots panel is shown in Figure 15.

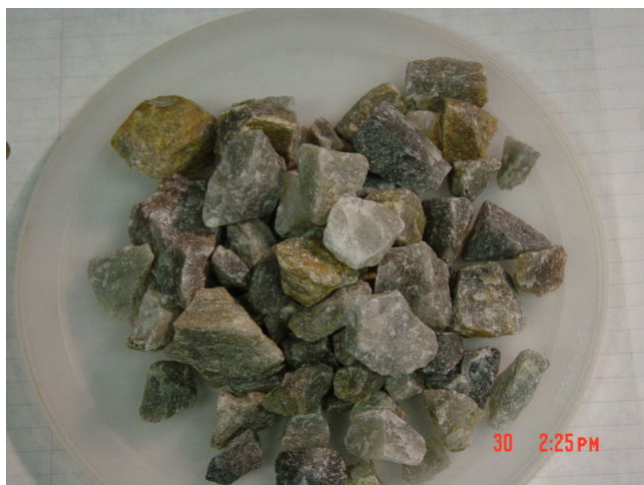
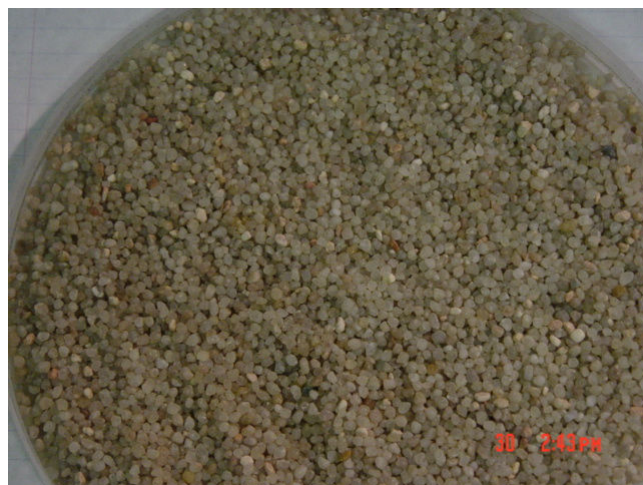
A detailed but simple process was developed and followed to wash rock and sand samples, dry, weigh, photograph, then insert in the sample baskets. The baskets were then carefully inserted in each pot; on August 1, 2002 for the 450°C pot and August 2, 2002 for the 500°C pot. Salt samples were taken just prior to sample insertion. Appendix C provides a copy of the monthly schedule, procedure and checklist that was followed to periodically sample and document observations of the condition and weight of the rock and sand samples as the test progressed. These pictures show initial rock and sand samples.

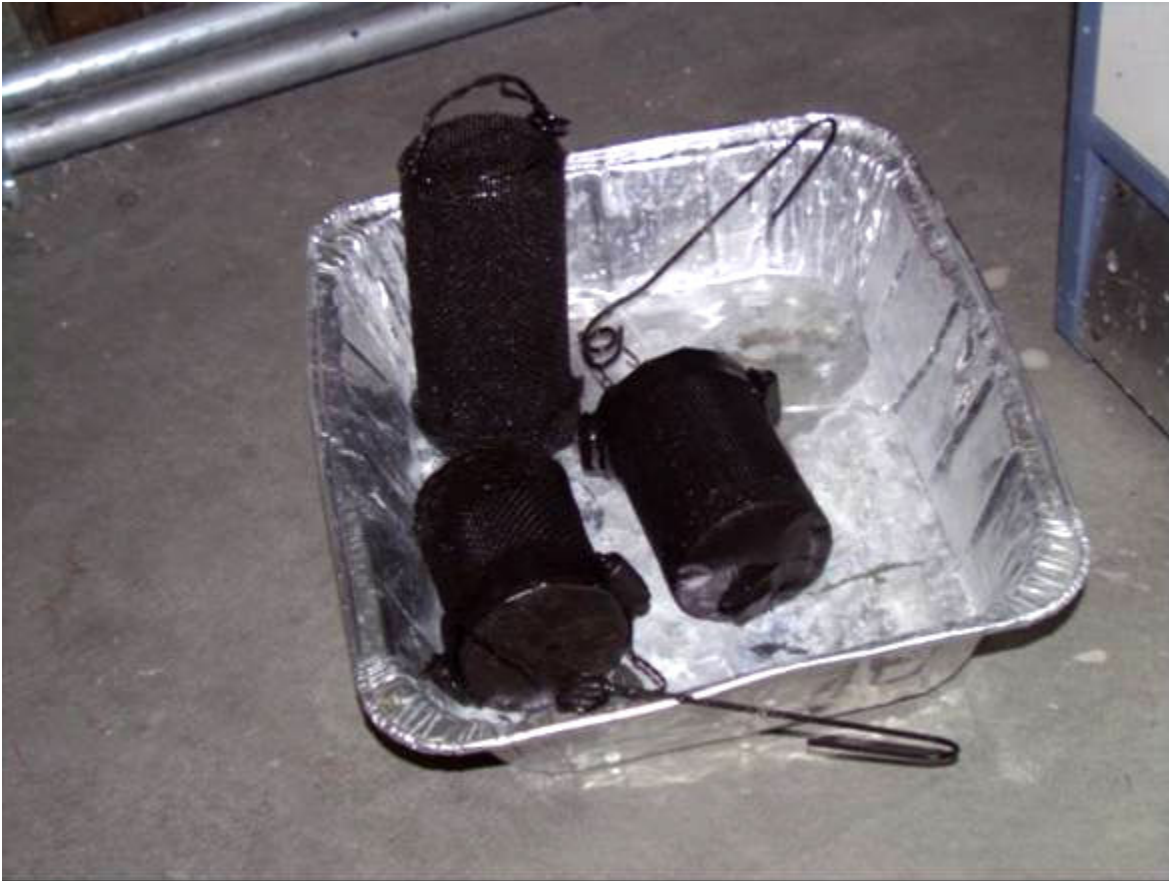
Figure 16 - Blackened Zone 2 Sample Baskets

The condition of the 316SS sample baskets changed as testing progressed. By January (Month 5), deterioration (noticeable “blackening”) of the sample baskets started in the Zone 2 pot at 500°C, along with surface deterioration of the covers and screen mesh (Fig. 16). At the same time, no notable deterioration occurred on the Zone 1 sample baskets exposed to 450°C salt. By February (Month 6), the Zone 2 sample basket containing sand required repair. External basket corrosion continued to worsen, and by Month 9 (May 1), was significantly advanced. Some additional basket reinforcement was added early June. By the end of isothermal testing (August 1, 2003), the Zone 2 sample basket was almost completely deteriorated and self-destructed upon removal for rock/sand assessment. By comparison, the Zone 1 (450°C) baskets were in very good condition.

Also noted during isothermal testing was significant deterioration of stainless steel sample baskets immersed in the molten salt that occurred during the 1-year test period. The baskets in the 500°C test pot required repair and reinforcement in less than 6 months, and basically disintegrated on removal after one year. On the other hand, the sample baskets at 450°C held up quite well for the entire test duration with no significant deterioration. A simple sample basket installed in the test chamber of the thermal cycling apparatus exposed to 10,000 cycles in the range of 285°C to 450°C also held up well.

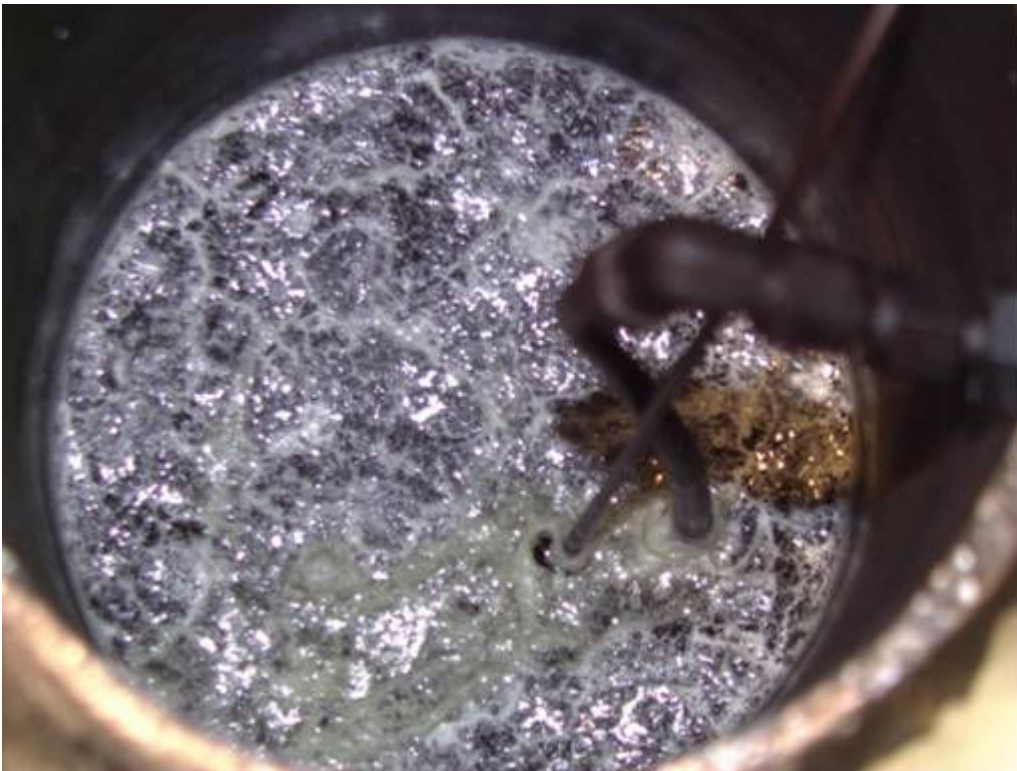
Figure 17 - Zone 5 Typical Crust Formation

There were three significant observations made during testing; details of these trends will be discussed at length later in this report. First, the rock and sand samples gradually increased in weight, most likely due to intrusion of molten salt and other chemical constituents in the small pores and cracks on the surfaces of the rock and sand materials. Second, the samples baskets in the Zone 2 test pot at 500°C significantly degraded over time, with very little comparative degradation in the Zone 1 test pot at 450°C. Third, a very significant crust formed on the surface of the salt in the Zone 5 control pot at 500°C, with very little similar formation in the Zone 2 pot (with samples) at the same 500°C temperature.

Another condition noted during testing was significant calcium carbonate ( $\text{CaCO}_3$ ) crust formation on the surface of the molten salt in one of the isothermal control pots at 500°C. This crust also formed to a significant degree in the “cold” tank of the thermal cycling apparatus, which was open to atmosphere and maintained at approximately 280°C to 285°C for the 14-month duration of the thermal cycling test. This observation in testing raised concerns regarding the treatment and control of this scaling in large, commercial-scale power plants, particularly in the piping and solar field heat collection element absorbers.

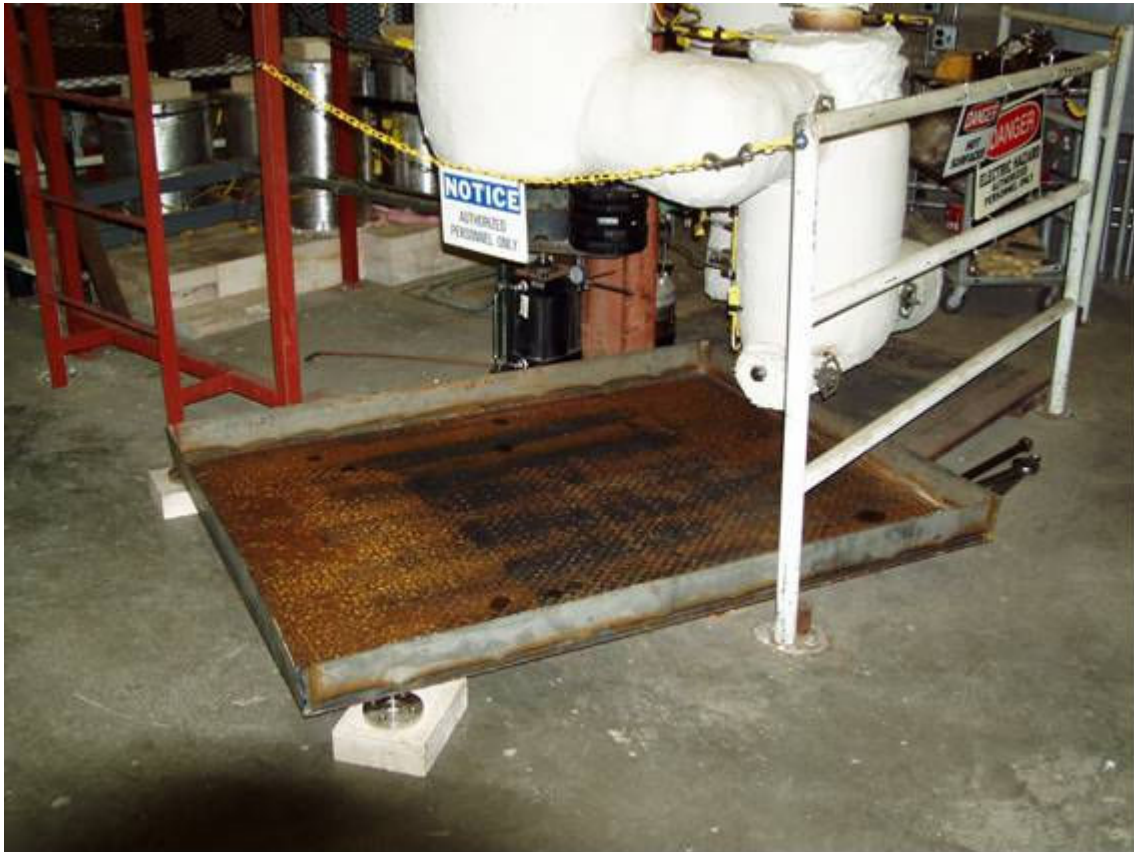
**Figure 18 - Drain Pan for Thermal Cycle Shutdown**

On October 29 and 30, historical data through the required test duration of 10,000 cycles were downloaded and copied to alternate locations for safekeeping and future access. The final molten salt samples were taken from both the hot and cold tanks. The system and test area were prepared for shutdown (Figure 18). However, due to other testing activities and the weekend approaching, thermal cycling continued through another weekend.

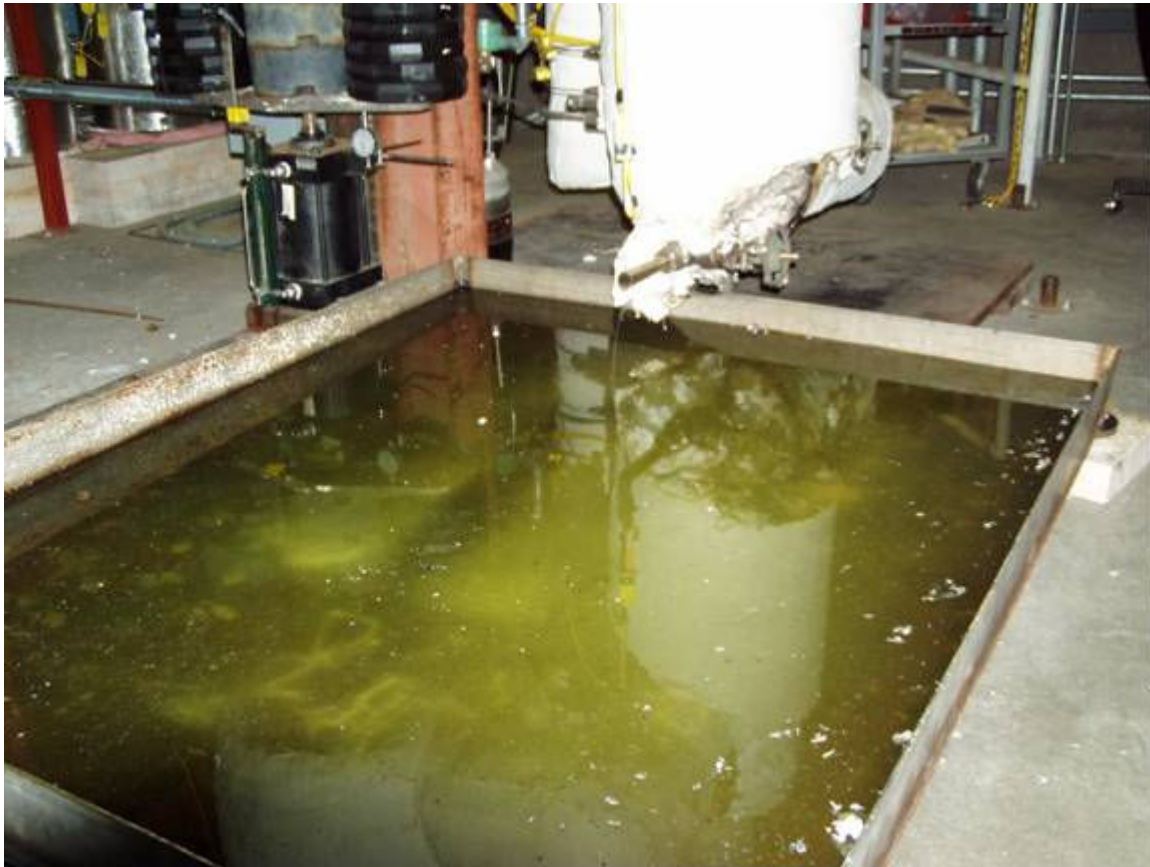
**Figure 19 - Molten Salt Following System Draining**

Shutdown operations began the morning of November 3, 2003. Initial efforts involved insulation removal and thawing out the drain valve and discharge piping (due to inadequate heat trace at that location of the apparatus). Once the drain valve was broken free, the team attempted to grab and screen the first samples of salt and any other products collected in the small “deadleg” near the drain valve. Unfortunately, the salt flow was too fast, and too hot to safely capture and filter any significant sample before onset of freezing. However, a small sample of the first discharge stream was obtained. Qualitatively, the team observed very little material (degradation products of rock/sand, or other un-dissolved solids) in the initial molten salt flow. Samples of material that collected in the small drain pipes below the hot and cold tanks were also obtained. The remainder of approximately 25 gallons of molten salt flowed into a large drain pan (Figure 19) and was allowed to freeze prior to disposal. All heat trace were set to control temperatures of approximately 85°C to 90°C to ready the system for water flushing. Cooldown was very slow, taking overnight and into the next morning.

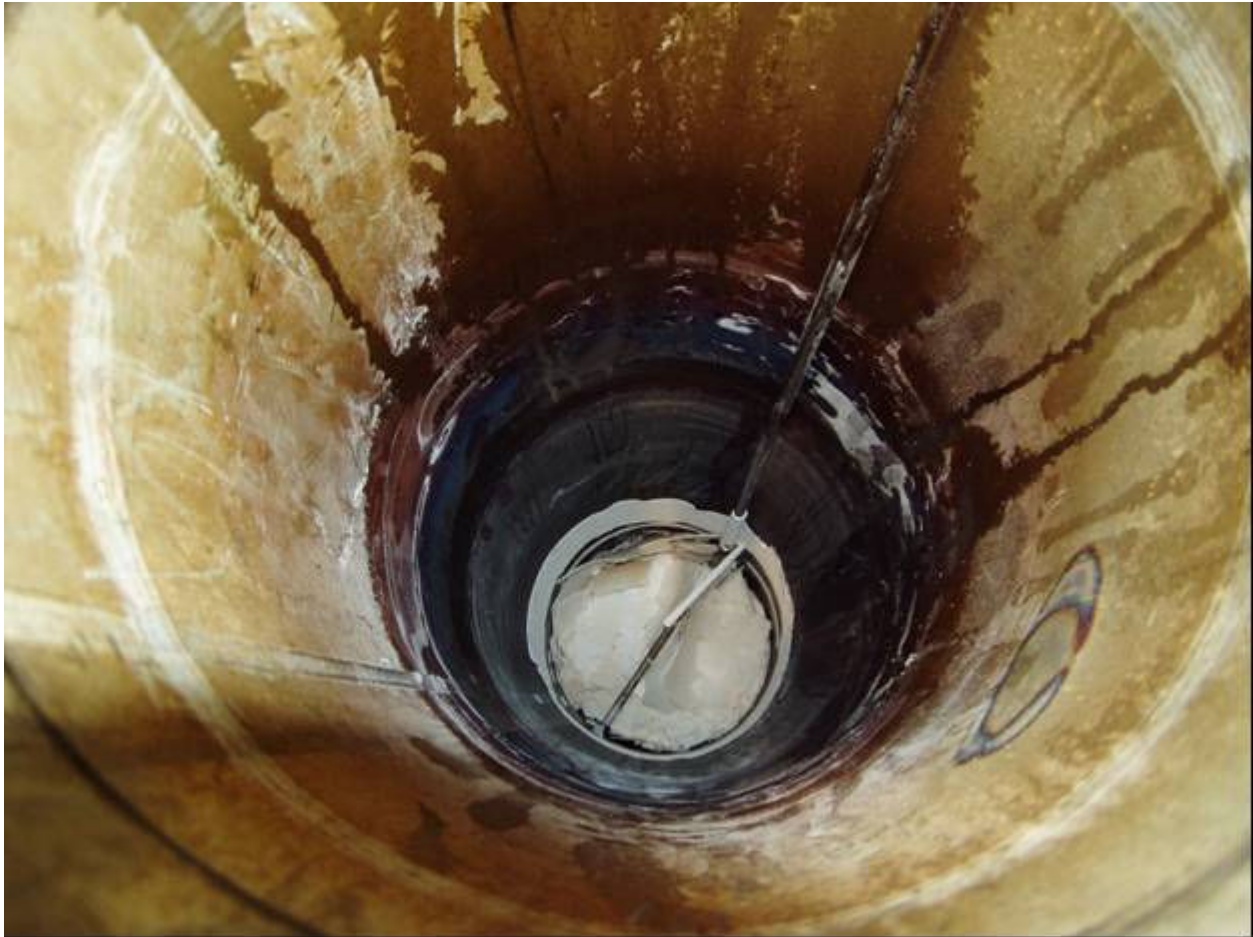
**Figure 20 - Calcium Carbonate Crust in Cold Tank After Breakup**

system a number of times. As the material broke away from the walls and collected in the bottom of the cold tank, drain flow was nearly stopped and the material did not readily dissolve and flush out of the system. Due to the heat and limited accessibility to the cold tank, it was difficult to accurately measure scale thickness. Small samples ranged from 1.5 to 3 mm (1/16- to 1/8- inch) thick, a significant buildup. Samples were taken and sent to a Sandia chemical lab for analysis. Later analysis, documented in the next section of this report, confirmed that the crust buildup was primarily composed of calcium carbonate ( $\text{CaCO}_3$ ). A similar crust buildup in the Zone 5 isothermal pot, which was at 500°C (Fig 17) was also noted, but it was significant to see the extent of this buildup at 280°C to 285°C in the cold tank. There was also a very small (but not appreciable) amount of similar white crust in the hot tank.

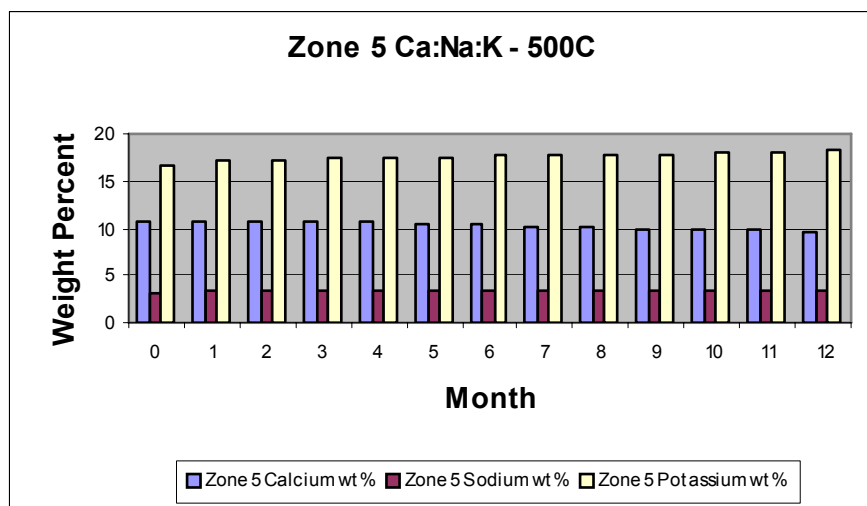
**Figure 23 - Zone 5 Calcium Concentration Change**

The ratio of Ca:Na:K in three of the four isothermal mixtures did not vary significantly over time. The calcium weight percent in Zone 5 dropped slightly over time (Fig. 23). Nitrite levels spiked to high levels early in testing, then attained a rough equilibrium with significant variation due in part to large measurement and analytical uncertainty.

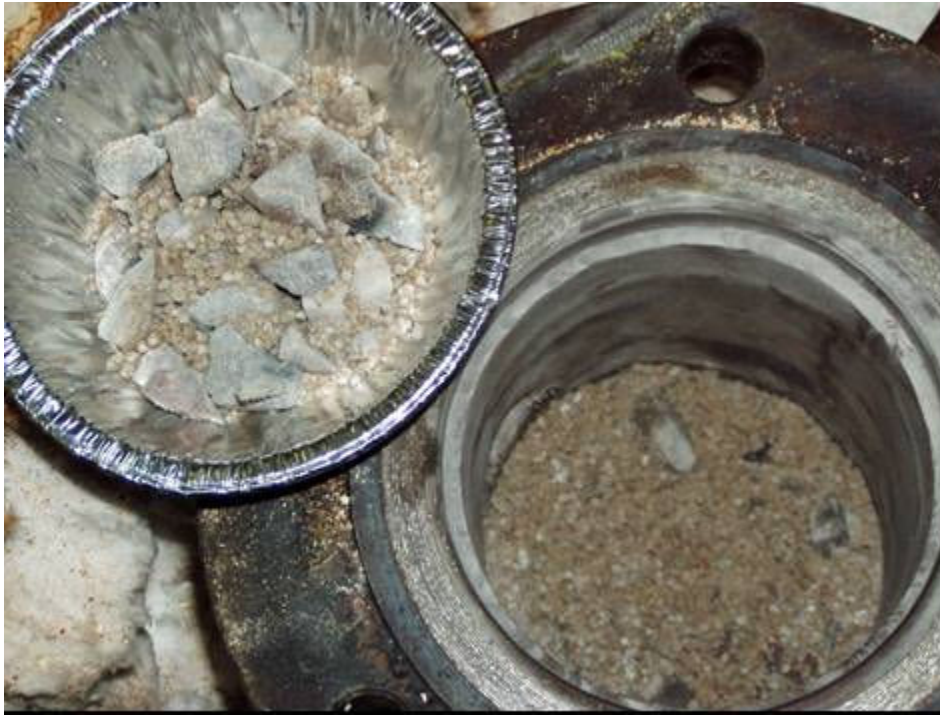
**Figure 34 - Initial Rock, Sand, Fines from Test Chamber**

The initial layers of rock and sand removed contained a fine light brown powder (Fig. 34) that was eventually sieved and captured for analysis. The material was determined to be a mixture of rock/sand fines, very minor nitrate salt residue, the  $\text{CaCO}_3$  crust, and very minor quantities of other degradation products. Notably, the sand did not turn a green tint as was evident during isothermal tests at  $500^\circ\text{C}$ . Succeeding layers were solidly compacted above the small, encaged sample that was installed approximately mid-height in the test chamber. Fines appeared to decrease as filler material removal progressed (Fig. 35).

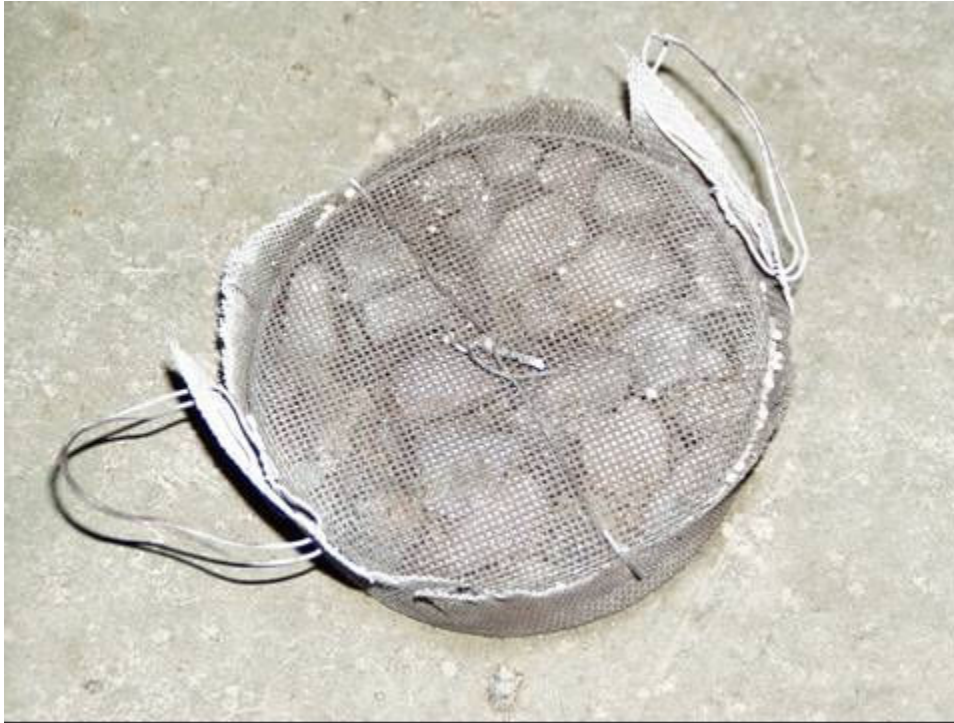
**Figure 36 - Caged Controlled Sample Basket Mid-Chamber**

Second, the Sandia team installed a “caged” controlled sample of rock and sand midway in the test chamber, with the hoped-for objective of periodically removing, observing, and weighing that well-defined mass of rock and sand. It was postulated that the screen mesh used to hold the sample might provide a collection point for corrosion products and provide a means to “filter” and retain fines from rock/sand degradation. Though any captured material might “backflush” during the alternate fill period, this condition was a concern. However, throughout testing, no significant deterioration of the desired thermal response was noted.

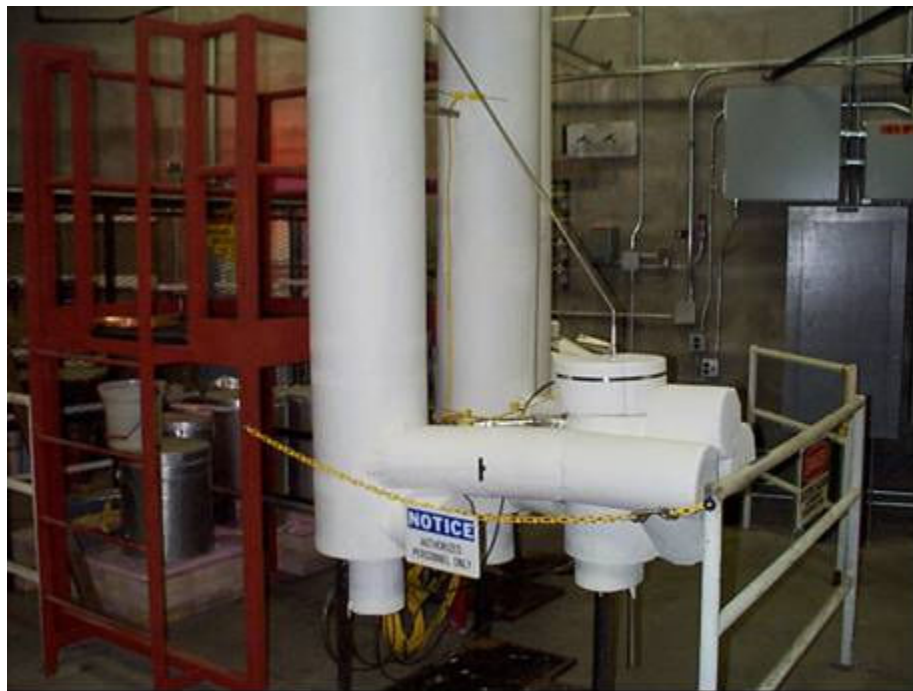
This picture again depicts the finished and operational thermal cycling apparatus used for screening.

This “hot rocks” test explored the durability of each rock sample by cycling hot salt (400°C) and cold salt (290°C) through a basin or test chamber containing the sample. The test chamber was located between the hot and cold tanks. Using air pressurization, the salt was alternately cycled through the test chamber from either the hot or cold tank, with “soak” times that were typically on the order of 30 minutes. This apparatus, unlike that used for the later thermal cycling system for testing to 10,000 cycles, was pressurized with air. Thermal cycling control was reasonable, but difficulties were experienced which pointed to the desire for a new design for the longer-term test phase. Lessons were learned particularly with respect to heat trace and insulation requirements.

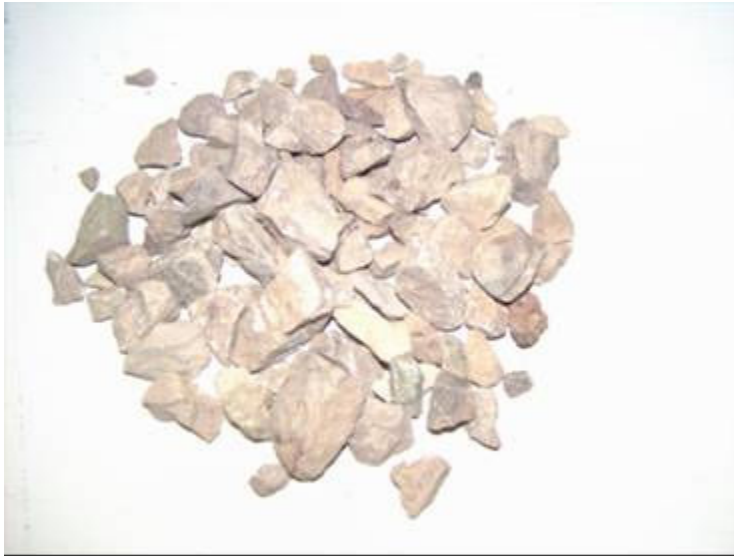
The following series of pictures shows the before and after condition of the samples tested. The limestone faired the worst in testing. This first picture is the initial condition of this material.

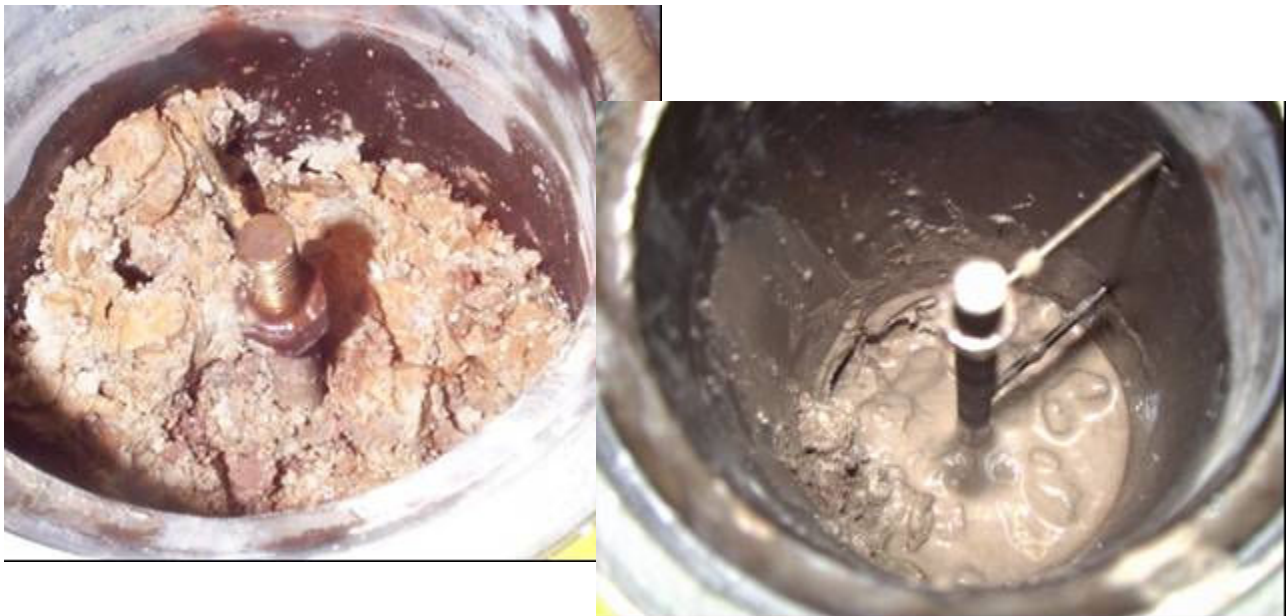
The following are two of the shots showing the condition of limestone after 365 cycles of testing.

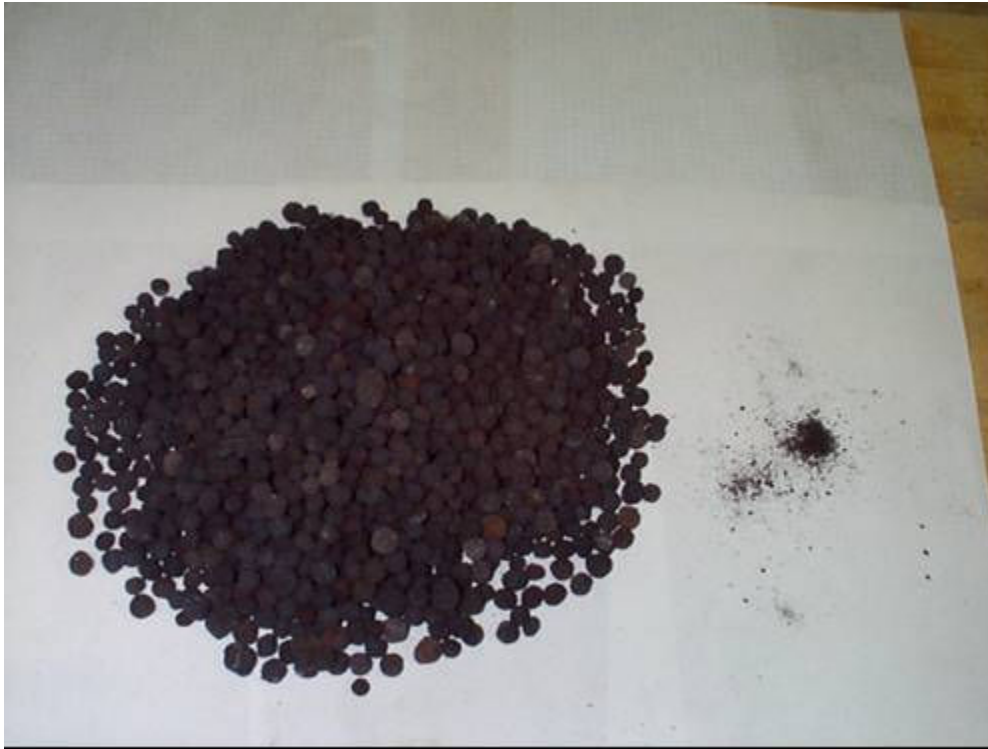
There were no pictures available that depicted the condition of the marble filler material tested. The following pictures depict the taconite pellets and some of the fines that resulted from thermal cycling exposure conditions in molten salt. Some of the taconite pieces were easily crushable between two fingers, even though the taconite seemed to hold up well overall.

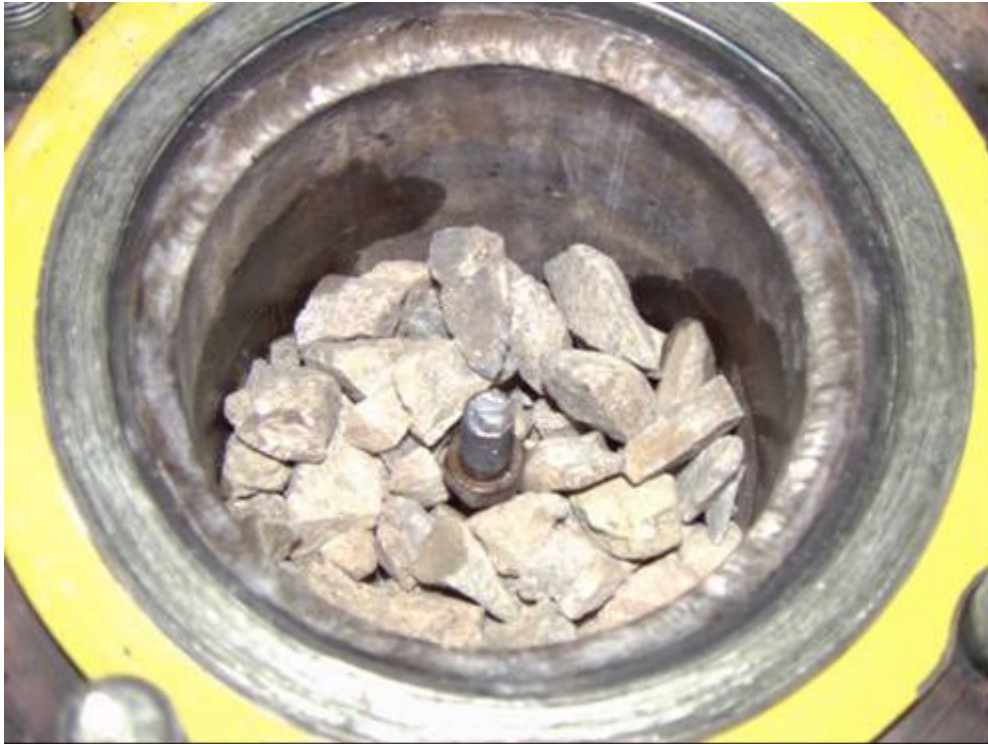
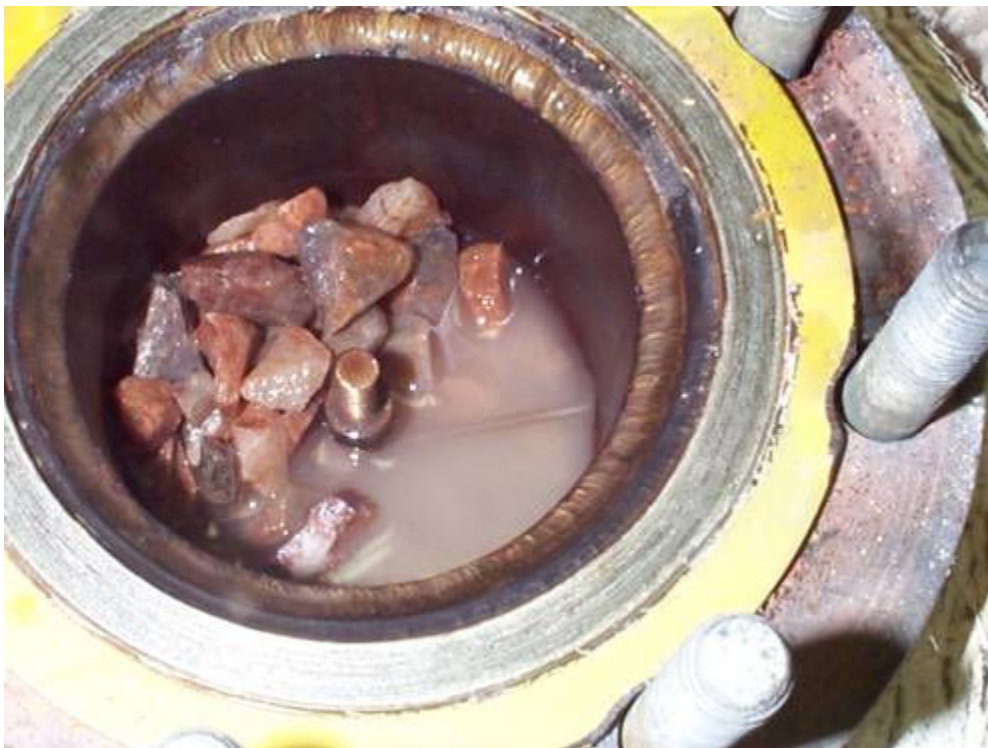
The next set of picture depict the before and after condition of the quartzite rock which was tested for 553 cycles. Note that the picture taken after included water that was used to clean the tank in preparation for the next test. As noted in the main body of the report, this filler material did well in this screening test.

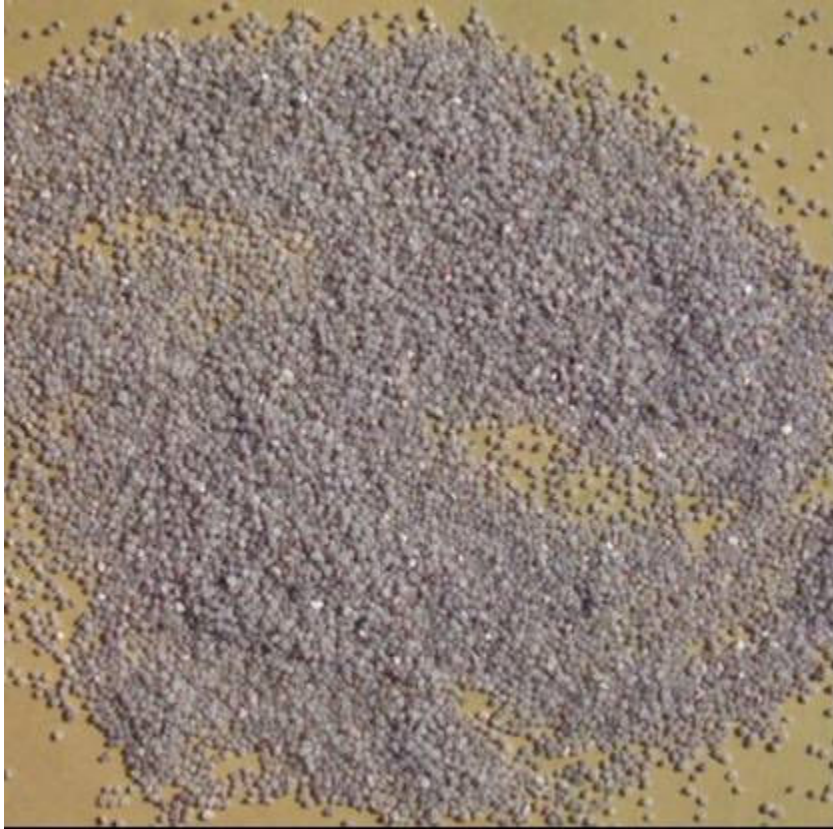
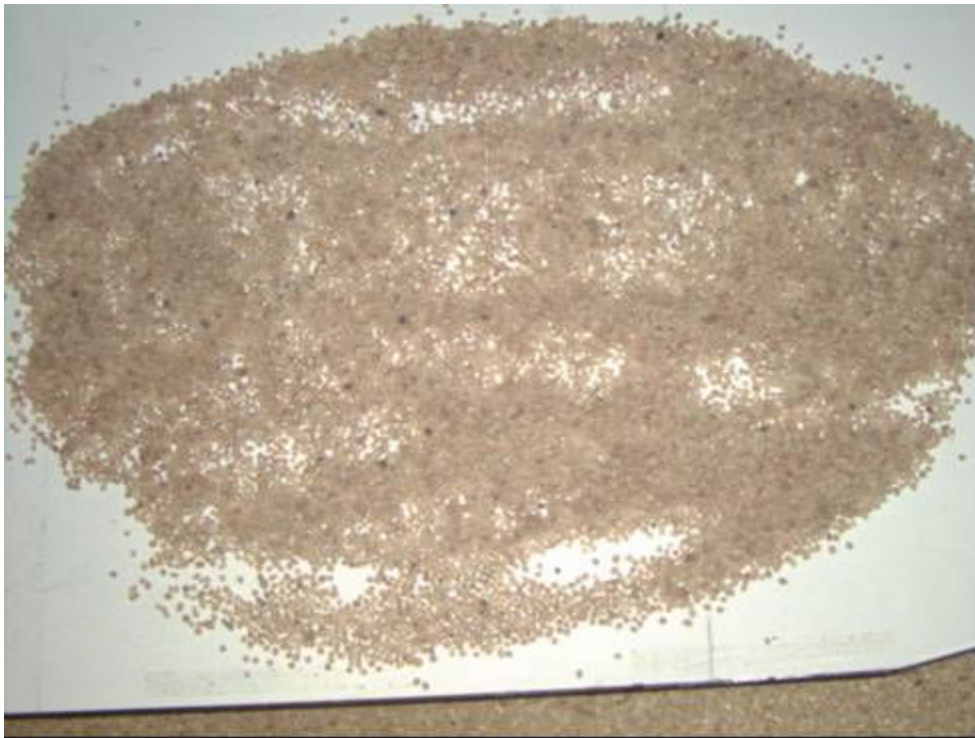
Finally, the silica sand that was chosen for use in combination with quartzite rock (in order to significantly reduce the void fraction) was also exposed to 360 thermal cycles. The before and after picture show remarkably little change in this material in these initial test conditions.

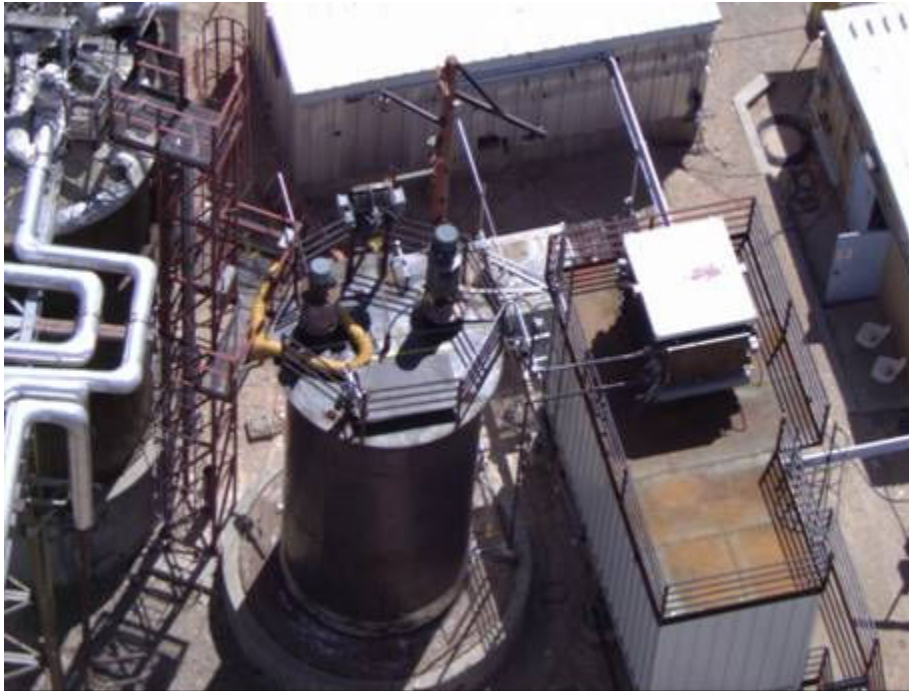
This first aerial photo shows the thermocline tank in the middle, the cooler on the right, and the propane heater on the left.
