# **Testing Thermocline Filler Materials and Molten-Salt Heat Transfer Fluids for Thermal Energy Storage Systems Used in Parabolic Trough Solar Power Plants**

## **Abstract**

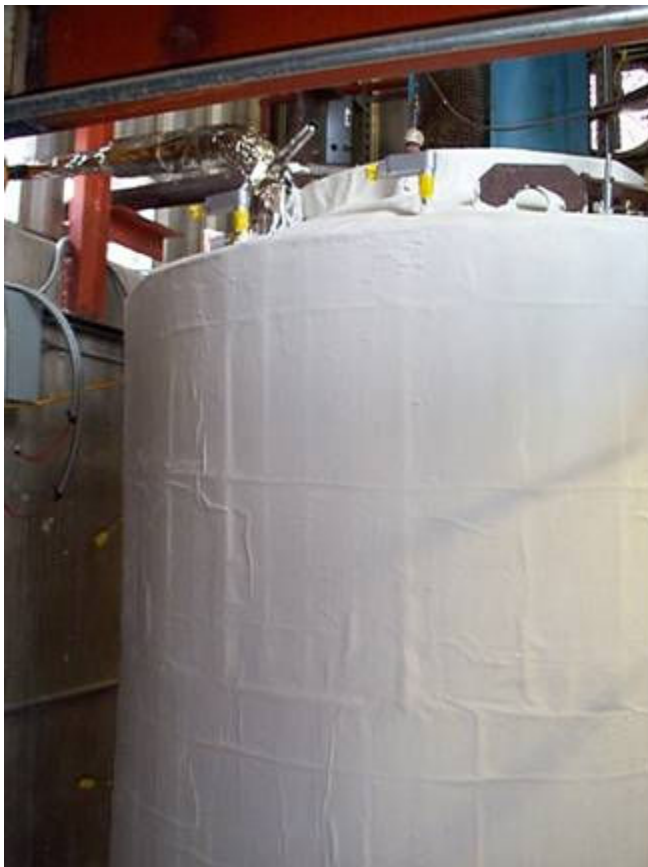
This image shows the insulated sump that collected molten salt from the heater and cooler at the end of a test. The inventory was then pumped back into the tank.

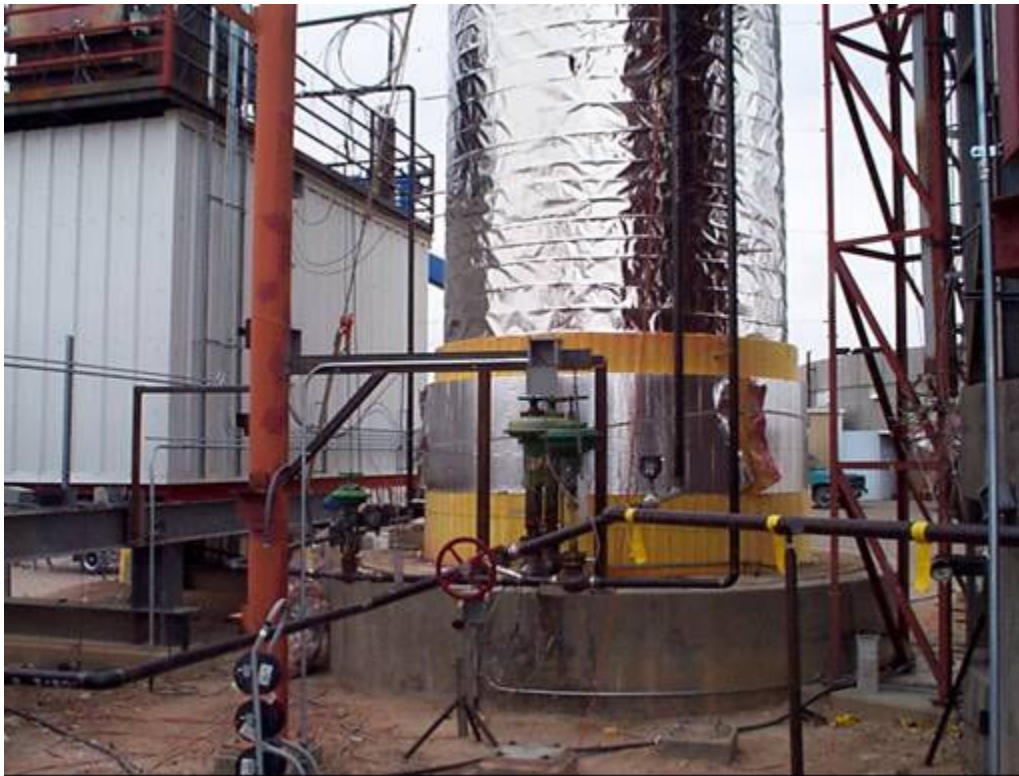
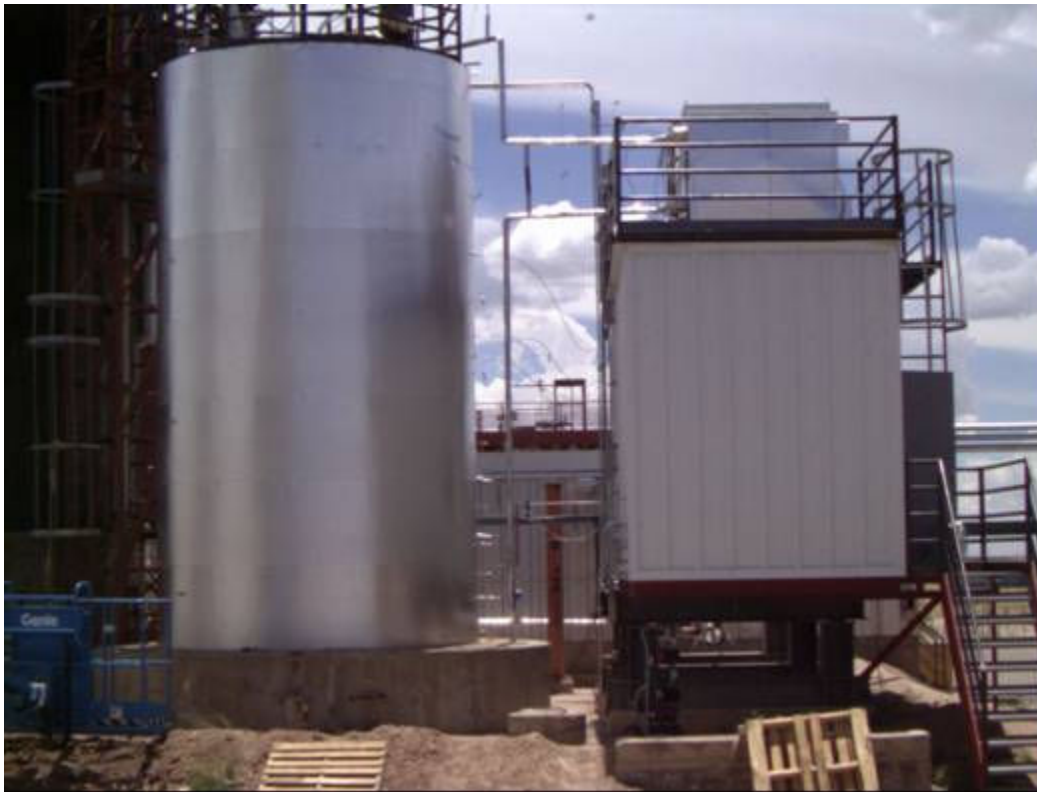
The above photo shows the thermocline tank fully heat traced, and the initial layers of insulation applied. The image below shows the completion of insulation, as well as the cooler on the right.

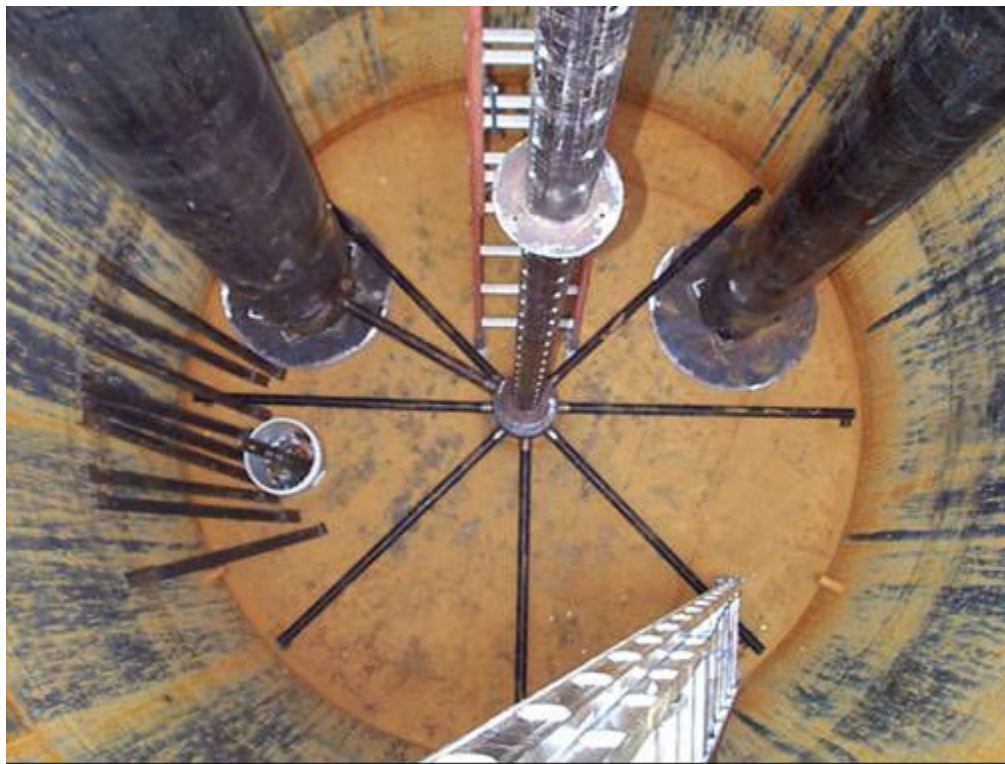
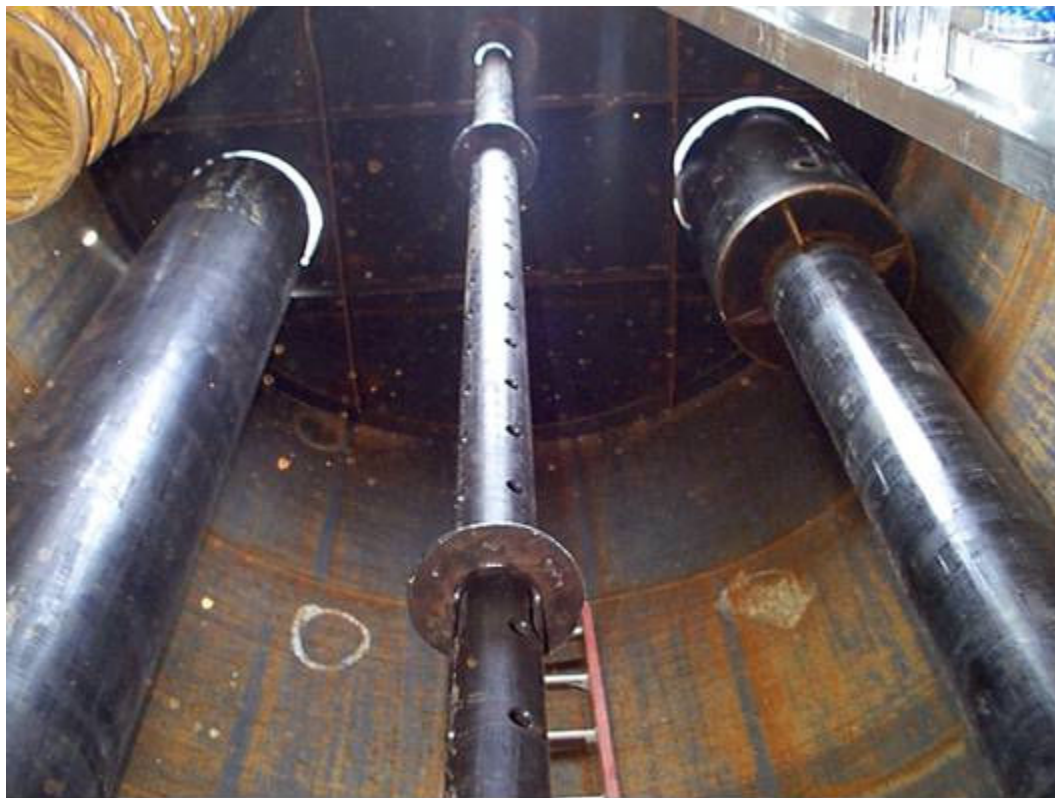
The photo above shows the thermocouple tree, the flow distribution manifold, and the hot and cold pump stand pipes, also noted in the picture below.

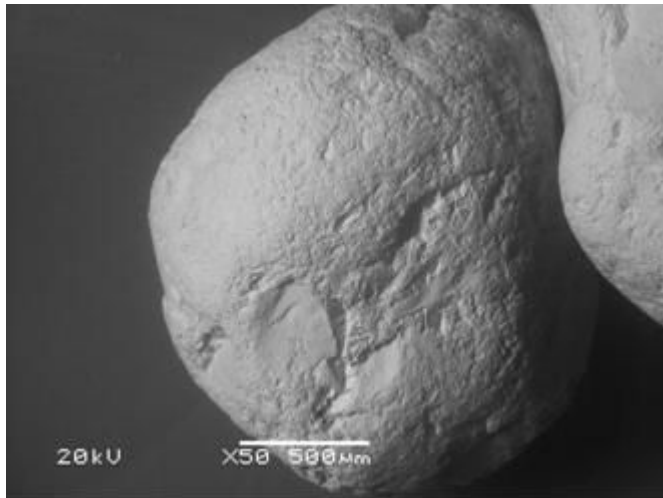
Figure 1. Low magnification SEM image of control sand grains showing a frosted (finely pitted and scratched) surface and spall scars. Spall scars are recognizable by their smooth surfaces.

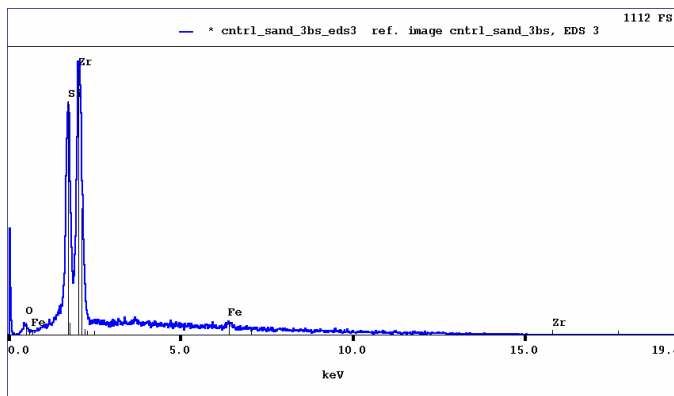
Figure 5. EDS spectrum of the bright grain in Figure 4. The major peaks are from zirconium, silicon, and oxygen indicating that this material is zirconium silicate.

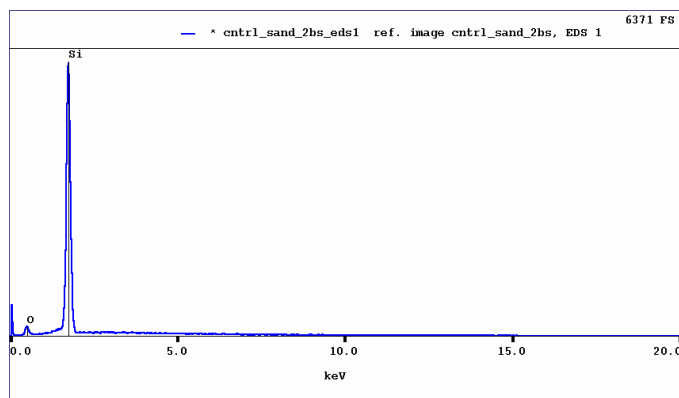
Figure 8. EDS spectrum of the majority phase in Figure 7. The major peaks are from silicon and oxygen indicating that this material is silica.
