APPENDIX B
REPORT OF MISSION EVENTS PANEL

Panel 1 was assigned the task to develop a detailed and accurate chronology of mission events directly related to the flight of Apollo 13. This event sequence would then form a baseline of data for analytical use by Panel 1, other Panels, and the Review Board.

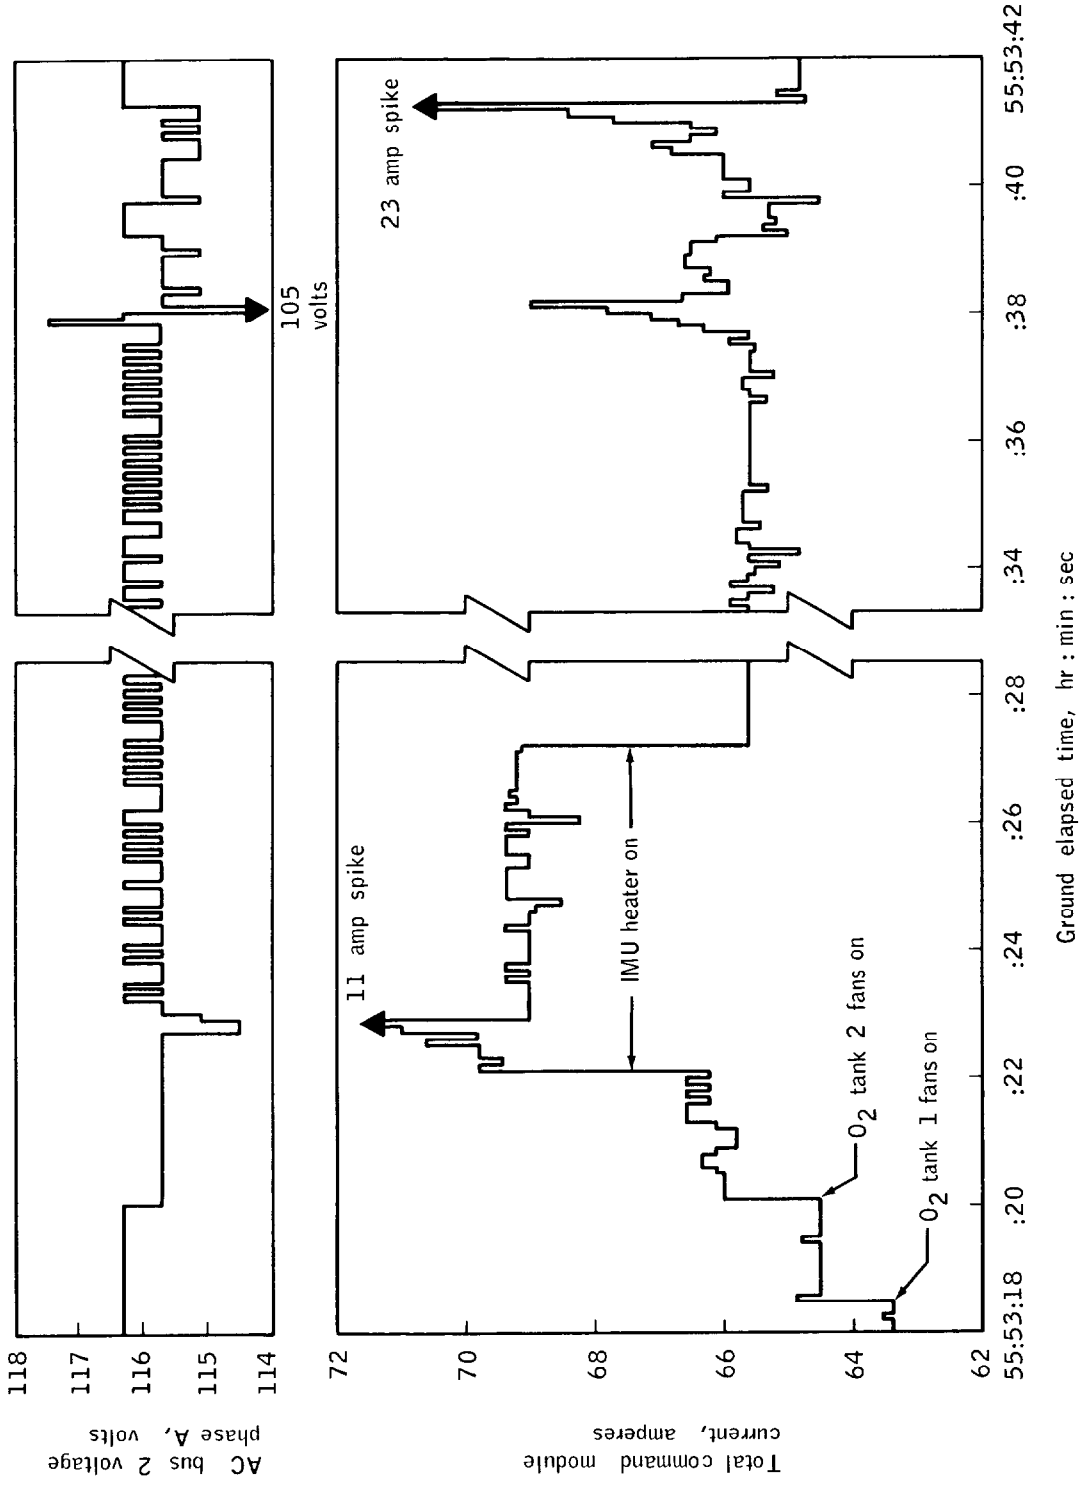
Figure B5-4.- Electrical anomalies.

voltage of 0.6 volt, and a glitch in the stabilization control system telemetry indicated that the fans had been electrically energized. These events are shown in figures B5-4 and B5-5. However, it is not certain that the fans began rotating at this time, since the tank no. 2 pressure showed a minimum observable drop and the fan motor stall current does not significantly differ from the running current. The quantity gage in tank no. 2 was already in a failed condition, and the fuel cell flowmeters were already being affected by the fan operation in tank no. 1 so that neither of these instruments could positively verify rotation of the fans in tank no. 2. During the next 20 seconds a series of electrical anomalies occurred which cannot be explained as a result of known loads in the spacecraft. These anomalies are shown in figure B5-4. The first, at 55:53:23 was an 11-amp positive spike in the output current of fuel cell 3. Several events were associated with this spike:

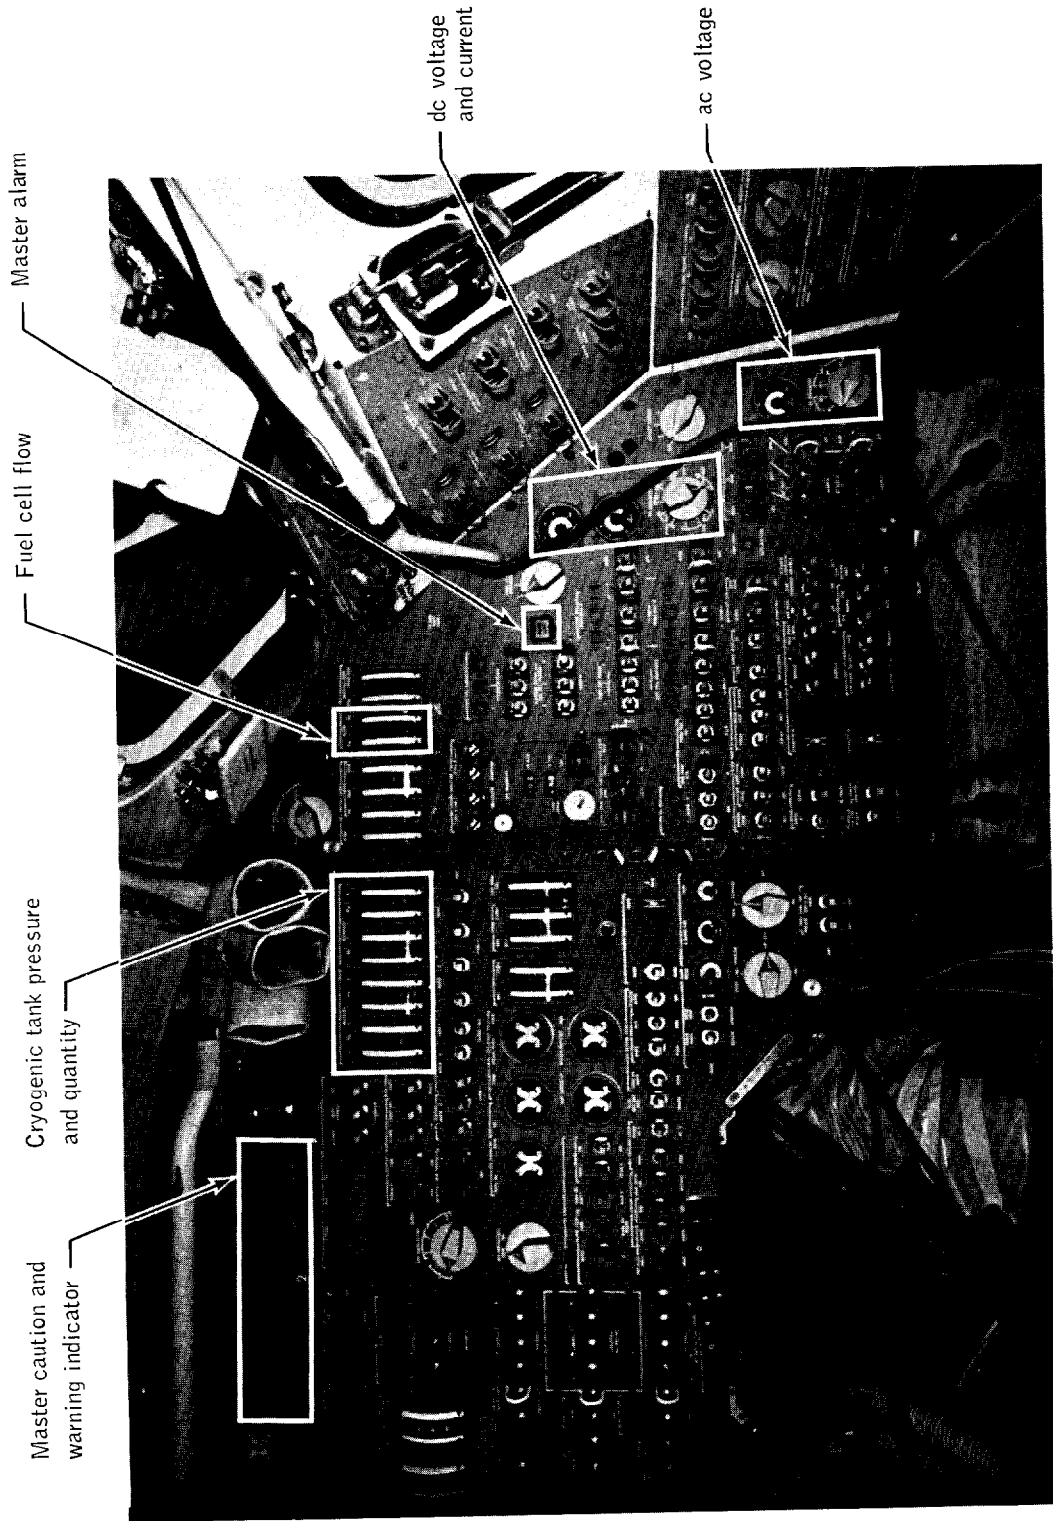
Figure B5-8.- Command module instrument panel.

Approximately at the time of telemetry loss all three crew members heard a single loud bang. One or two seconds later they noted the master caution and warning caused by main bus B undervoltage and at 55:55:00 turned off the alarm. They also verified that fuel cell currents were normal at this time. Figure B5-8 is a photograph of the command module control panel showing the type of displays provided the crew. At 55:55:20 the crew reported, "I believe we've had a problem here," and at 55:55:35, "We've had a main B bus undervolt." Later they reported that a computer restart had occurred at the time of the bang, which had already been noted in Mission Control.

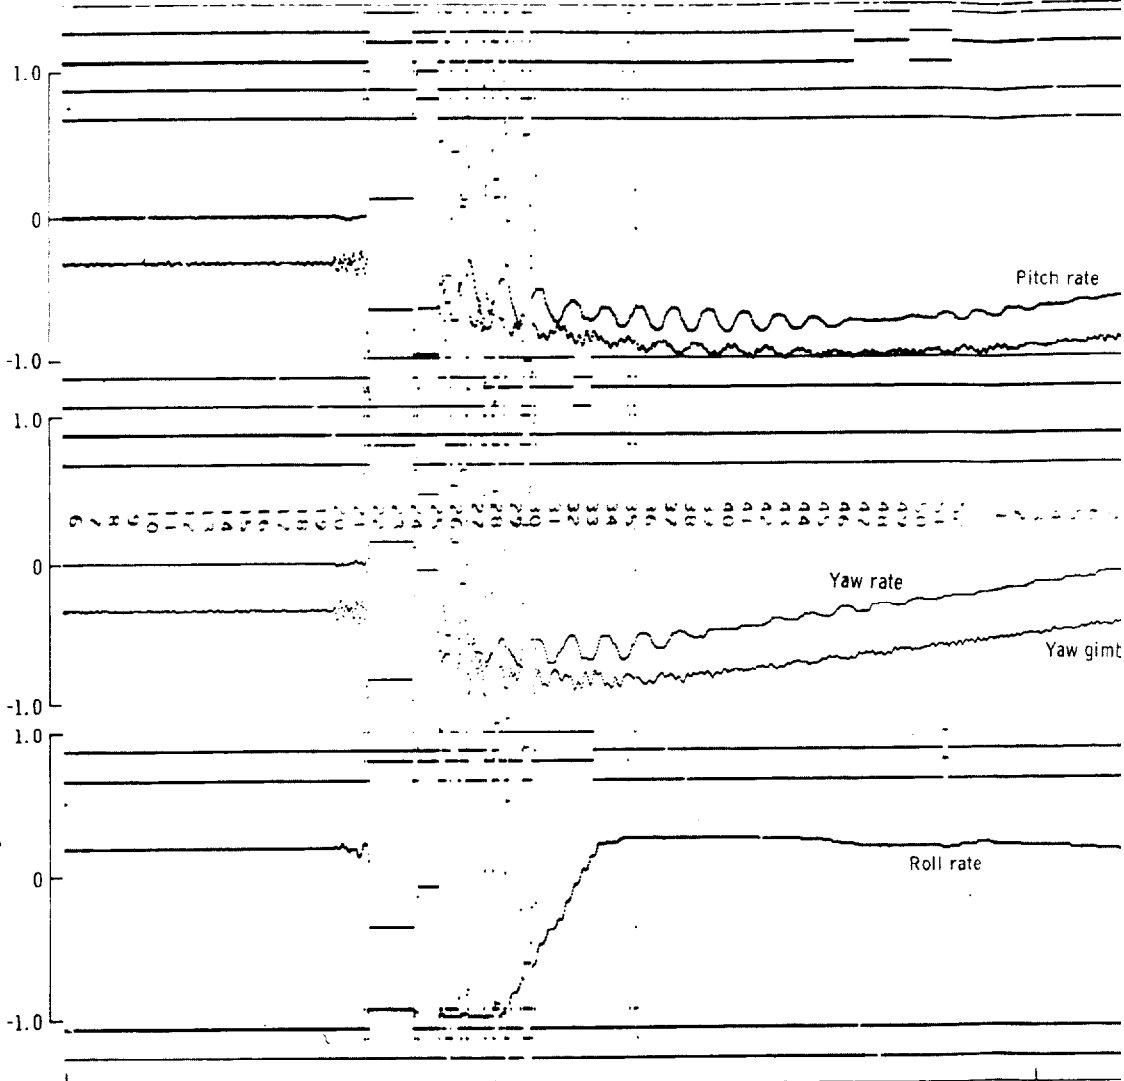
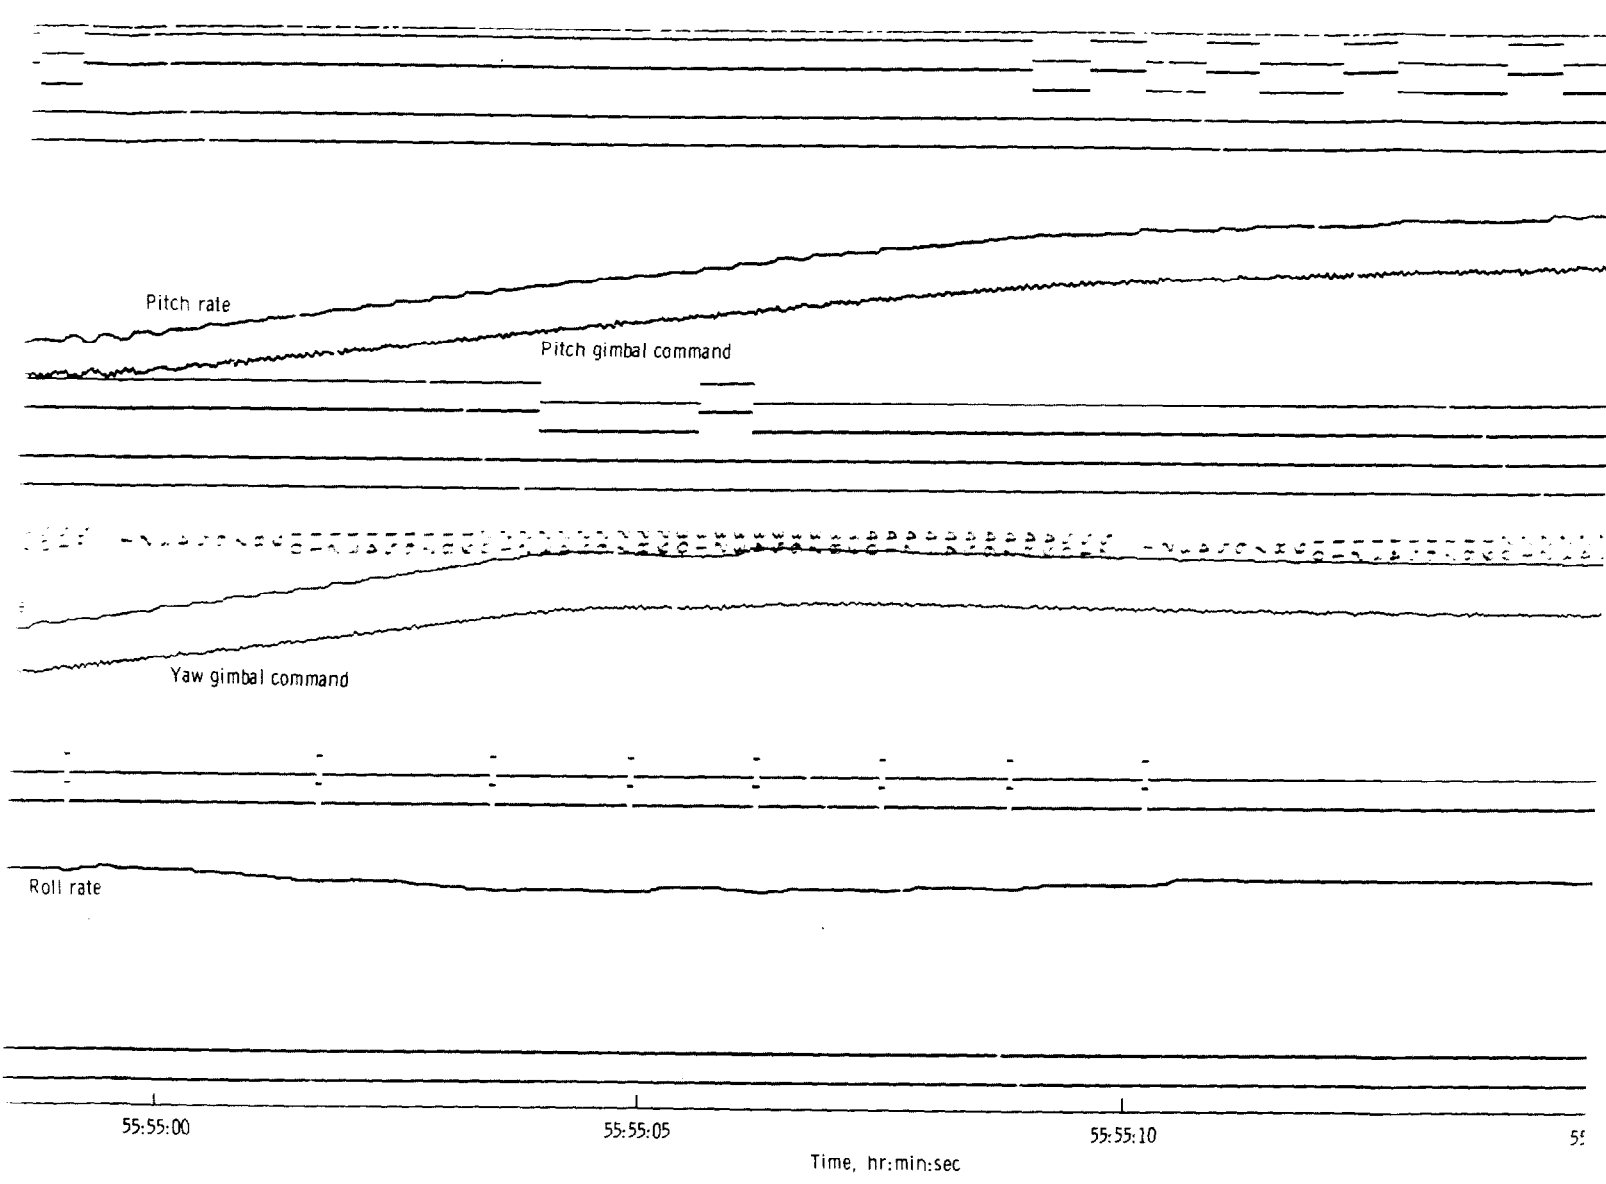
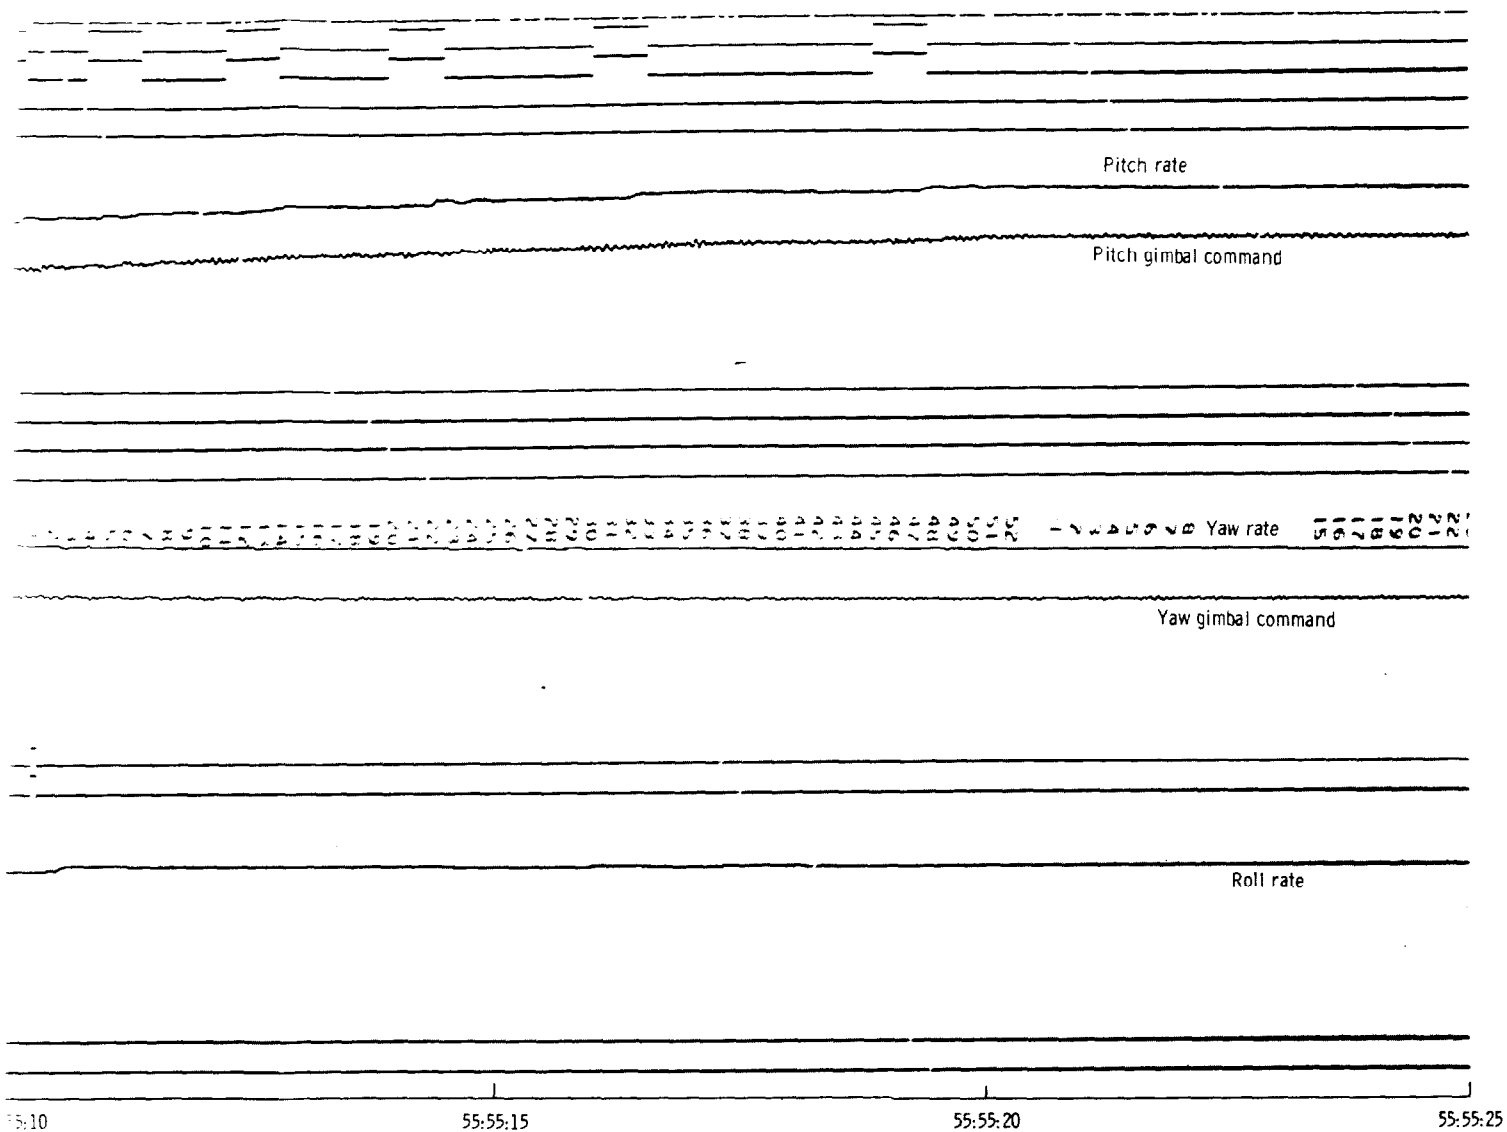
Figure B5-11.- Roll, pitch, and yaw rates.

When transformed from platform coordinates to spacecraft coordinates, this represents a velocity change of 0.4 to 0.6 fps. The uncertainty in this measurement is due to the fact that the PCM system has an increment value of 0.2 fps. The velocity change was combined with the observed roll, pitch, and yaw rates; and a single equivalent impulse acting on the spacecraft calculated. The impulse components are:
