MILL TAILINGS DAM BREAK AT
CHURCH ROCK, NEW MEXICO

OVERSIGHT HEARING
BEFORE THE
SUBCOMMITTEE ON
ENERGY AND THE ENVIRONMENT
OF THE
COMMITTEE ON
INTERIOR AND INSULAR AFFAIRS
HOUSE OF REPRESENTATIVES
NINETY-SIXTH CONGRESS
FIRST SESSION
ON
MILL TAILINGS DAM BREAK AT CHURCH ROCK, NEW MEXICO

HEARING HELD IN WASHINGTON, D.C.
OCTOBER 22, 1979

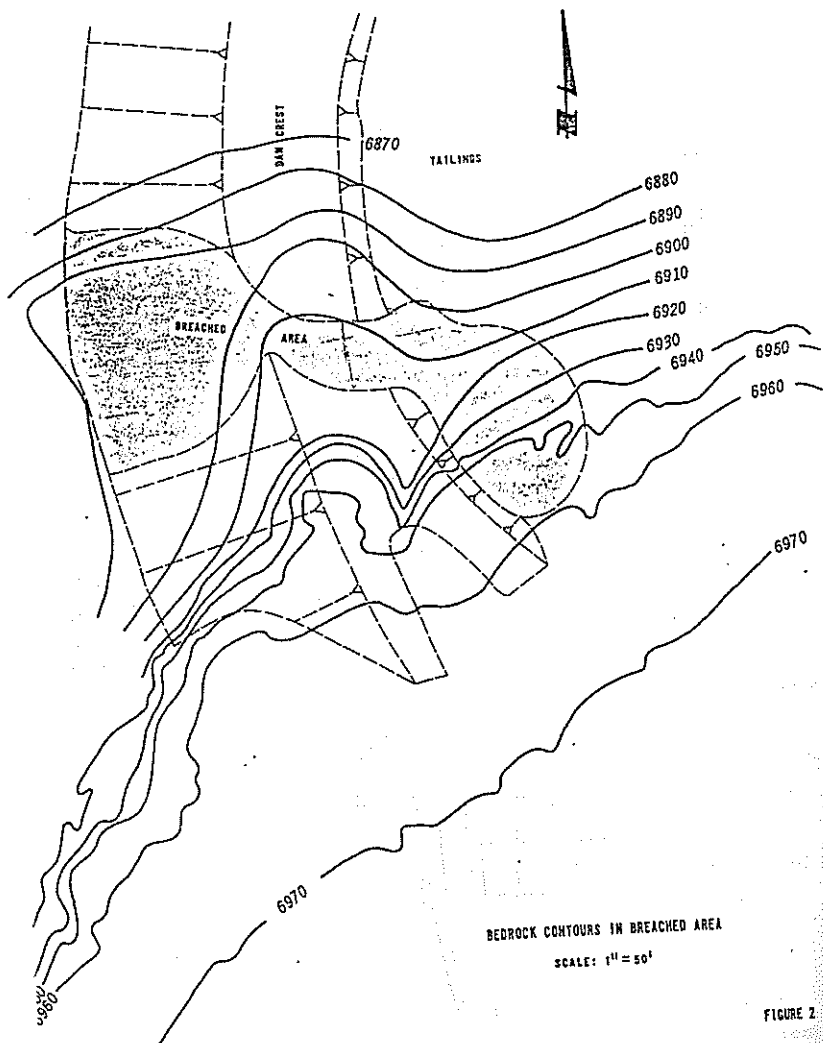
FIGURE 2

The non-uniform and steeply inclined bedrock profile and backfilled arroyo (See Figure 1) and the configuration of the bedrock contours (see Figure 2) jutting from the near vertical rock face above the general level of the alluvial valley floor influenced the non-uniform consolidation and stress distribution in the embankment.

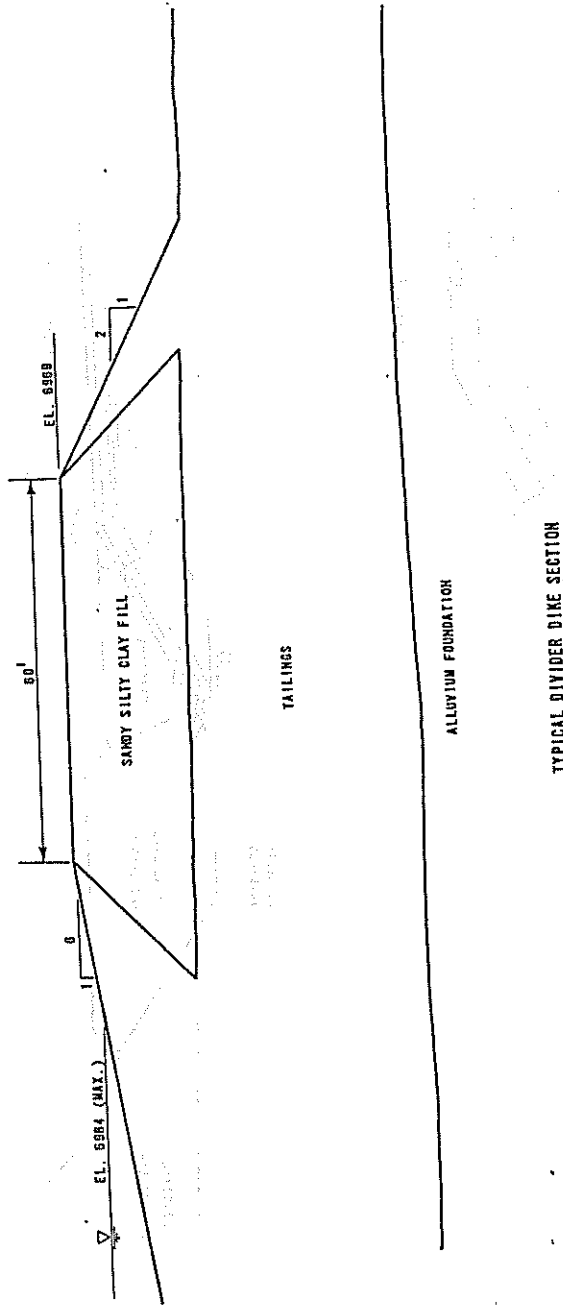
FIGURE 2

Divider dikes to contain tailings in the central and northern portions of the tailings impoundment have been constructed. A cross section of the divider dike is shown on Figure 2.
