Report to the Honorable  
Timothy E. Wirth, U.S. Senate

# NUCLEAR SAFETY

## Reactor Design, Management, and Emergency Preparedness at Fort St. Vrain

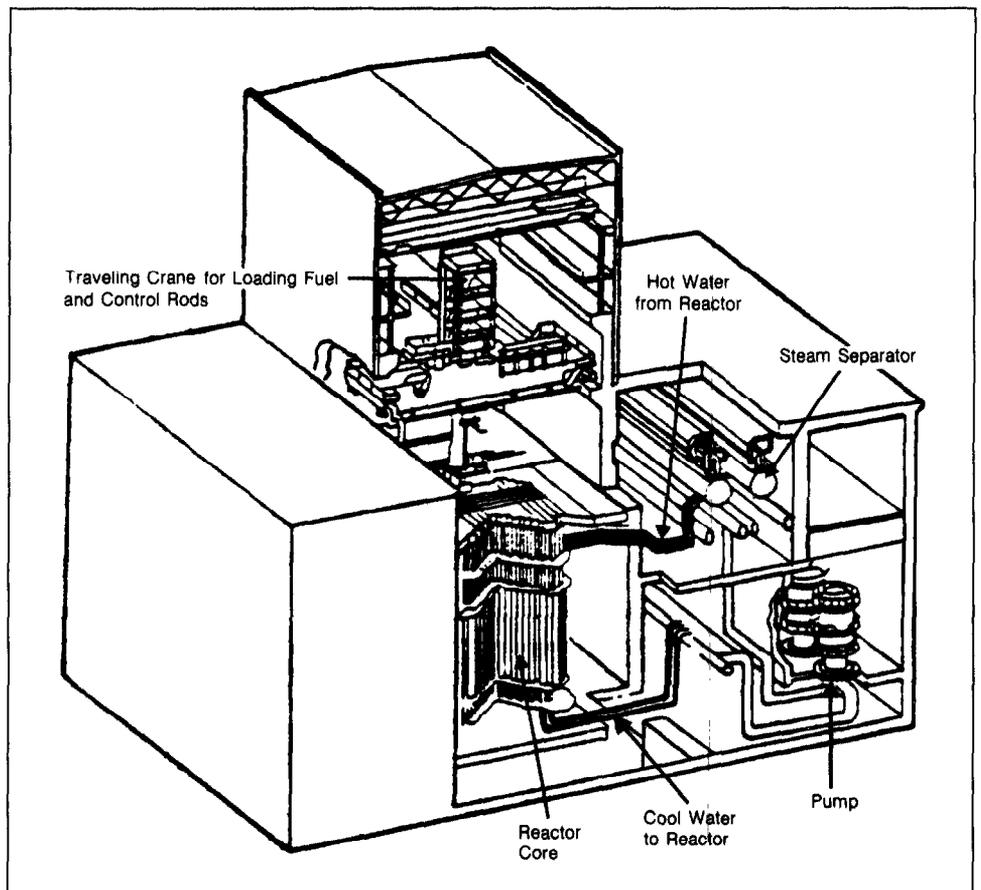
Figure 1.1: Diagram of Chernobyl Reactor

The Chernobyl reactor was housed in a building constructed mostly of concrete and metal. The reactor core was in the middle of the structure and provided steam for two large turbine generators located near the reactor core. Above the reactor was a large crane and support equipment used to refuel the reactor (see fig. 1.1).

The core of the reactor was constructed of graphite blocks stacked together to form a cylinder approximately 23 feet high and 39 feet in diameter. The blocks used to construct the graphite stack were about 24 inches high and 10 inches wide. The core had at least 1,872 vertical channels, or holes, which accommodated 1,661 tubes containing fuel and coolant, and 211 rods to control the reactor. Each fuel tube could be opened at the top to remove old fuel and insert new fuel. The reactor

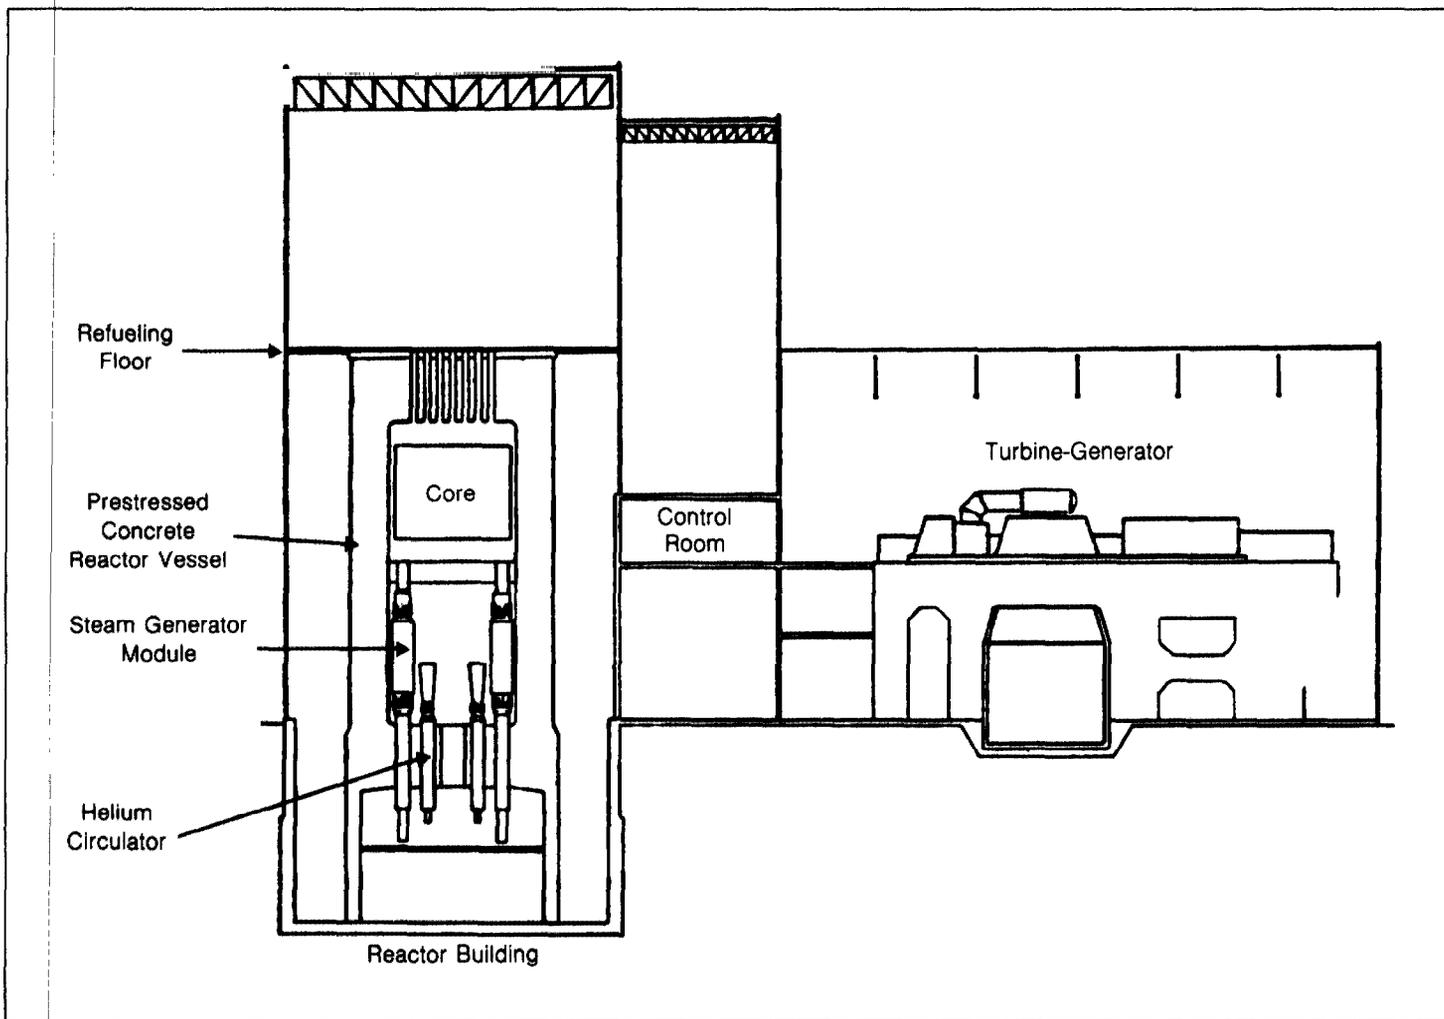
Figure 1.2: Diagram of the Fort St. Vrain Nuclear Power Plant

concrete walls are cooled with circulating water. There are 12 penetrations through the vessel for steam pipes that run to and from the steam generators. Unlike light-water reactors, the entire cooling system and steam generators are encased in the concrete vessel. A more detailed description of the Fort St. Vrain design is presented in chapter 2. A diagram of the Fort St. Vrain nuclear power plant is shown in figure 1.2.

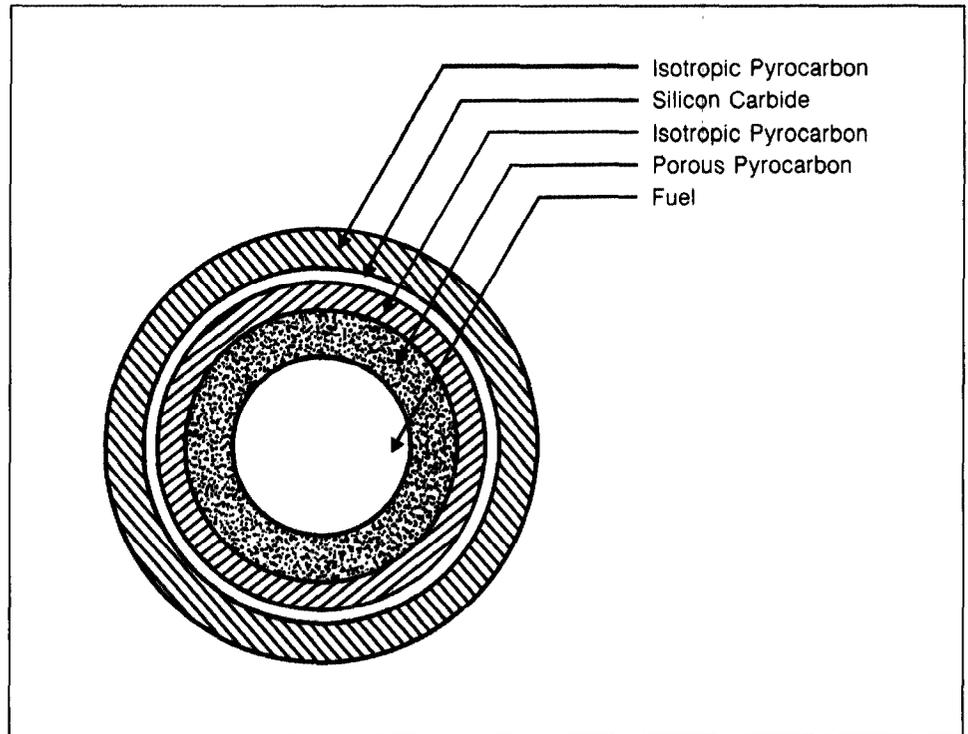
Figure 2.1: Diagram of Fort St. Vrain Fuel

The fuel used in the Fort St. Vrain reactor is fabricated by applying four separate coatings around micro particles of uranium and thorium fuel (see fig. 2.1).<sup>2</sup>

Each of the coatings has a separate function in protecting the fuel from damage during normal operations and accident conditions. The coating directly adjacent to the fuel is a porous pyrocarbon<sup>3</sup> material that allows for expansion and accommodates radioactive gases created when thorium and uranium atoms are split. The second coating, isotropic pyrocarbon,<sup>4</sup> provides the first barrier to release of fission products. The third coating, silicon carbide, is another form of carbon that resists high temperatures and prevents metallic fission products from escaping outside the fuel. The outer coating is the same as the second, isotropic pyrocarbon, and is used to compress the silicon layer to prevent it from cracking.

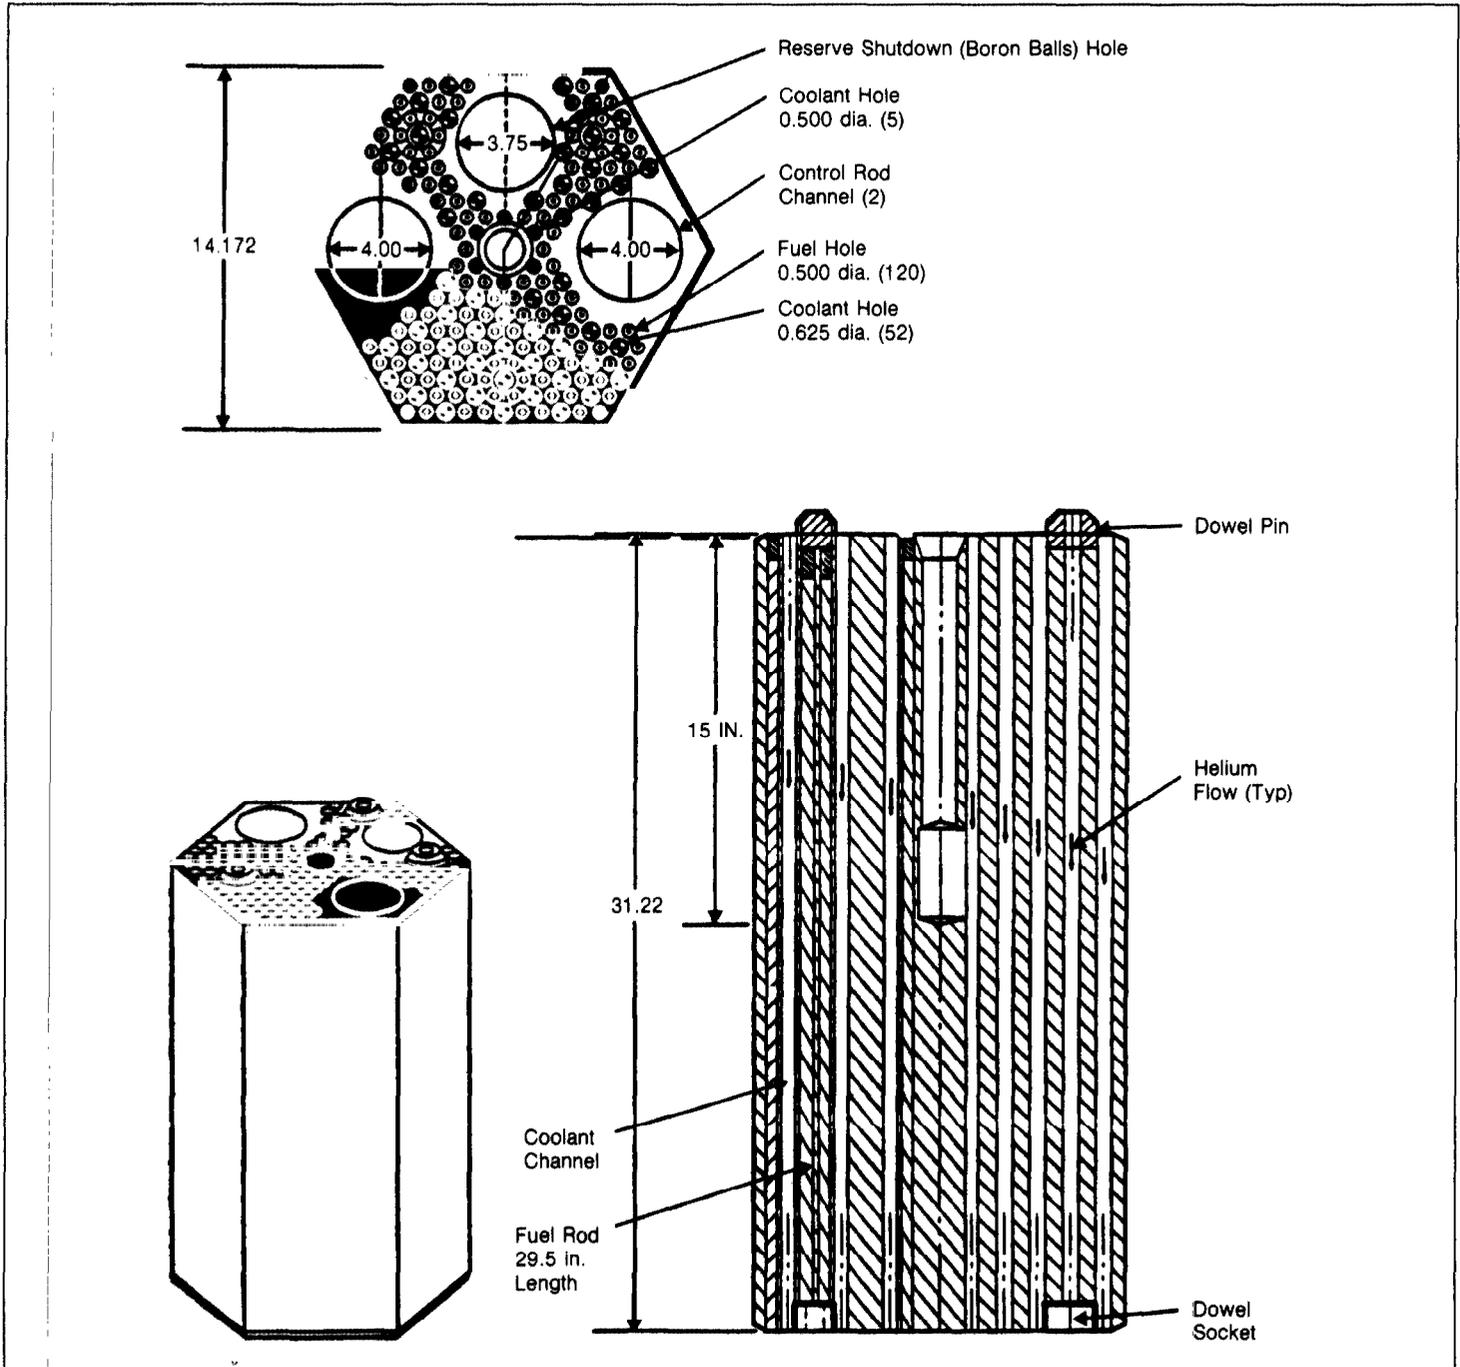
Figure 2.2: Diagram of a Fort St. Vrain Reactor Graphite Core Block

The reactor core at Fort St. Vrain is constructed primarily of hexagon-shaped graphite blocks stacked in columns to form a structure approximately 15.6 feet high and 19.5 feet in diameter. The structure contains about 1,500 tons of graphite. Each block is about 31 inches high and 14 inches across (see fig. 2.2).

The blocks are stacked in columns in a dowel and pin arrangement that aligns each block. The reactor core consists of 247 vertical columns that are about 6 blocks high. The coolant holes extend vertically through each column, thus permitting the gas coolant to flow completely through the core structure.

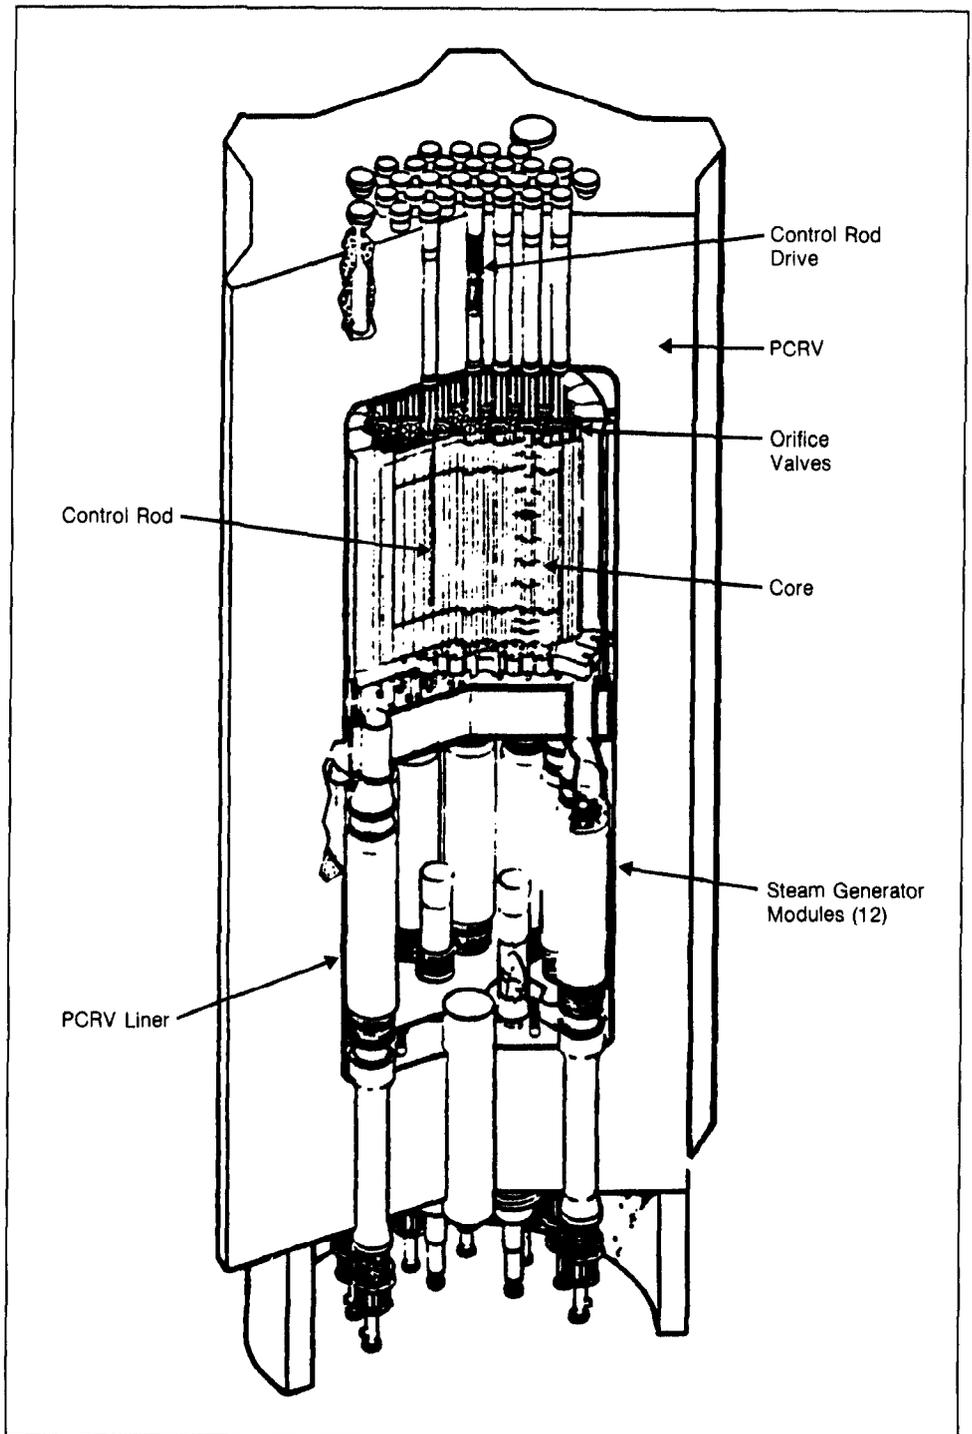
Figure 2.3: Diagram of Fort St. Vrain's  
Pressurized Vessel

The pressurized vessel that acts as a containment at Fort St. Vrain houses the core, coolant circulators, steam generators, and other components in a large reinforced concrete pressure vessel. The reactor core and other components are located in a cylindrical cavity inside the vessel, which is 31 feet in diameter and 75 feet high. The walls around the cavity are a minimum of 9 feet thick, and the top and bottom walls are 15-1/2 feet thick (see fig. 2.3).

The helium gas coolant, which fills the cavity inside the pressure vessel, is pressurized to about 688 psig, thus requiring the concrete to be reinforced to contain such pressures. This is accomplished by a network of 448 wire or cable tendons that run vertically through the vessel, around it, and across the top and bottom. The tendons are attached to steel plates located on the outside walls of the vessel. The tendons are stretched tight and fastened to the steel plates, which actually compress the entire concrete vessel. The tendons limit any expansion or distortion that might occur during reactor operation and enable the pressure vessel to accommodate up to 1,875 psig. In addition, there are two pressure rupture discs that are designed to release at 845 psig to serve as protection against overpressurization.

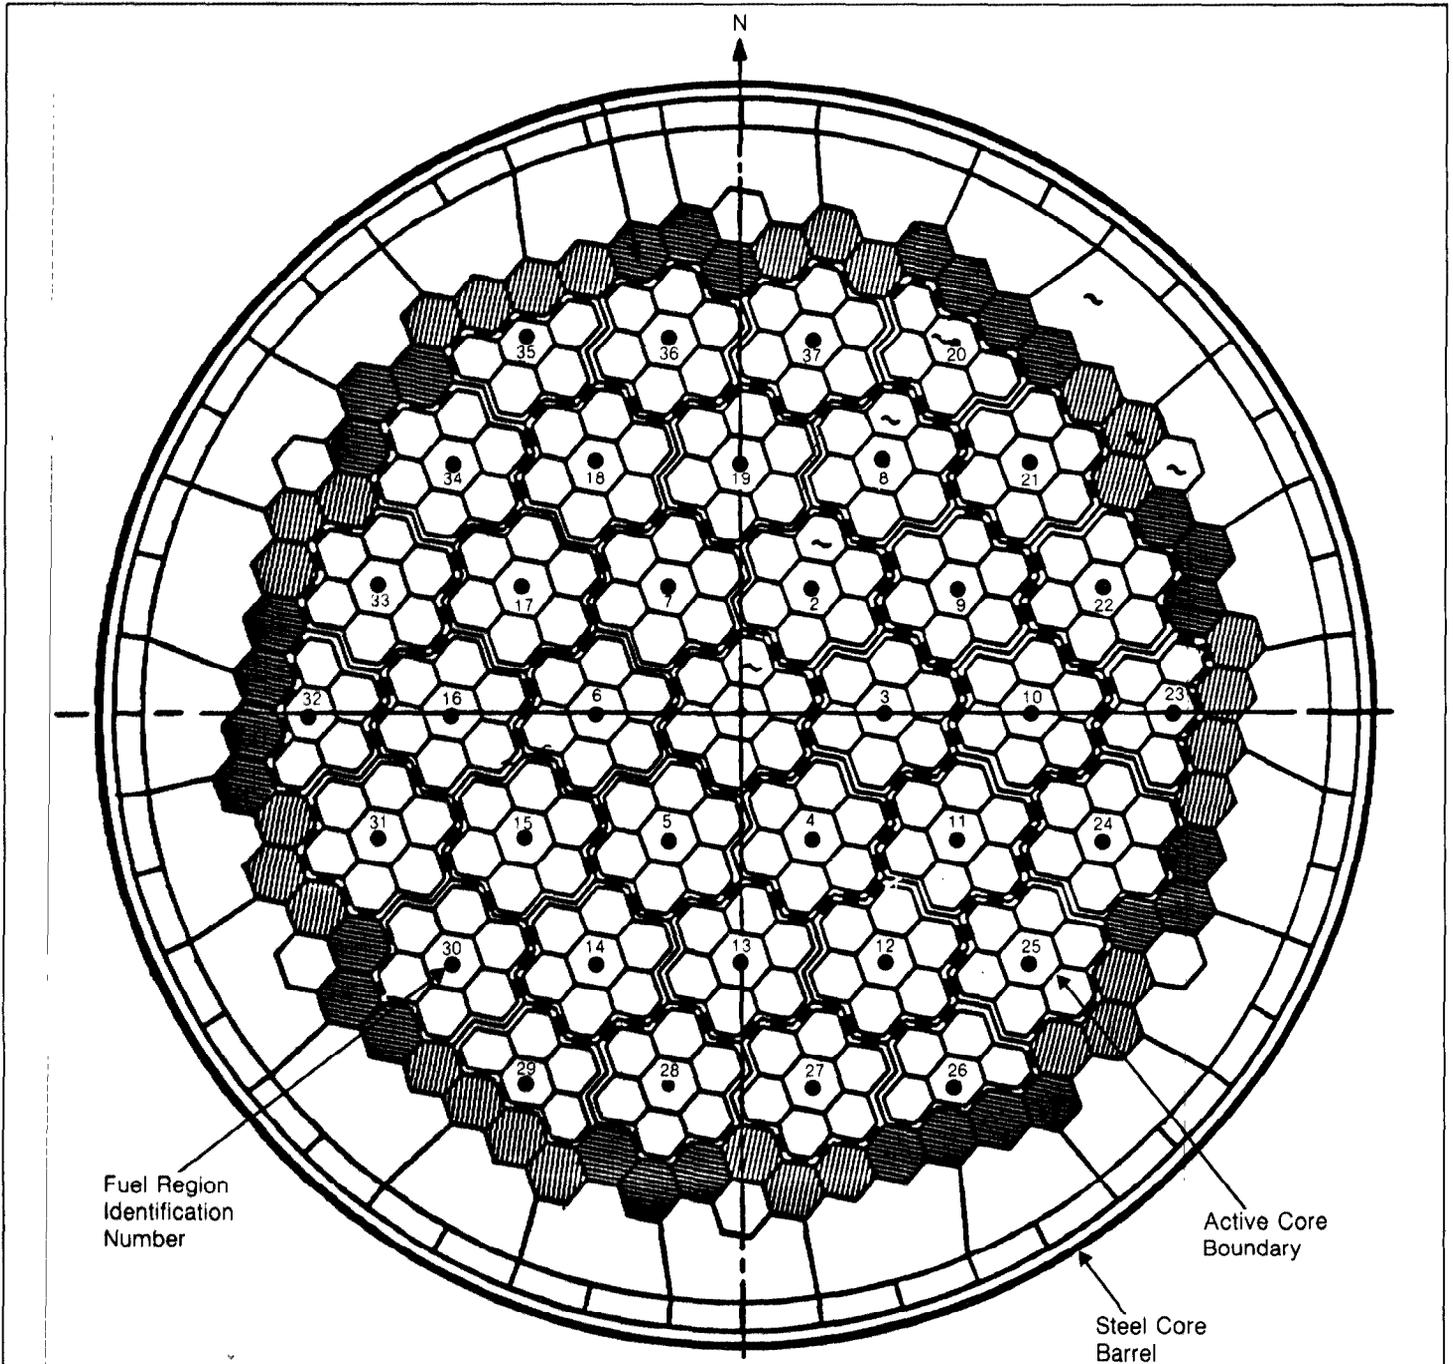
Figure 2.4: Diagram of Fort St. Vrain Fuel Regions

The Fort St. Vrain reactor is controlled by regulating the coolant flow and positioning the boron control rods in 37 separate areas called "fuel regions."<sup>8</sup> Each fuel region, which normally contains seven vertical columns (with the center column containing channels for two control rods and an emergency safety system) is covered at the top with a hood-like arrangement that seals the fuel region. (See fig. 2.4.)

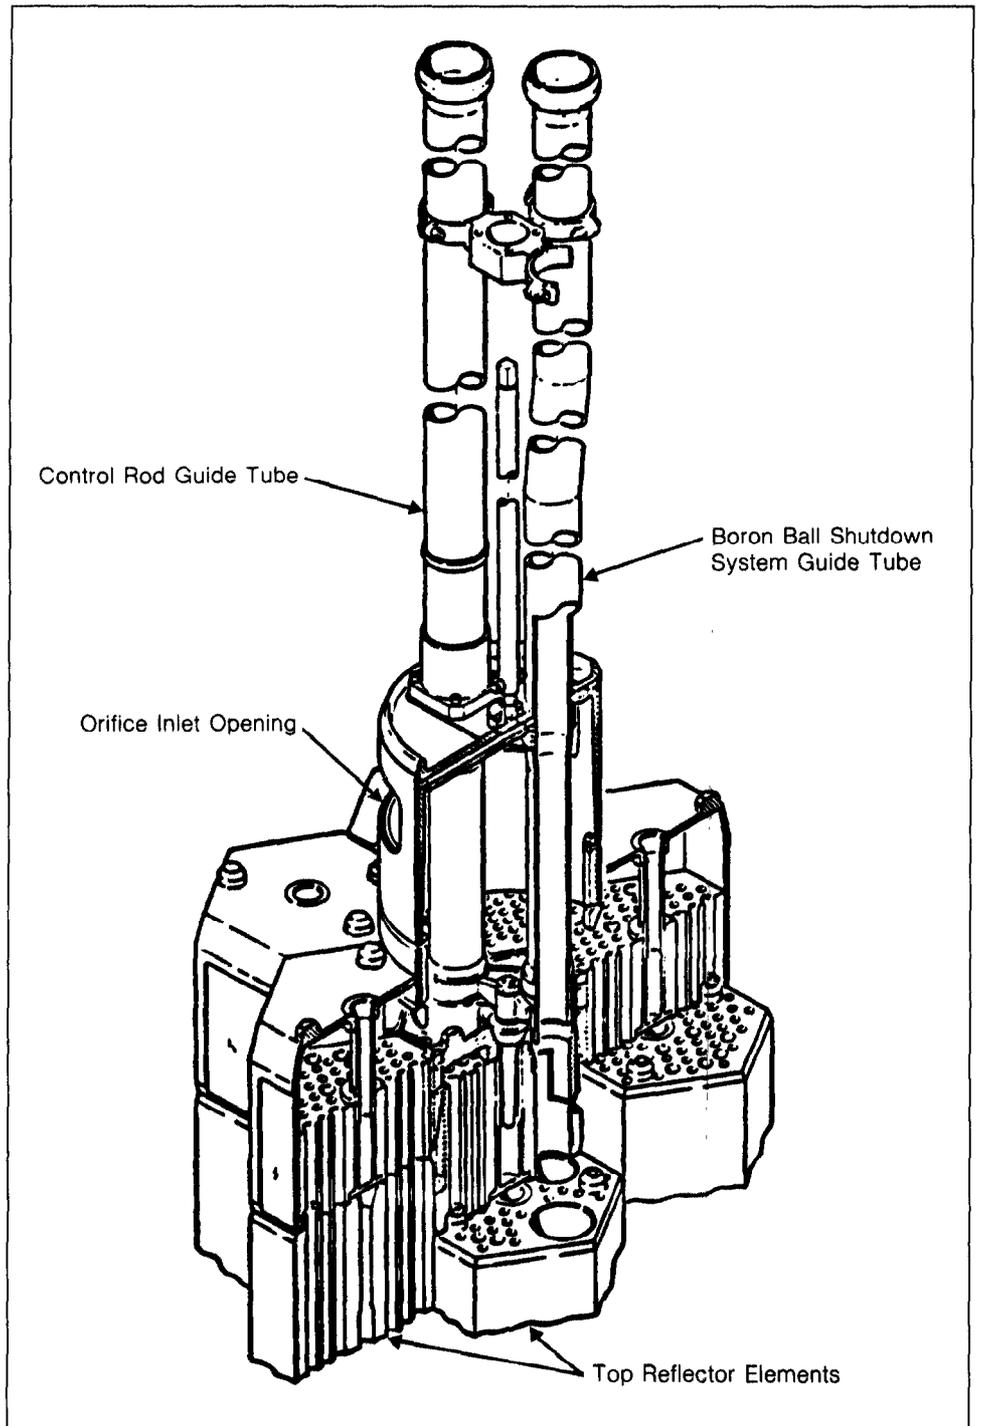
Figure 2.5: Diagram of Control Rod Mechanism

The control rod mechanism, which penetrates the hood, is also sealed (see fig. 2.5).

Coolant to each fuel region is controlled by an inlet hole or orificing device that is monitored and regulated from the reactor control room. Control rods are also monitored and regulated from the control room.
