Remote Control

by Malgorzata K. Sneve

Russia's northwest coastline is dotted with hundreds of old and large radioactive sources. Known as RTGs, they mostly power remote lighthouses. Now the power packs are being safely dismantled. Norway is helping Russia do it.

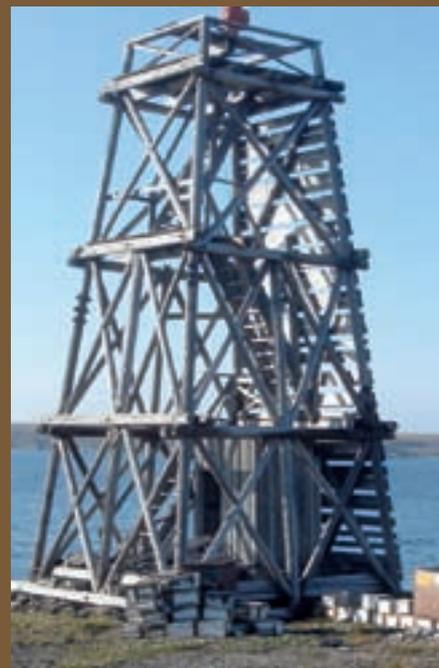
what is an RTG?

A Radioisotope Thermoelectric Generator (RTG) is a simple electrical generator which is powered by radioactive decay. In an RTG, the heat is released by the decay of a radioactive material and converted into electricity using an array of thermocouples. RTGs can be considered a type of battery and have been used as power sources in satellites, space probes and unmanned remotes facilities such as lighthouses. RTGs are usually the most desirable source for unmanned and unmaintained situations needing a few hundred watts or less of power for durations too long for fuel cells, batteries and generators to provide economically and in places where solar cells are not viable.

In spite of this, RTGs are still a potential source of radioactive contamination: if the container holding the fuel leaks, the radioactive material will contaminate the environment. To minimize the risk of the radioactive material being released, the fuel is stored in individual modular units with their own shielding.
